BAKER STREET STATION ACCIDENT – 14 JUNE 1925

by Michael Hayward

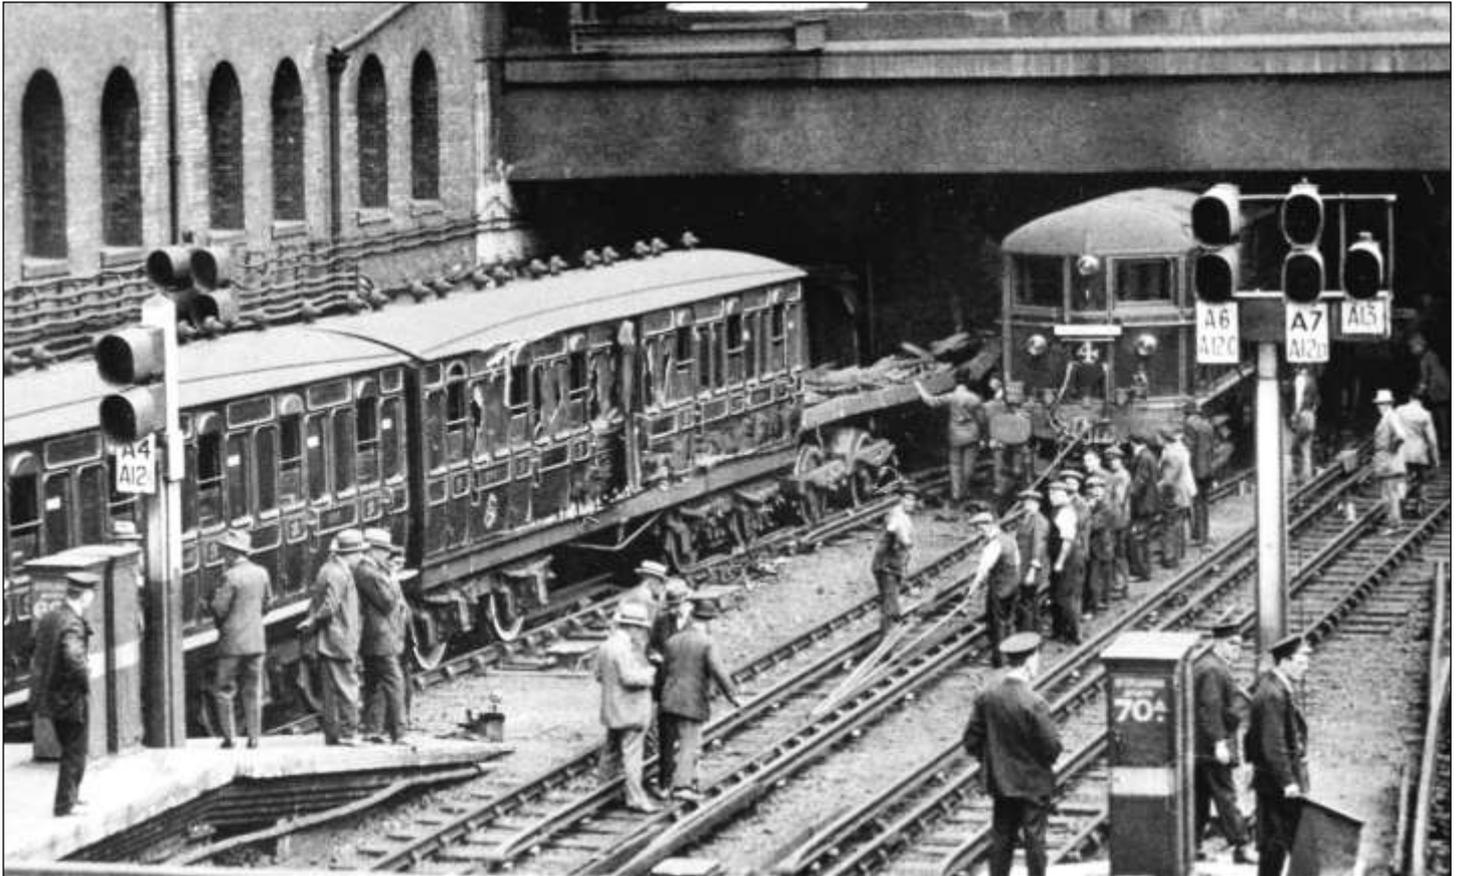
The photograph (Above) of the aftermath of the accident that occurred at 10.28 on Sunday 14 June 1925 at the Metropolitan Railway's Baker Street station was found amongst the photographic collection of the Manchester Locomotive Society but has little to trace its origins. It shows the railway officers and staff hauling electric locomotive No.4 away from the carriages that it had hit earlier. The following has been printed on the reverse of the photograph:

"In this case the electric locomotive, running light, was being shunted out of No.2 road and came into side-long collision with the 9.42 a.m. passenger train from Uxbridge, as the latter was crossing from the up line to No.1 platform road. The locomotive struck the second, third and fourth coaches, the body of the latter being knocked off the under frame and thrown outwards. The wheels of the fifth coach and the two back wheels of the leading bogie of the locomotive were derailed, and nine passengers complained of injury – some of these were taken to hospital but were not detained. The locomotive guard was also injured".

The photograph shows the wreckage of the multiple unit and the locomotive (No.4) being manually pulled back from the point of collision by means of a pulley block and hawser. The body of the fourth vehicle, seen on the right (First Trailer No.362) is nowhere to be seen, with only its leading bogie and under frame on view. When looking closely at the photograph I noticed that the diameter of the wheels on the exposed bogie appear larger than that on the adjacent Third Trailer No. 344 though I would have expected them to be the same. Is this correct? The Third Trailer No.399 looks intact with no apparent damage though the Report mentions some damage to windows and footboards to both Third Trailers.

staff were involved in signalling by means of hand held flags. The disputed shunt signal (No.12^B) can be seen on the left at the end of Platform 2 with the starting signal (No.4) above it on the same post though the associated trainstop cannot be seen in the photograph.

The track work was repaired and Inspector Alder tested the signals at 22.08 before ordinary working was resumed. Though Sunday was not a busy day for the Metropolitan Railway, nevertheless it must be to their credit that traffic returned to normal so quickly.

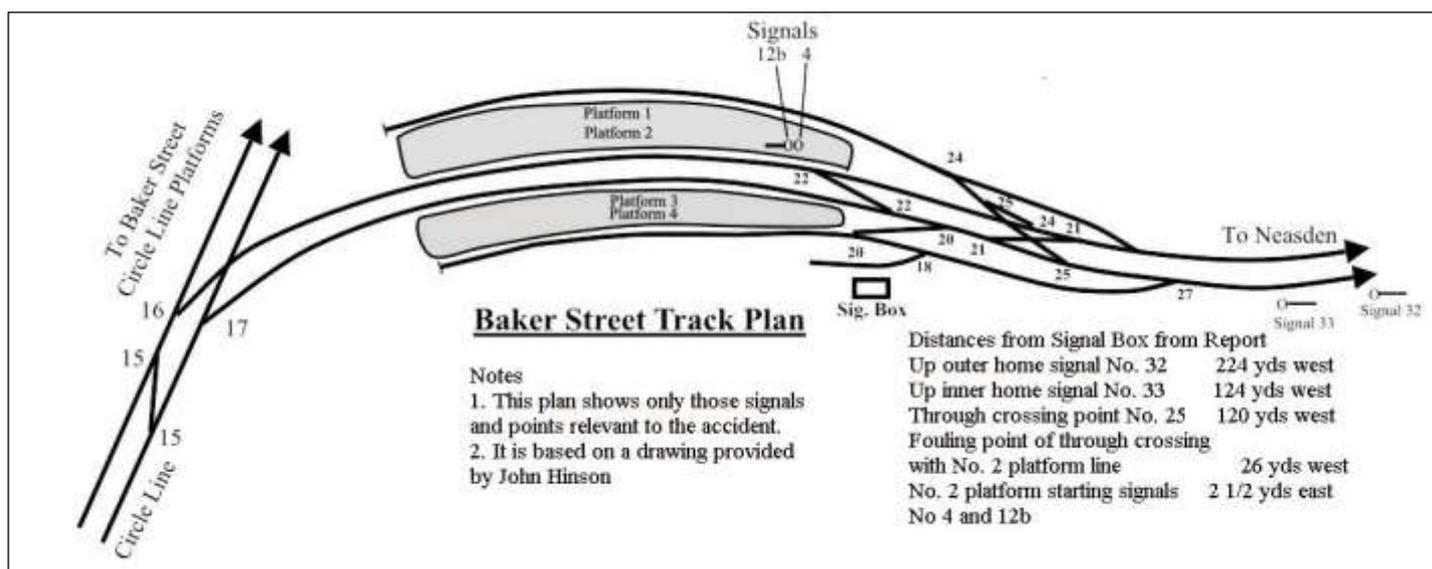
TRACK LAYOUT

The diagram shows the track layout as it was in 1913 which I understand was the same in 1925. At their other end, platforms lines 2 and 3 formed a double junction with the Circle Line. They then curved sharply northwards so that a motorman operating from the rear cab of a locomotive moving from the Circle Line along Platform 2 line would sight number 12^B shunt signal at a distance of 76 yards but loose sight of this signal after running a further distance of 30 yards due to the curvature of the line. However, an assistant motorman in the front cab would have a continuous view of No 12^B for a distance of about 110 yards before passing it.

- Motormen to change their position and drive from the leading end whenever the direction of movement is reversed.
- The braking distance between No.12^B signal and the fouling point of the through crossing in advance was short (85ft 7ins) and unless speed was reduced to less than ten miles an hour, the margin for over-run was insufficient.
