# DISTRICT ELECTRIC TRAINS

## 25 – CATCHING UP

by Piers Connor

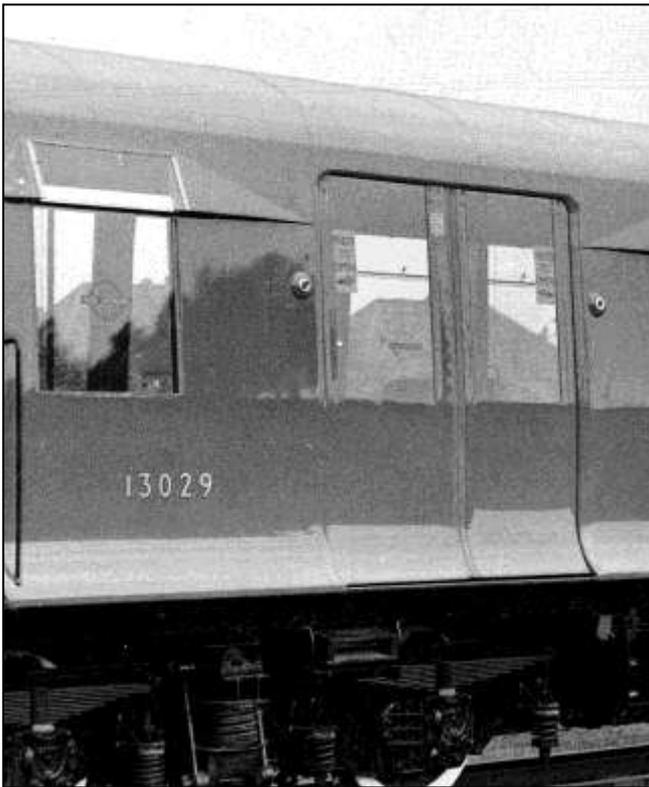
*Fig. 1: Part of O Stock motor car showing the door glazing slightly offset (by almost an inch) in one door. Photo: LT Museum.*

To begin with, Mike sent in these two photos to show that O Stock double-door pairs (Car 13029, Fig. 1 on the left) were not symmetrical but that P Stock doors (Car 14200, Fig. 2) were. He writes that one door of a pair (and presumably the single door when not a double doorway) had a wider leading edge on the O Stock to carry the door control button on the door, but it was not fitted there. Buttons were fitted on the bodysides instead. As far as we know, all P/Q Stock had symmetrical doors. This is fairly obvious from photos if you are looking for it. Mike suggests correctly that my list isn't very clear and it implies that 'door frames were slightly bigger'. Here we have a better idea of what was going on. From inspection, Mike says, it seems that the doors were all same width but that the glass was slightly offset on one door of pair (between half and one inch) on the O Stock only. The photos also show that the external door buttons appear different on O Stock compared with P & Q Stocks.

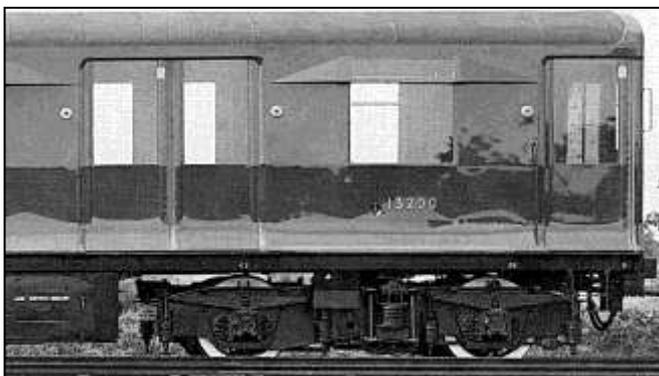
*Fig. 2: Part of P Stock motor car showing symmetrical door glazing. Photo: LT Museum.*

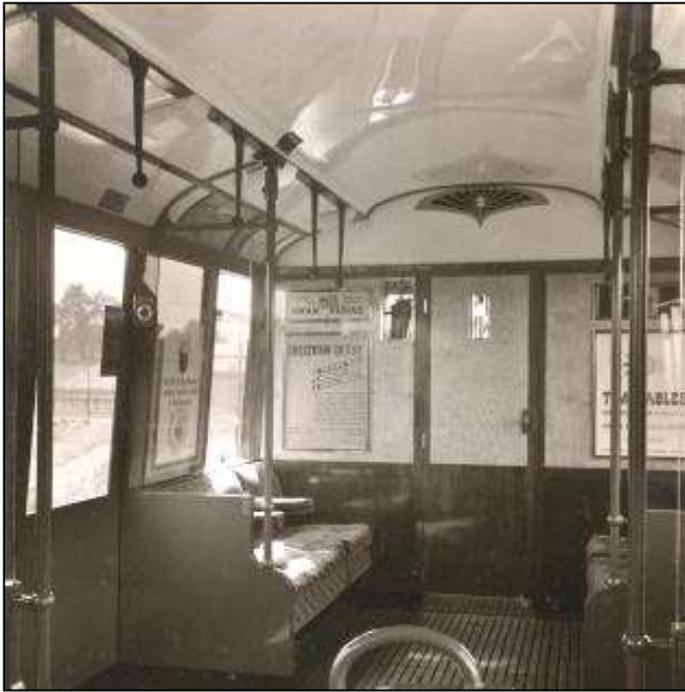
*Fig. 3: Interior of O Stock "D" motor car with end ventilation grille which was unique to this stock.*

There was, as Mike suggests, a variety of interior ventilation arrangements. The photo (left, above, Fig. 3), shows an interior of the driving end of an O Stock "D" end motor car of the 140xx series. It was the only O Stock location that had an interior ventilator grille and rather stylish it was too. The photo on the right (Fig. 4) shows the trailing end plain cover over the end door of the 130xx "A" driving car.

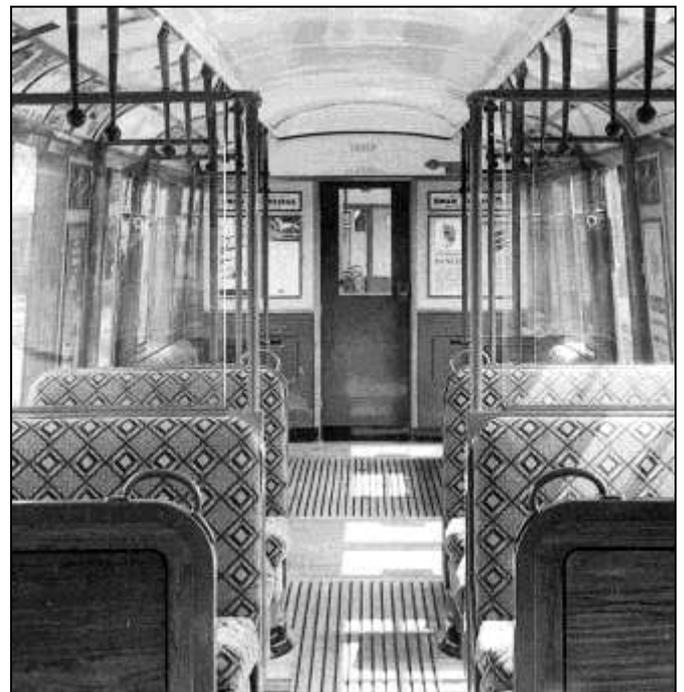
*Fig. 4: There is no ventilation grille on this trailing end of an O Stock "A" motor car. Photo: LT Museum.*

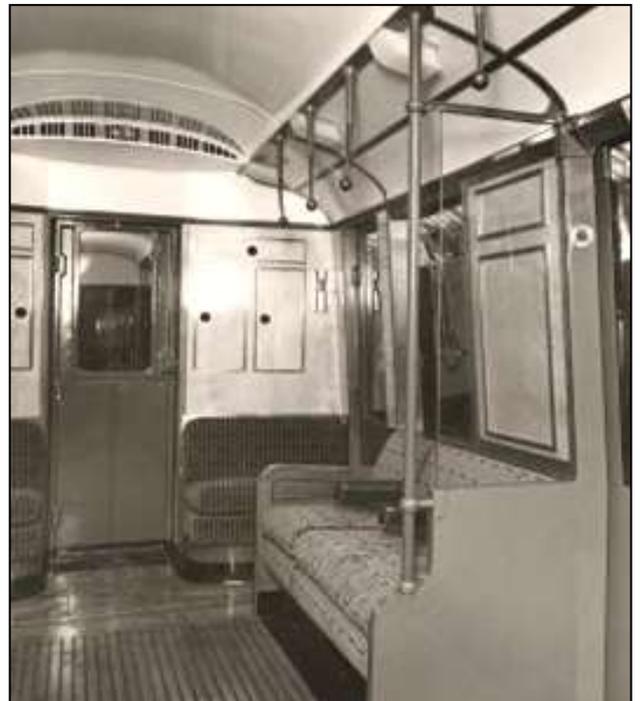
*Fig. 5: Ventilation grille on trailing end of a Q Stock trailer. This is the dummy cab end. Photo: LT Museum*

The lower photo on the right (Fig. 5) shows the style of end grille that P/Q Stocks had at both ends of all cars. It also reminds me that the communicating doors of the dummy cab ends of Q Stock trailers were of pressed aluminium, while the others were pre-fabricated and covered with steel panels. I wonder if they were interchangeable. I doubt it matters to anyone now but it must have been important to the shed staff who had to look after them. I do remember that all these end doors had small egg-shaped handles on the inside which were just too small to get a proper grip on and which made opening a sticky door very difficult, particularly if you were walking through the train trying to carry your bag, your tea and the driver's without spilling anything. If you were sensible, you carried your door key in your pocket to avoid the risk of dropping it between cars as you walked through. One guard, who did that whilst walking through his train in the yard, got out of the train and down onto the ballast and reached between the two cars to retrieve it. As he reached over the current rail, his steel watch strap, which he wore rather loosely, touched the positive rail and he received a nasty burn. It left a mark on his wrist which took several weeks to heal.

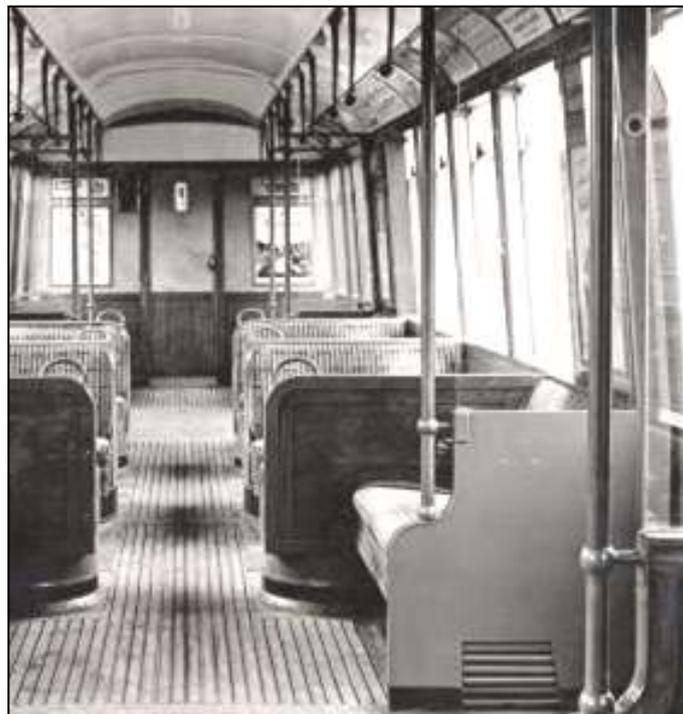
*Fig. 6: Interior of P Stock "A" motor car showing Metadyne ventilation grille at the base of the draught screen. Photo: LT Museum*

Mike points out an extra grille. In the photo on the right (Fig. 6) of the interior of a P Stock motor car, a large vent grille can be seen at the base of the draught screen. This was part of the Metadyne ventilation system unique to the P Stock version which thus did not appear on the O Stock. There were two such grilles. The other was in the seat riser of one of the transverse seats.

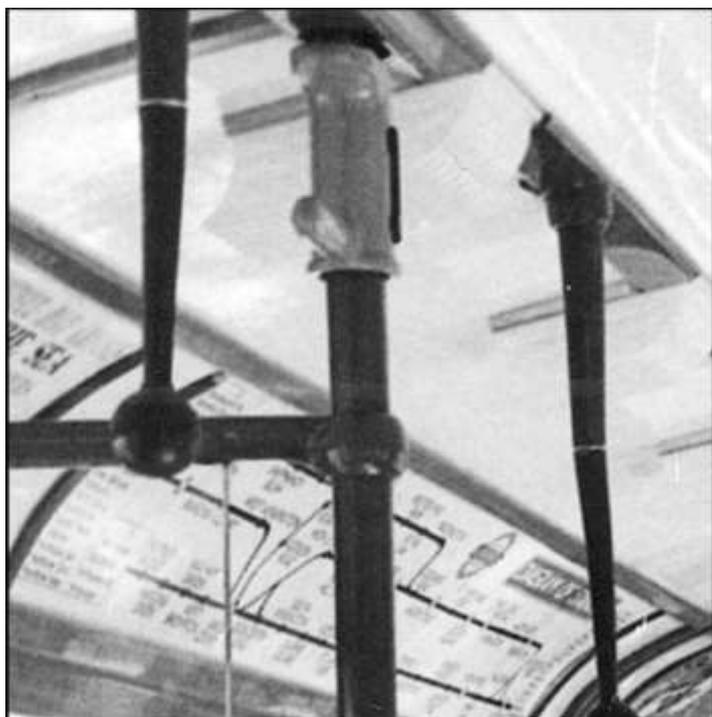
*Fig. 7: District Railway type of pull-down passenger emergency valve as used on O Stock. Photo: LT Museum.*

There were two types of passenger alarm handles. Mike points out that O Stock intermediate passenger emergency handles had a kind of collar at the top of some of the grab poles – these were fitted with stub arms and to operate them – the whole device was pulled down, opening a valve somewhere (see below left). This arrangement had already been in use on the District, having been introduced on the K Stock in 1927. The P/Q Stock cars had a different setup – a simple valve with an operating lever (see above right). Mike notes too that the trailing end bulkhead passenger emergency alarms also varied in type and position, but this conformed with many other trains where the Passenger Emergency Valves (PEV) was placed more conveniently for the guard's use, usually next to the air brake pressure gauge.

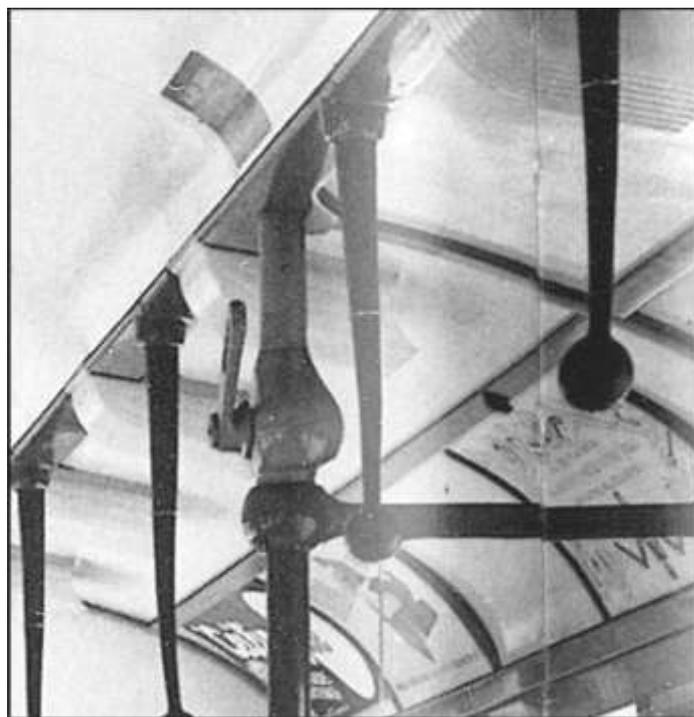
*Fig. 8: Lever type of pull-down passenger emergency valve as used on P & Q Stocks. Photo: LT Museum*

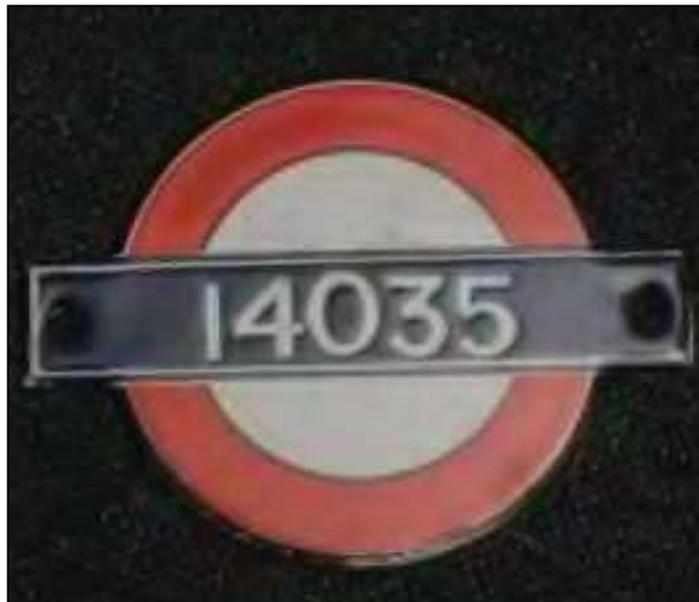
*Fig. 9 (Left): O Stock interior number plate as used on the "D" or 140xx cars. It was screwed to the ventilator grille over the end doors. The "A" cars had no grilles and the numbers inside the cars were transfers.*

Finally, in the information he sent me, Mike added me a couple of photos of the internal car number plates. Of course, they were different on the P Stock when compared with the O Stock as shown in Figs. 9 and 10.

Interestingly, the O Stock plate uses a non-standard typeface, whereas the P Stock one (Fig. 10) uses the corporate standard. I very much doubt there was a "standards manager" who complained that the O Stock plate didn't meet the design criteria but I suspect a very senior person would have inspected the vehicles and pointed it out. My thanks to Mike for gathering all this extra information.

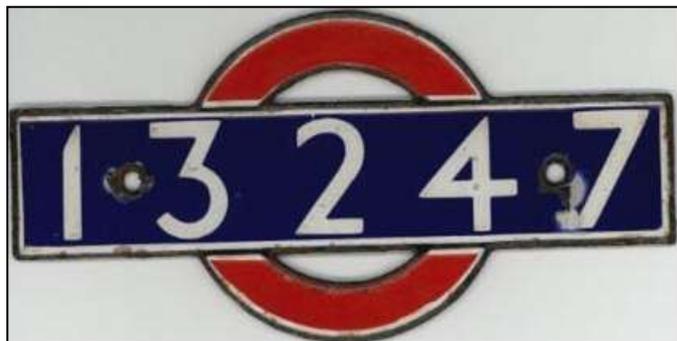
*Fig. 10 (above): A P Stock number plate. This was*

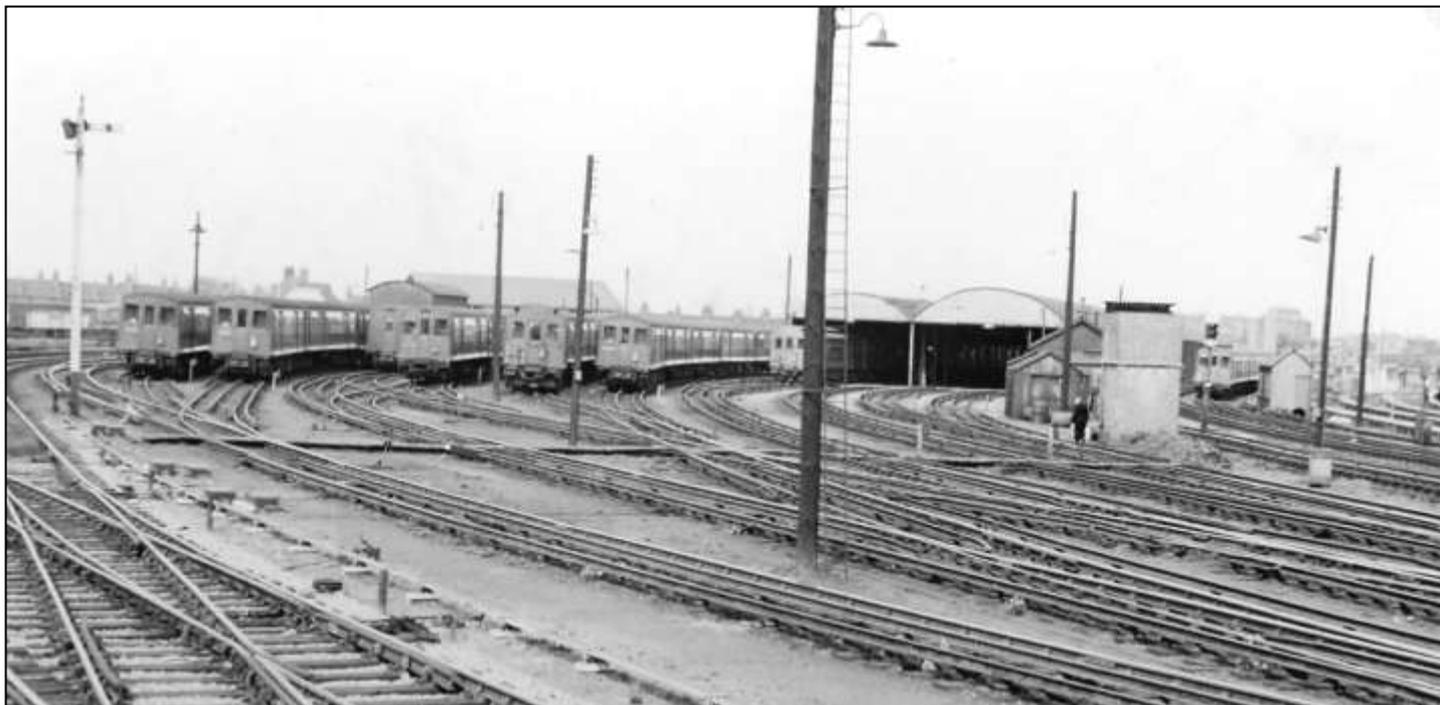
*Fig. 11: Little Ilford Sidings looking east. Photo: The late Alan A Jackson.*

Now, a look at some of the odds and ends, starting with depots. There is often much to be learned from photos of depots. In this selection, we get a flavour of what was going on in three District depots in the 1950s. The first photo (Fig. 11 above) is a well known view of Little Ilford Sidings taken about 1956 before it was demolished to allow the new main line depot for the electrification of the London, Tilbury & Southend line. The site was never officially known as "East Ham Depot", the depot being the LT designation of the train crews signing on point. The office was at track level at the west end of the station – a long walk from here.

This photo shows the diversity of the fleet at the east end of the District. Looking from left to right, the first two trains are O Stock for the H&C, there's then a 2-car east end R Stock unit and then a complete R Stock train. Next is a Q Stock, an H&C and another Q inside the shed. On the far right is a westbound R Stock train coming from Barking. The present westbound track is roughly where the non-electrified track in the foreground left is in this photo.

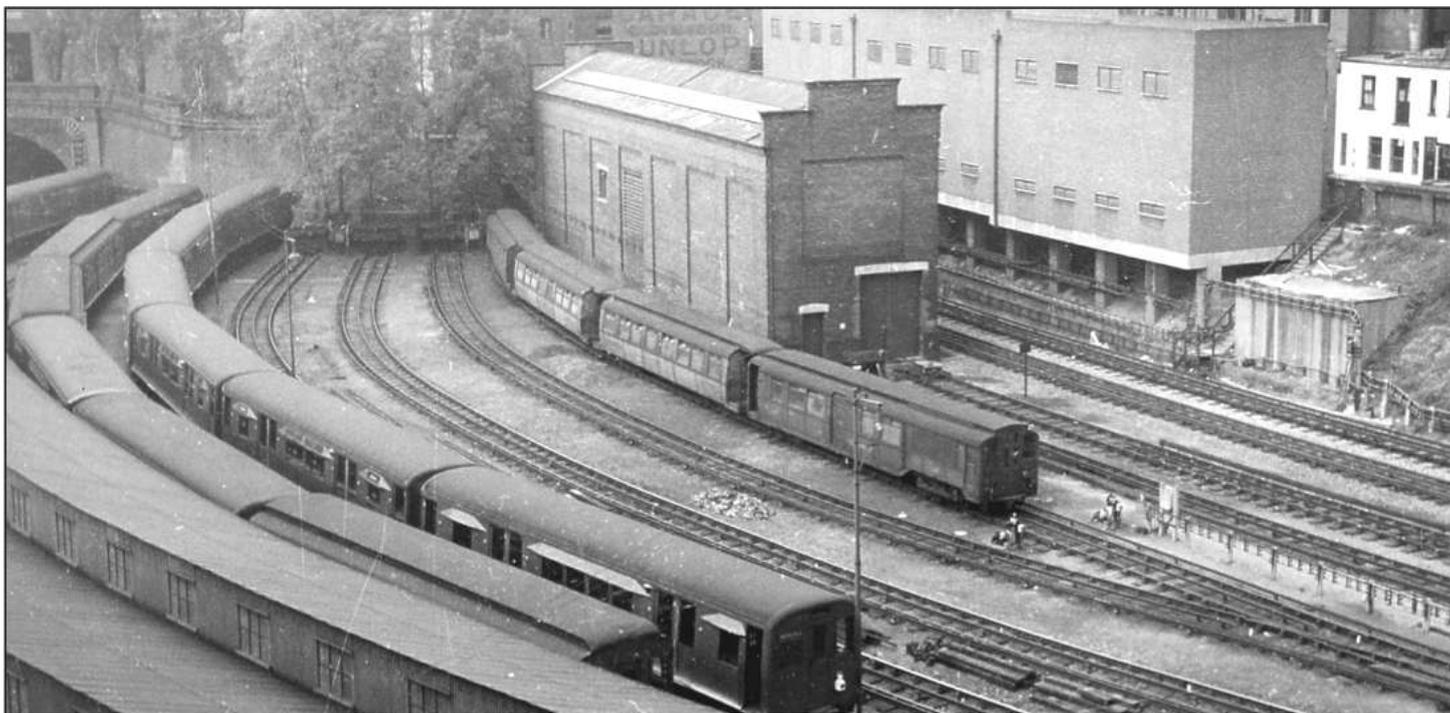
*Fig. 12: A view of part of Cromwell Depot about 1955, with Q, R and Gate Stock.*

The next photo (Fig. 12 above) shows part of Cromwell Depot about 1955. The 4-car tube train is a set of former Piccadilly Line Gate Stock cars which were converted into a rail grinding train. It is standing on No.1 Road in the depot. It was withdrawn in 1956. Behind this train are the two ex-Metropolitan Railway sidings where they used to stable two Circle trains. Beyond these sidings are the two Circle line tracks. The tall building at the end of the sidings is the substation. In the depot, a Q Stock and R Stock train. The next two roads are in the maintenance sheds.

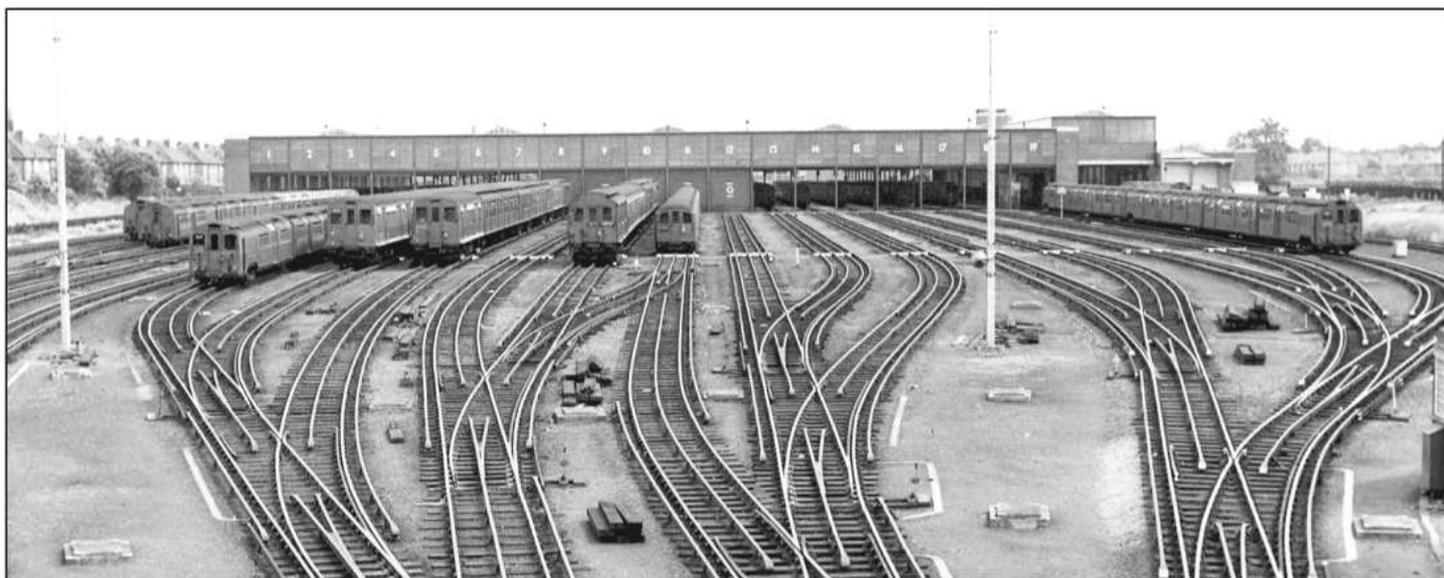
*Fig. 13: A view of the Boston (Manor) end of Northfields Depot with District & Piccadilly stocks about 1955.*  
 The photo above (Fig. 13) shows Northfields Depot taken from the road bridge at the Boston Manor end of the yard. It was always known to us who worked there as "the Boston End". Looking at the stock stabled on the occasion of this snapshot, we can see, looking left to right, Nos. 2, 3 and 6 roads are occupied by Standard Tube Stock, with R Stock (7 Rd.), Q Stock (8 Rd. and 10 Rd.) all of 8-car formation. The train on 11 Rd. is 1938 Tube Stock. Far over on the right is a 7-car Standard

Stock on 19 Rd. Just inside the shed on 19 Road was the drive-through washing machine. The lifting shop is on the far right (20 and 21 Roads) but District stock was not normally lifted there.

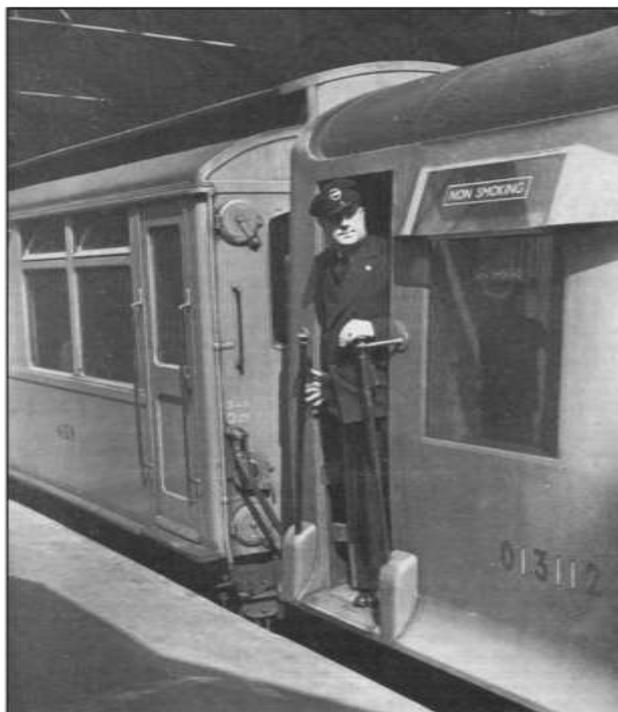
Fig. 14: Experimental centre-guard operation as tried on the District in 1949. Photo: LT Museum

The trial on the District was carried out on an 8-car Q Stock train (Fig. 14) where the door controls were provided on a specially adapted Q38 trailer, No. 013112. They were fitted on poles mounted either side of the cab door and seem to have been similar to the New York system, where the doors were opened with a trigger switch in the pole and then closed by unlatching the switch using a plunger on the top of the pole<sup>2</sup>. This train, formed of cars 4200-013144-013147-4159+013112-4165+014118-4161, was also the subject of an experimental installation of door fault indicator lights (Fig. 15), another import from the US<sup>3</sup>. The lights illuminated to indicate when a door interlock was open on a car, very useful in finding a sticking door on a crowded train.

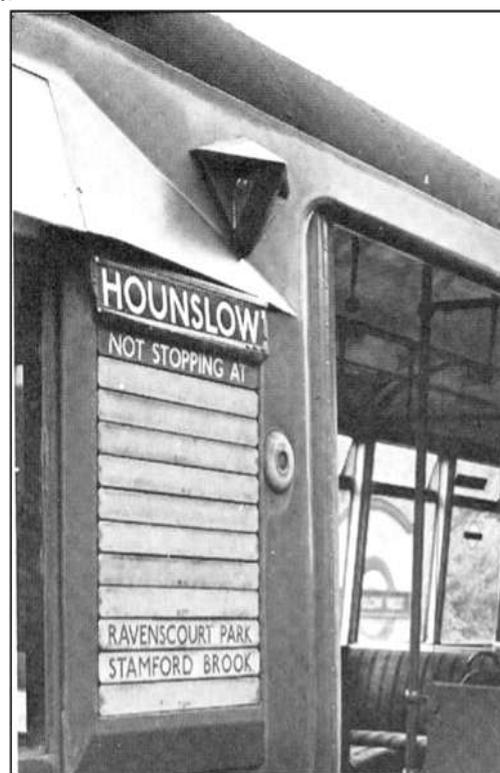
Fig. 15: Door fault indicator light as tried on the centre-guard train in 1949. This photo also shows the new type of destination plate introduced on stock built from 1938 for the non-stop indicators. Non-stop indicators were abandoned from January 1951. Photo: LT Museum.

Fig. 15, one of the photos that Mike Horne sent me, also shows the non-stop destination plates fitted on train sides after about 1938. They were not the plates previously used – they were rather smaller and designed to

slide in from the side. Mike wonders if this may be related to the arrival of air doors and the difficulty of changing plates at termini on the offside of the train. He suggests that opening the doors on the wrong side to do so was allowed. I suspect it was due to the shape and position of the toplight fairings. The photo shows that it obviously wasn't possible to get a plate in from the top.

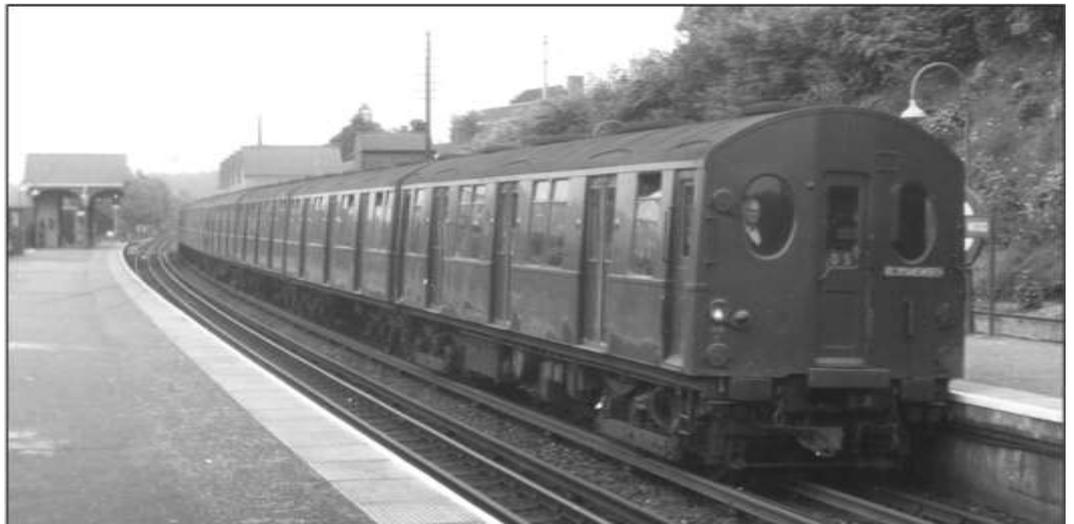
*Fig. 16: Ex-District 1920 F Stock running through Chorley Wood on an empty stock working from Amersham to Rickmansworth. This is probably at the end of the evening peak service. Such empty stock trips were often a chance for a guard to get "a go on the handle". The driver, if he knew and trusted his guard, would often allow him to drive the train on empty trips. I wonder if this is happening here. Electric trains started working north of Rickmansworth in August 1960. By this time, the F Stock was 3 years away from withdrawal. It*

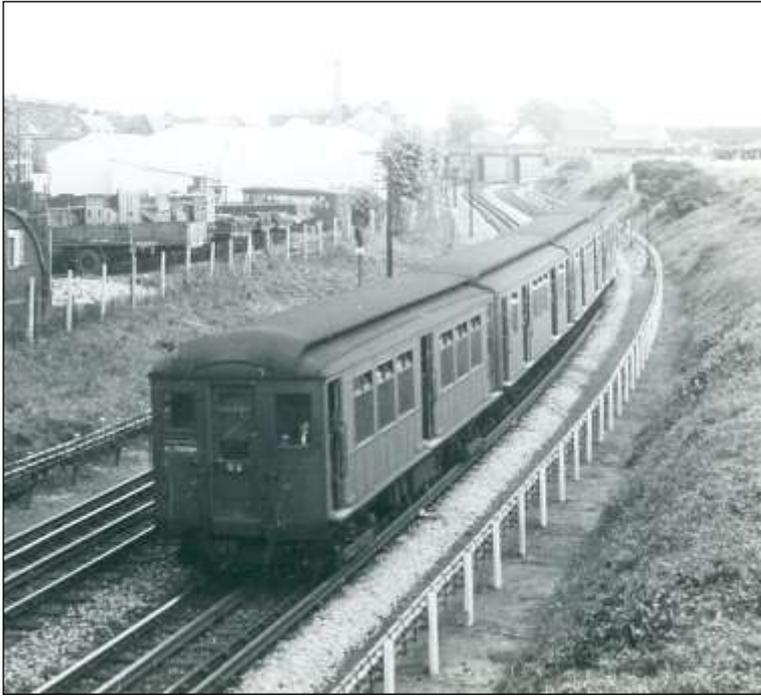
*Fig. 17: A 4-car set of H Stock on the East London Line about 1950. The usual formation (M-T-T-M) seen here comprises two 1910-11 motor cars with two 1931-35 trailers between them. Careful examination of the original photo shows that the trailers have been through the first stage conversion to Q Stock, having been fitted with e.p. brake and air-door equipment but they are being retained in the H Stock fleet until required to replace Q38 trailers sent away for conversion to R Stock. It must be a rather warm, if dull day, as most of the train doors have been left open. As mentioned in last month's article, F Stock should have appeared on the ELL early in 1951 but, because of the rehabilitation programme, H Stock continued to work on the line until towards the end of 1953.*

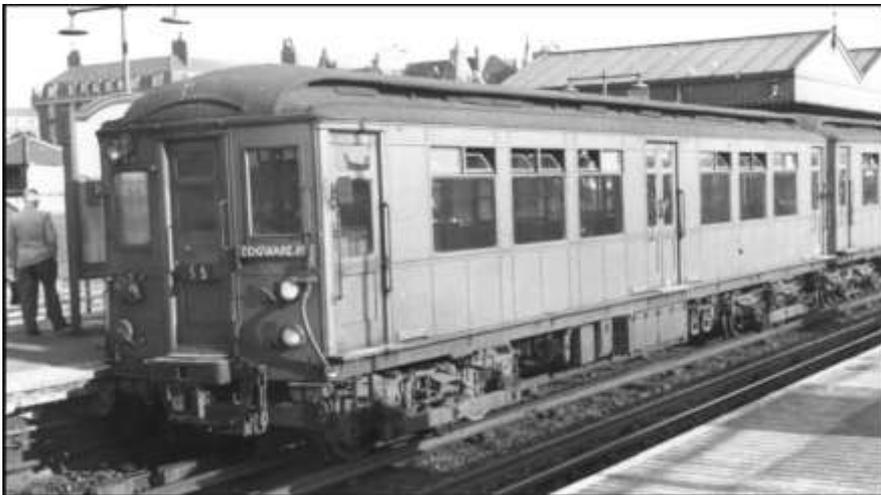
*Fig. 18: When not working on the East London Line, H Stock continued to appear regularly on the Putney shuttles. This train of H Stock at Putney Bridge sometime in the early 1950s is led by C Stock motor car No.4059. The off-peak Putney "locals" as the District used to call them, were normally 4-car sets during the off-peak and continued to be so right up until the October 1964 timetable change. This photo also shows the Ward coupler at the east end modified with the shroud.*

Until the arrival of the R Stock, the District continued to use the Ward coupler it had adopted in the early days of electrification (Fig. 18). It was automatic, but only in the sense that if you lined up the two coupler heads and drove one car gently<sup>4</sup> into the other, they would couple. However, since this was only a mechanical connection, it was necessary also to manually couple the two air hoses and connect the three control jumpers and the power busline every time cars were coupled. There was also a pair of safety chains to hook up. The coupling process was a tiresome and slightly risky operation, requiring staff to be on the track with live rails, and it led sometimes to mistakes being made with connections and to damaged pins, drawbars and coupler heads. It was a source of failures and an expensive maintenance item. It was only the introduction of the O and P Stocks in 1937-38 that saw the appearance of the new Wedgelock automatic coupler. This provided for mechanical, electrical and pneumatic connections to be completed all in one operation with the push of a button in the cab. It was not without its problems, being a complex piece of kit and requiring pneumatic and electrical controls to synchronise, but it did help to speed up coupling and uncoupling and it got the staff off the track. Whether it saved any maintenance costs is questionable but it was, once the initial bugs had been got rid of, reasonably reliable if used regularly. The Wedgelock coupler was only provided at those positions on a train where uncoupling was required on a regular basis, normally at the outer ends of units.

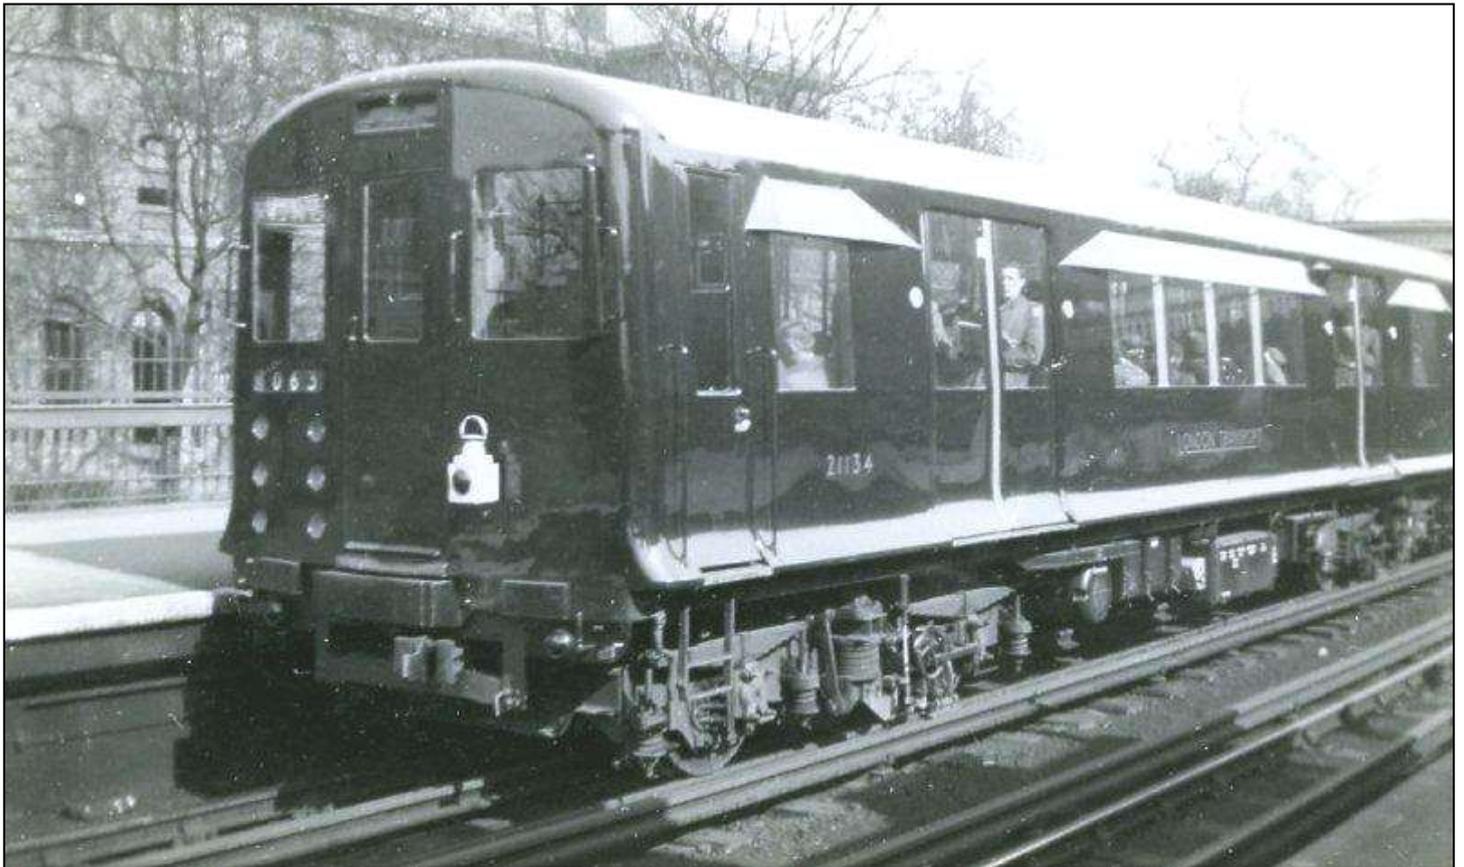
*Fig. 19: Newly converted R38 Stock driving motor car No. 21134 at the rear of a train at Bromley (now Bromley-by-Bow) going to Upminster. Judging by the cleanliness of the underfloor equipment, the photo was taken not long after the car went into service in March 1952. It has the train set number 063 in an illuminated box where the destination plate was on older cars and the destination display in a roller blind box at the top of the offside window. Although not used at the time, the passenger door open buttons are clearly visible either side of each doorway. The door fault light is just next to the second pair of doors. A Ward coupler is provided on the west end of this car. It wasn't normally required to couple to anything so the expense of an automatic coupler was saved. The shoe gear is of the original retractable type and is easily recognised by the lack of the usual wooden shoebeam attached to the axle ends. There were a number of versions of this arrangement and it was eventually replaced by conventional shoebeams.*

We will look at these in more detail in future articles but to get a flavour for the main visual changes, I have selected a photo (Fig. 19) which shows the original appearance of a newly converted R38 car and another (Fig. 20) showing a new R47 NDM (No. 23538) at the Birmingham Railway, Carriage & Wagon works before dispatch to London.

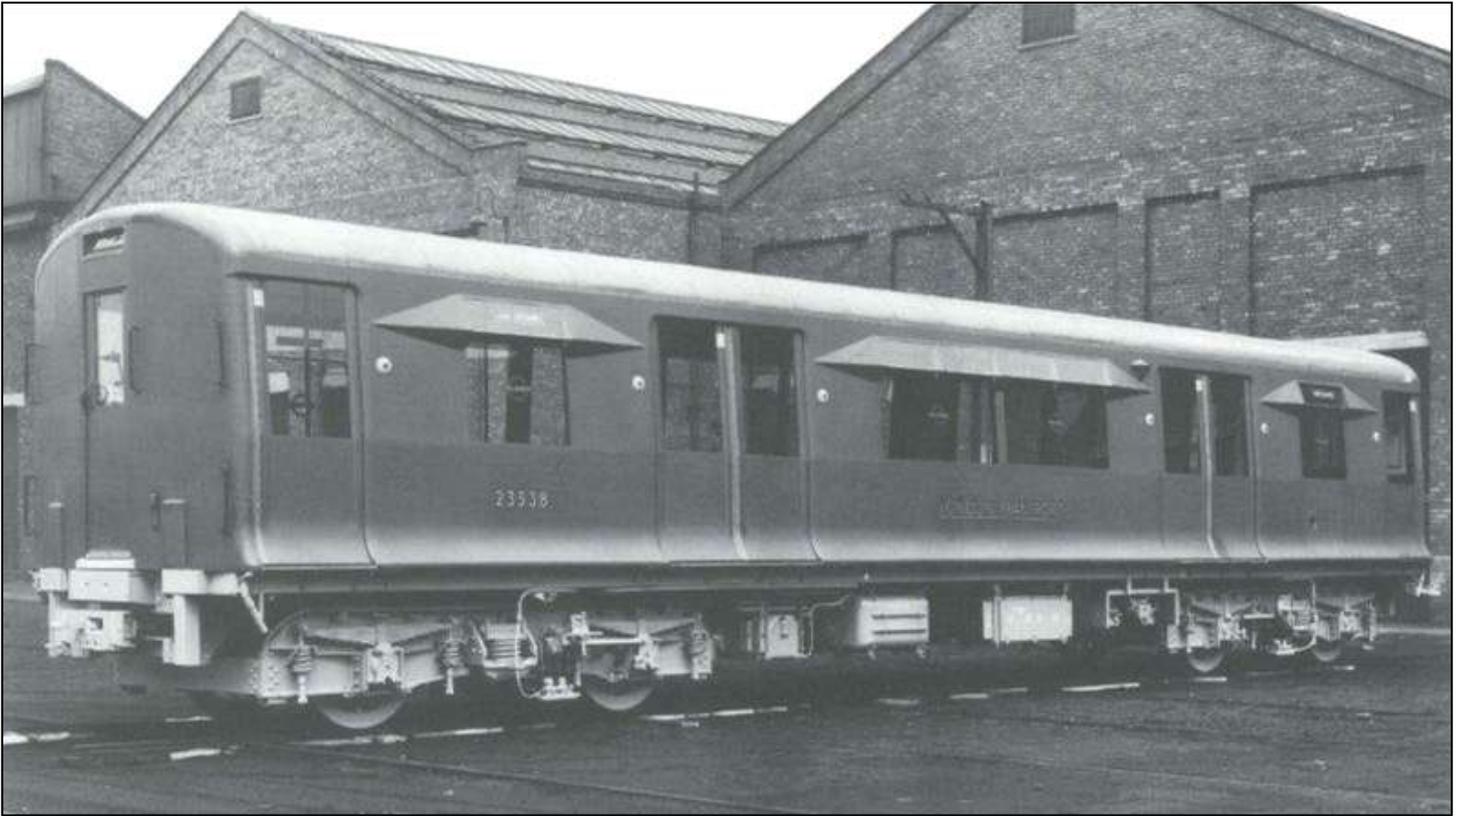
*Fig. 20: A specially posed view of R47 NDM car No. 23538 at the builder's works just before dispatch to London in April 1950. It shows the new design of toplights and their covers and the revised layout of windows and doors compared with the R38 arrangement. The end nearest the camera is provided with a Wedgelock automatic coupler and additional grabrails near the floor level. This was the end which would couple to a 4- or 6-car set as required to make up the train. Since, with auto-couplers, the crew wasn't supposed to have to get down on to the track, the extra grabrails might seem to be superfluous but, it was sometimes necessary to line up the couplers before coupling and this could only be done by manhandling them, into position from track level. The outlines of the two big, vertical anti-collision pillars can also be seen at the car end. The underfloor equipment is painted grey to allow it to show clearly in the photo. Immediately after the leading bogie is the Westinghouse DHC2 compressor and, if memory serves me correctly, then the e.p. brake case, the auxiliary contactor case and the shed receptacle. The traction equipment was on the other side of the car.*
