THE 67s AND THE VICTORIA LINE

2 – DESIGN & BUILD

by Piers Connor

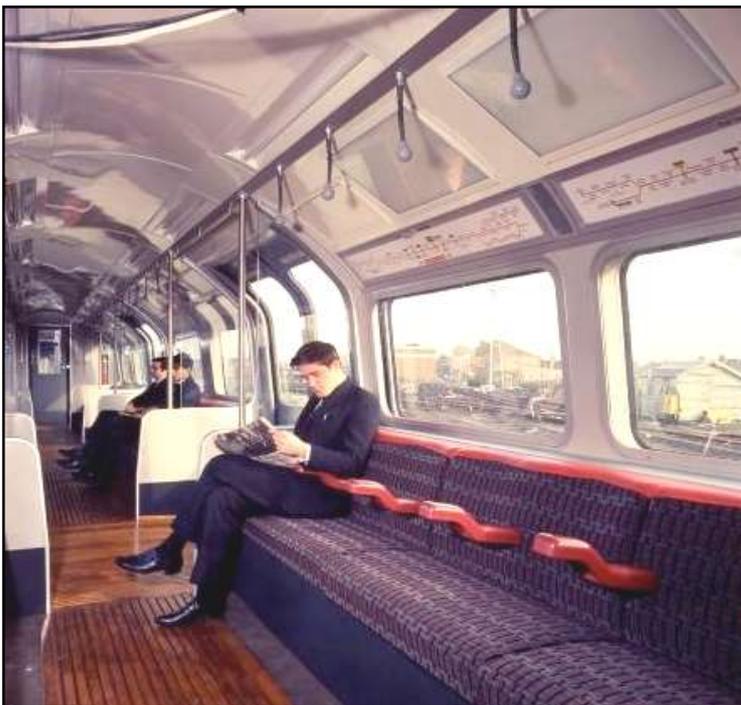
Figure 1: Interior of 1967 Tube Stock trailer car, instantly recognisable by the central longitudinal seats. Note the lovely, varnished, grooved maple wood floor standard at that time. The motor cars had transverse seats between the double doors. The doors had glazing that was extended up into the roofline to provide better visibility of station names for standing passengers. The maps over the windows are pasted on to the tilting ventilator covers. They show the Central Line, since the 1967 Stock was being used on the Woodford – Hainault shuttle before it was transferred to the Victoria Line. Above the maps are the illuminated advertisement panels adopted on this stock for the first time. This unit is being used for testing and has been commandeered by the publicity department for a photo shoot. The photo shows a few seated “passengers” but the unit’s use is betrayed by the electrical cables dangling from the ceiling. The exterior view shows that the train is in Northfields depot. Photo: LT Museum.

All cars were provided, as usual, with three seating bays, separated by the double doorway vestibules. The seating layout was standard in the motor cars, with longitudinal seats in the end sections of the saloon over the bogie boxes and transverse seats between the double doors, giving 40 seats in each car. Trailers had only 36 seats and all were longitudinal in an attempt to provide more standing between seats. The cars retained this layout to the end of their lives.

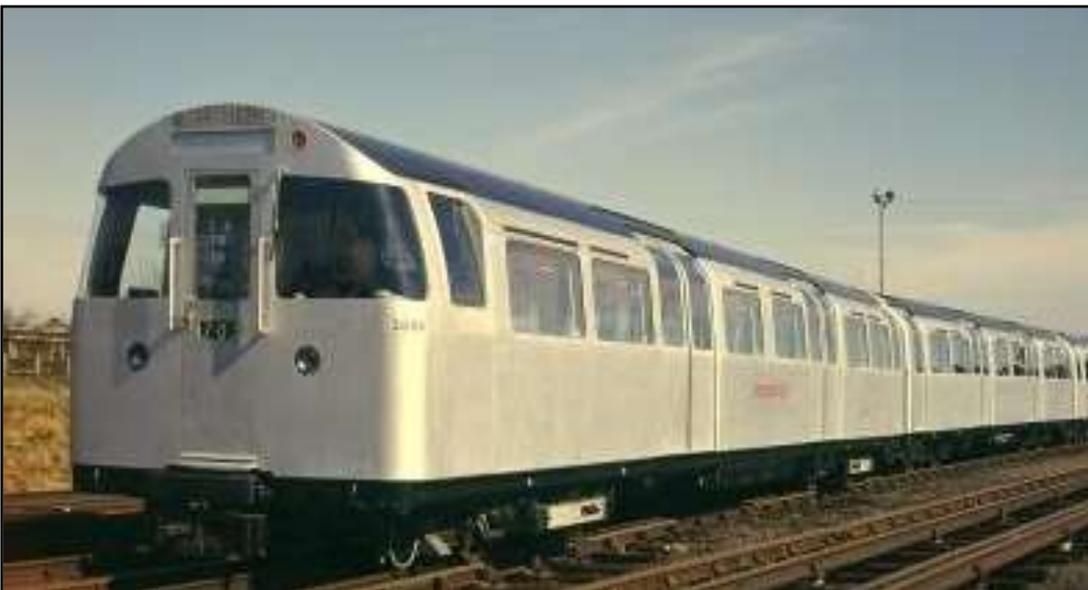
Figure 3: Official photo of 1967 Tube Stock 4-car unit showing the original cab front, ventilation slots above the windows and the curved door glazing. The body was unpainted, sanded aluminium and the roof black. The photo was most likely taken in December 1967, shortly after this unit (3006) was delivered to Ruislip Depot. Photo: LT Museum.

The '67 Stock front end followed the principles started on the 1960 Stock, with a more stylish approach nicely rounded cab roof dome incorporating the destination roller blind with a ventilator grille above it. The cab profile was rounded above the waist level and it incorporated wrap round windows for the cab windscreen. These windows were a rather complex shape and were undoubtedly expensive but they gave the front end of the stock a unique and iconic look that was so successful that it didn't date over their 40-plus years in service.
