THE 67s AND THE VICTORIA LINE

5 – THE STOCK SETTLES IN

by Piers Connor

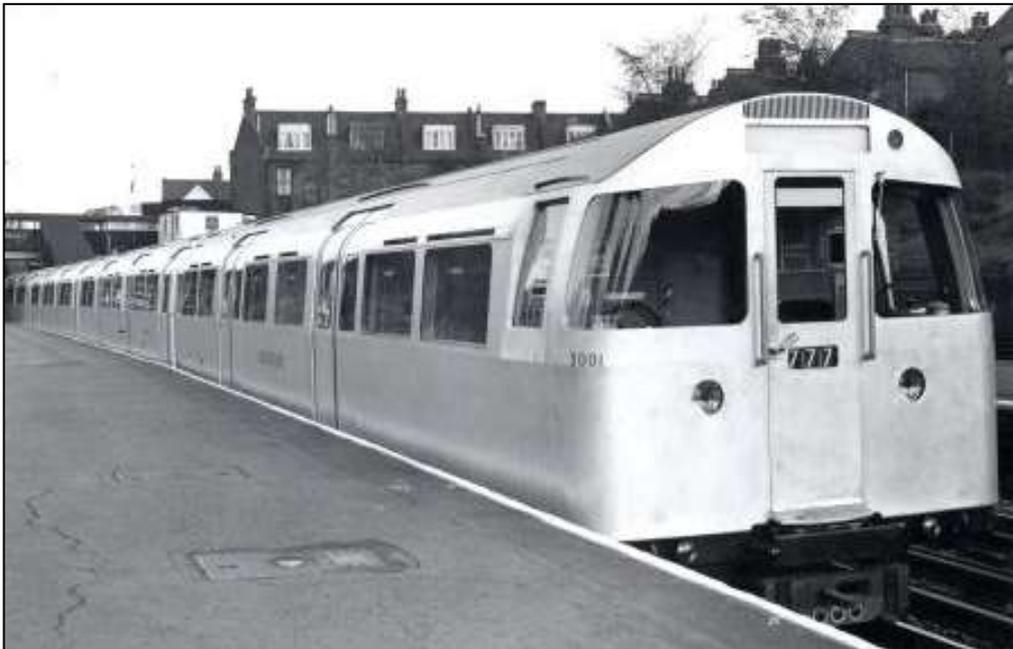
Figure 1: The first 4-car unit of 1967 Tube Stock (Unit No. 3001) on test at South Ealing, 3 November 1967. As a driver on the Piccadilly Line at the time, I used to see this unit regularly. It was sometimes stabled in Northfields depot where I was based, so I would sneak a look inside from time to time. There was a lot of instrumentation, I recall. The testing was done on the fast tracks while the Piccadilly Line service used the local tracks. LT Museum photo.

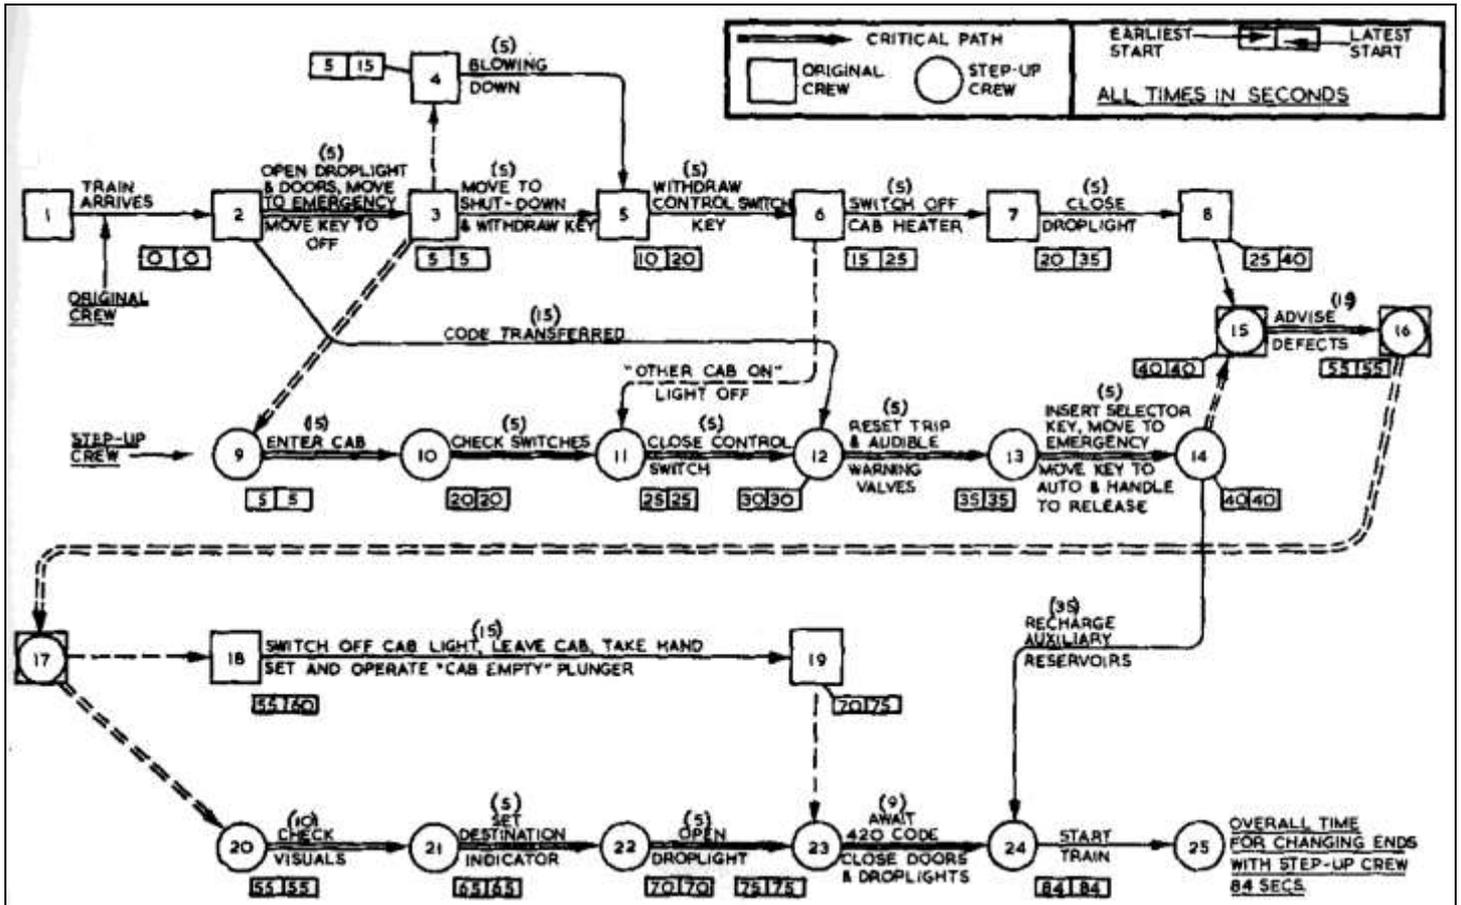
Figure 2: Network analysis of train reversal procedure at terminal using stepping back of drivers (Webster 1969).

Interestingly, the whole train turnround process was carefully studied during the design stage for the 1967 Stock. A network analysis was carried out and Webster provided a diagram for it in his 1969 paper as shown on the next page (Figure 2). Time was allowed for drivers to exchange comments over the cab-to-cab phone if necessary and for drivers to collect their belongings or settle in. Looking at the detail in Figure 2 shows how many tasks are actually involved in something the driver does several times a day, almost without thinking about it. The whole process was timed to be completed in 84 seconds. It was often done in less.

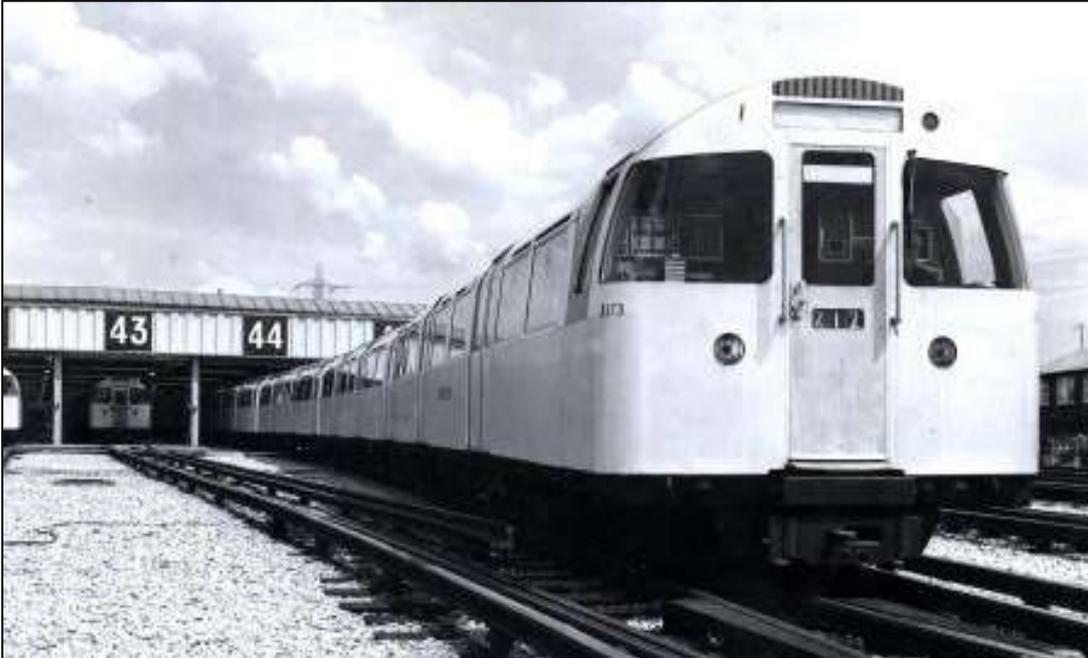
Figure 4: One of the Brixton extension trains is shown in Northumberland Park depot in 1973. The Brixton trains were identical to the original order. The photo is a posed shot with the train standing with almost half outside the inspection shed. Photo: LT Museum.

Nine additional trains were purchased for the Brixton extension, as mentioned in an earlier article and, to house some of them, an additional four roads were built at Northumberland Park depot in a new shed to the east of the original building.
