# EARLY DAYS ON THE C STOCK

by Piers Connor

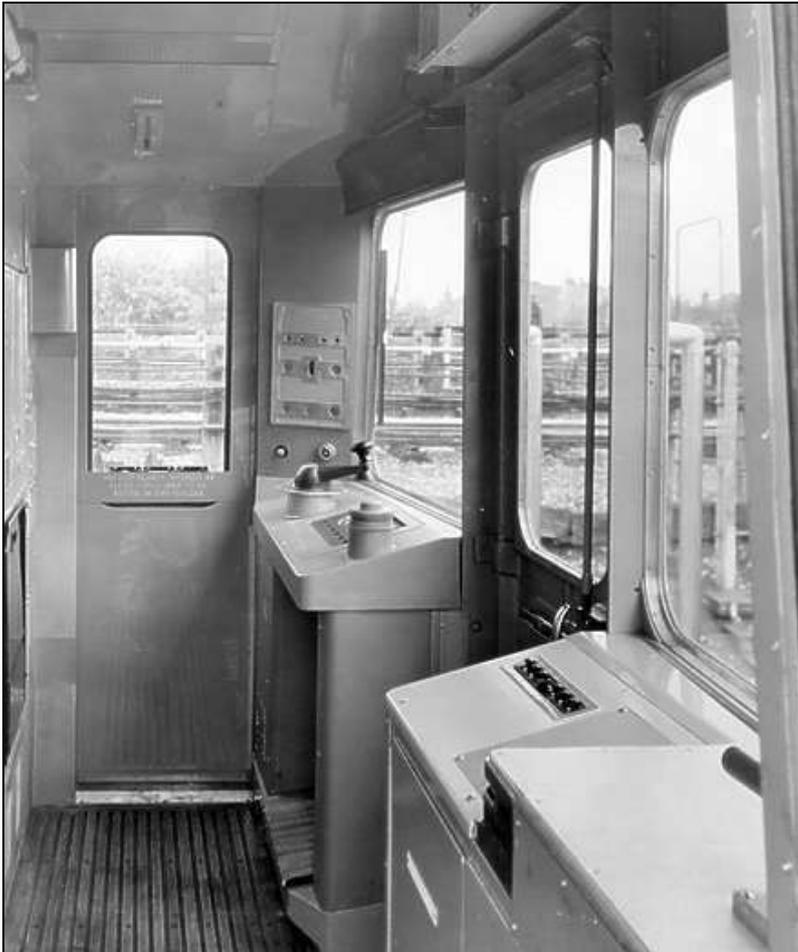
*Left: C Stock cab in original condition. The décor was a pale grey. The single "Combined Traction Brake Controller" is visible on the left hand side of the driver's control desk. The air and electrical indications were in the centre of the desk and the reverser key switch, which had an ATO position, was on the right. The door control panels were only provided on the back cab walls. The desk controls for door operation were added later, soon after OPO was introduced in March 1984. The cab light switch was in the row of switches nearest the camera. The relatively clean lines of the design were spoiled by the addition of large amounts of junk added over the years for new controls, communications equipment and safety devices. There was also a side number plate bracket mounted on the cab door. This was to allow the train set number to be read by an external reading system. This was never fitted but it did make train identification from the platform easier and it was a shame that it was discontinued. Set numbers should be added to side destination displays. Note the wooden floor that survived for both passenger and staff areas of the train until it was removed during refurbishment in the mid-1990s.*

Then there was the cab-to-cab telephone. This was a victim of the intention to convert trains to ATO and it included a public address (PA) facility. The handset and push button controls were in a little cabinet on the back wall immediately behind the driver's position. The door was on a spring, so you had to hold it open while accessing the handset. This was OK as long as you didn't want to use the phone while driving (which I guess we weren't supposed to do) but, if you did need to use it on the move, you had to reach behind you with one hand (the other was holding down the deadman), slide your finger into the door to get it open, then knock the handset off its seat. It would then drop to the floor and you could reach down to pick it up. You then stuck it under your chin and used your free hand to push the call button. Of course the door sprung shut onto the handset cable, which eventually got frayed, while the handsets got damaged from all the dropping. Often, the handset would be left hanging down while the train was in service.

The cab light switch was another hostage to fortune. Being designed for ATO, where the driver does not have to sit in the seat and hang onto the controller whilst the train was moving, the switch was located on the offside control desk. To use the switch, you had to stretch across the central doorway whilst hanging on to the controller. The controller itself was located on the left hand side of the desk. This was not a problem for a leftie like me, but many right-handed drivers had to drive with their right arm across their chest to make it usable. I once asked why it was decided do arrange it like this and was told it was because the brake was traditionally on the left so it was considered important to leave

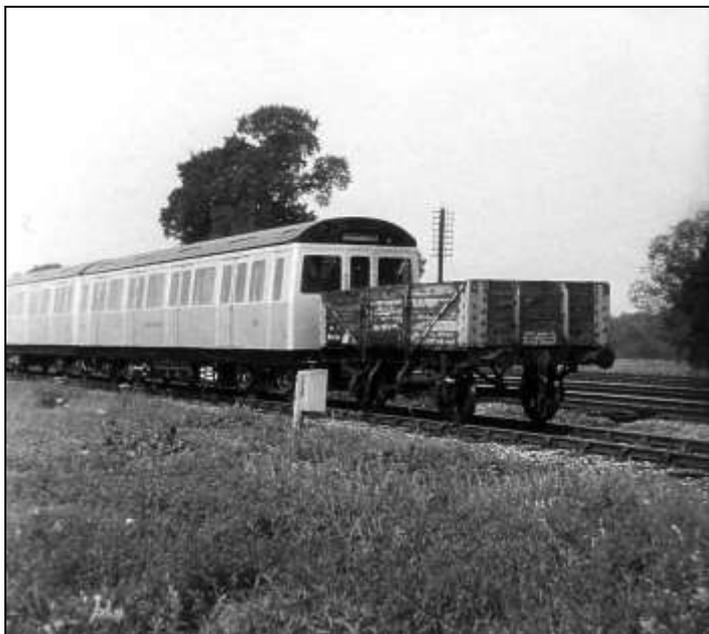
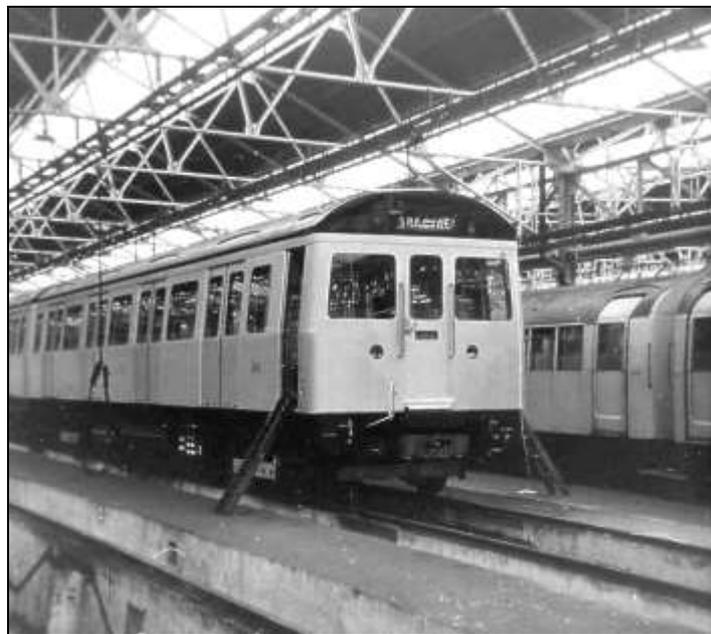
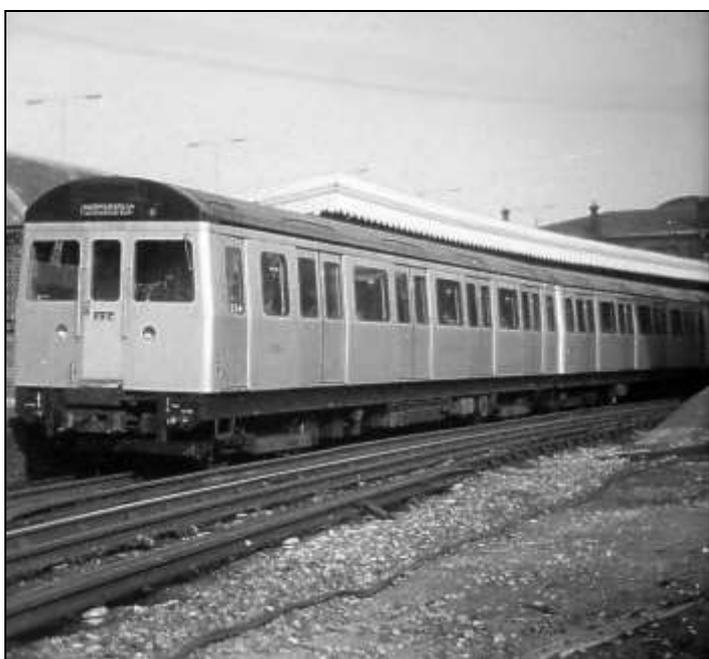
### EARLY C69 STOCK

Three views of C69 Stock when new, with a train awaiting delivery to London Transport just west of West Ruislip (*Above Left*), one in the process of being commissioned (*Above Right*) and the rear of a train newly into passenger service at Westbourne Park (*Left*). It is interesting to note that when new the C69 Stock had provision for train set numbers in the driver's side cab door, in this case being 224, which was another one of those train recognition trials that didn't work. (The Northern and Piccadilly Line side cab doors [1938 and 1959 Tube Stocks respectively, in January 1966 and November 1969 also respectively] were given set numbers in their side cab doors for a short while).
