THE METROPOLITAN RAILWAY ELECTRIC TRAIN

by Piers Connor
with Charles Horsey
19. MORE TRAINS

THE 1921 SALOON STOCK

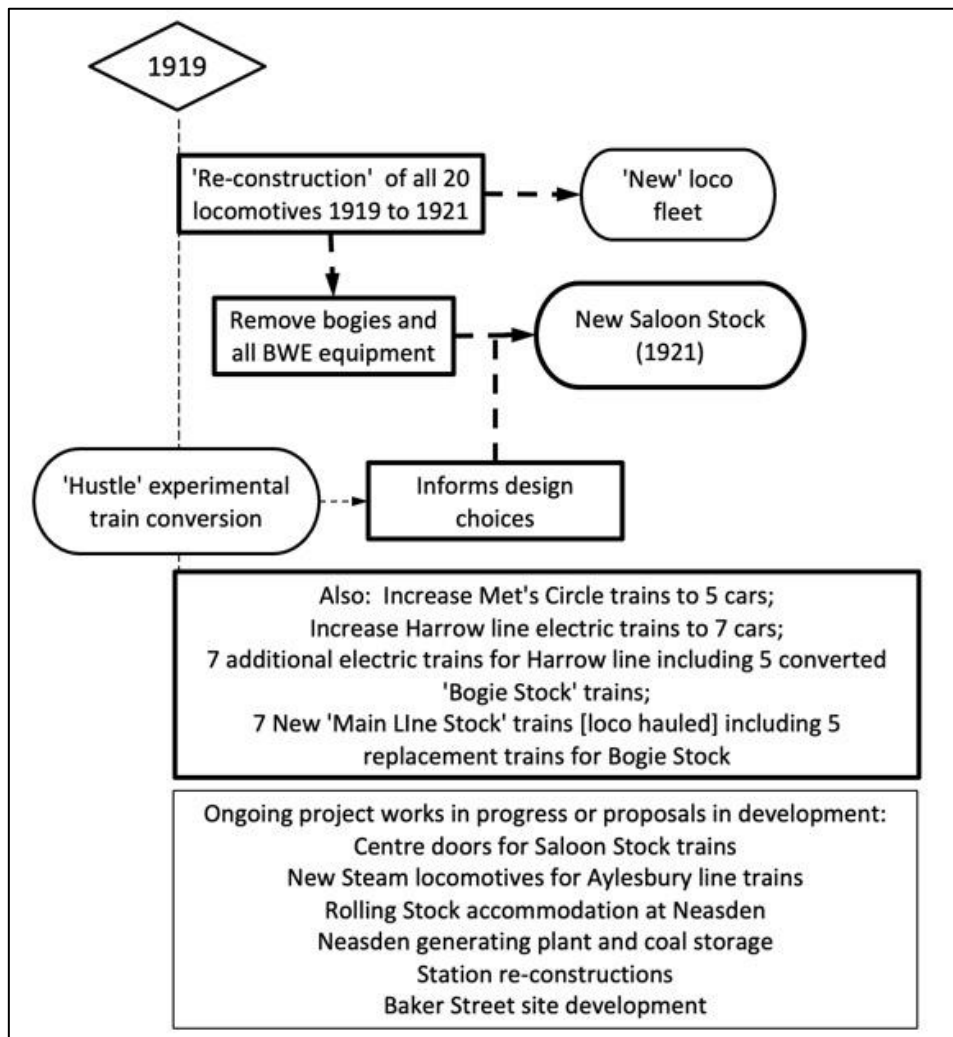
Figure 1: A chart showing the Metropolitan board's plans of April 1919 for upgrading the railway to meet increased traffic. The plan was followed over the next three years. Diagram modified from original prepared by Charles Horsey.

The expansion plan also included that the five converted Bogie Stock trains, mentioned in Figure 1 as intended for the Extension line, were to be made up of the 5 x 6-coach trains working on steam hauled services. These were to be converted to electric operation (as described in Article 9) after their replacement by seven new 6-coach Dreadnought trains (The 1920 Stock, described in Article 17). Ten new Saloon Stock motor cars were purchased to power them.

The plans required the purchase of new Saloon Stock (Figure 1). This included the 10 motor cars mentioned above, two 7-car trains for the Harrow/Uxbridge line, plus a third train and four extra motor cars to cover the spares requirements. There were to be a total of 20 new motor cars and 39 trailers. Six of the trailers were 1st driving trailers for the new trains, together with 12 x 3rd trailers. The remaining 21 x 3rd trailers were used to lengthen existing 6-car trains into 7-car trains.

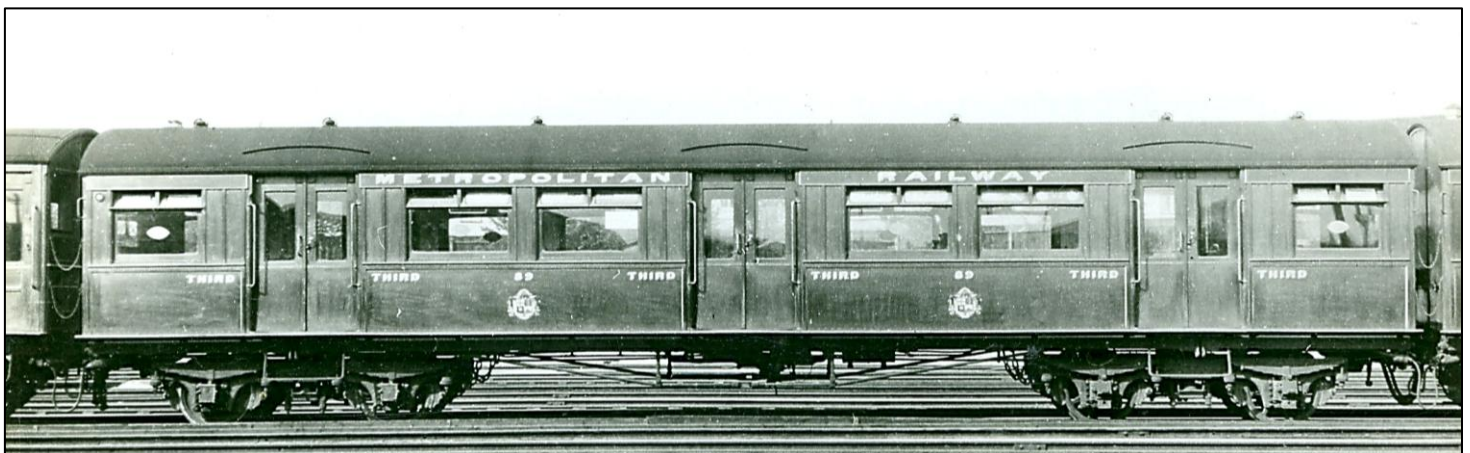
Figure 2 above: 1921 Stock 3rd Class trailer car No.89. The three sets of double doors on each side made it ideal for work on the Circle and it is a design that has survived to the current S Stock. Photo: LT Museum.

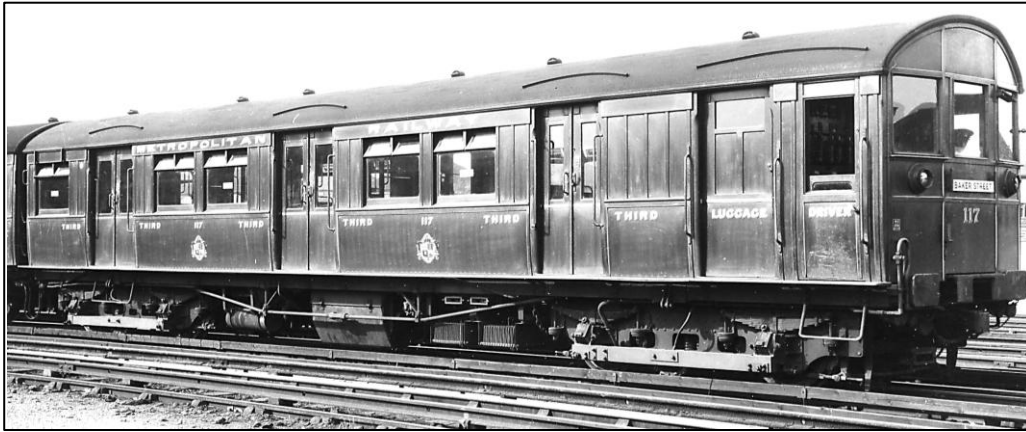
Figure 3 left: 1921 Stock motor car No.117. Note, the car number is displayed on the centre of the cab front. Photo: LT Museum.

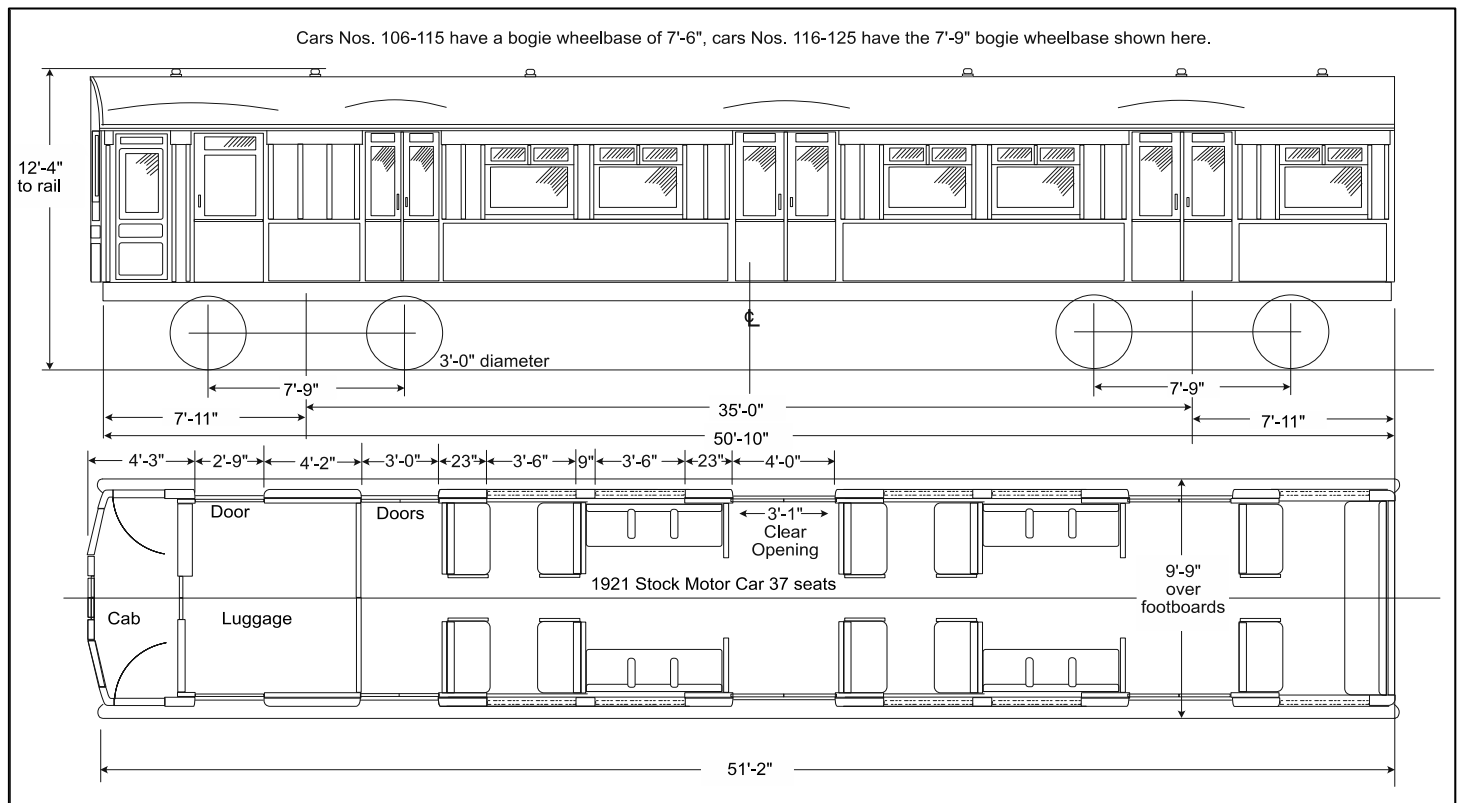
Figure 5: Side elevation and plan of 1921 Saloon Stock motor car. The leading pair of double doors was narrower at 3ft-0ins than the standard 4-foot doorways provided on this stock. The current S Stock has a similar door arrangement, with narrower leading end doors on the driving doors. The driver's cab had the usual hinged doors. The cars had 37 seats. Drawing: P. Connor.

The layout of the new motor car bodies was a combination of the previous designs with a luggage compartment behind the driver's cab but with the new design having three sets of passenger doors. However, the leading passenger doors were fitted into a 3ft-6in wide opening as opposed to the usual 4ft wide opening provided for the other doorways. The leading doors provided access to the front end of the passenger compartment only, as the area was separated from the luggage compartment next to it. The luggage compartment door was immediately behind the driver's door. As usual for the Saloon Stock, there was no separate guard's compartment. The guard was supposed to travel in the rear cab on this stock.

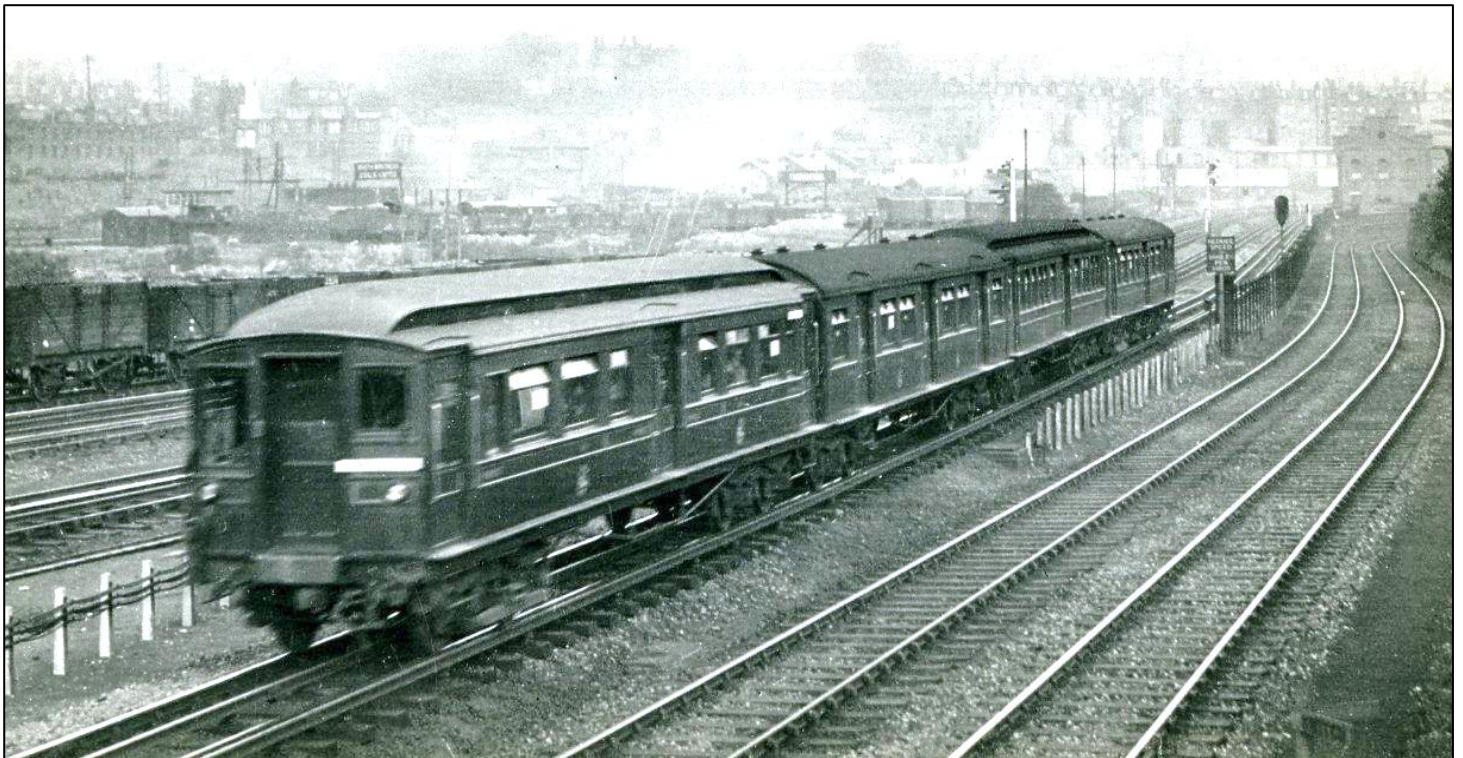
Figure 6: A 4-car set of mixed Metropolitan Railway Saloon Stock containing a complete selection of the range. The leading vehicle is a 1905 Stock driving trailer (note the asymmetrical cab window arrangement), the second car is a 1921 Stock trailer, then a 1904 Stock trailer and finally a 1913 Stock motor car. The 1913 Stock 200hp BW motor car had just about enough grunt to push a 4-car set, which was probably uncoupled from a 7-car or 8-car train at the end of the morning peak period. On 7-car trains, it was normal to run the 4-car portion at the Up end (Baker Street end) as seen here and to use this for off-peak working. Note that the driving trailer has shoe gear on the leading end. Originally, it was not thought necessary to provide shoe gear on the driving trailers. Power for lighting and heating could be obtained through the power train line provided to connect the 600-volt supply on the motor car throughout the train. On BTH trains, power for the master controller was tapped off the car lighting circuits. On BW trains, the 14-volt control power was supplied from the motor generator on the motor car via the control cable. The shoe gear was eventually added to provide an alternative contact with the current rails in case the shoes on the motor car were 'gapped'. The photo was taken some time between 1926 and 1933. Photo: Collection B.R. Hardy.

Although structurally most suited to work on the Circle, the 1921 Stock appeared all over the Metropolitan, indiscriminately mixed in with other BW equipped cars as was the Met's rolling stock management style of 'as long as it works, send it out' (Figure 6).

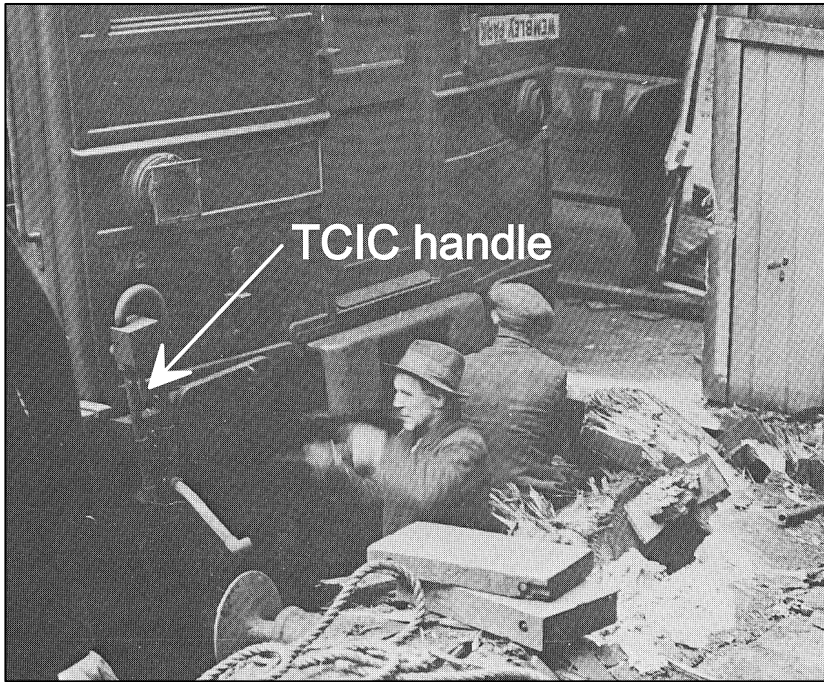
Figure 7: This photo of a train being rescued after a buffer stop collision at Moorgate shows the pipework on the front of the train for the tripcock isolating cock. The cock handle can be seen at the bottom of the switchbox. This modification was introduced sometime around 1914-1916 on the Metropolitan's electric stock. Photo: Collection B.R. Hardy.

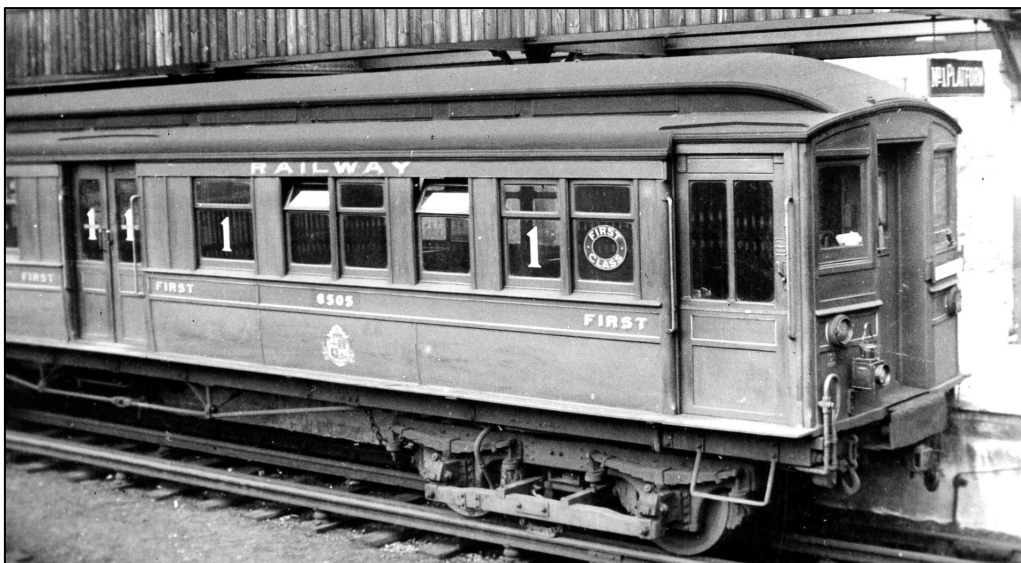
Figure 8: A 1904 Saloon Stock 1st class driving trailer at Watford in the days immediately after the takeover by the LPTB in 1933. The pipework for the tripcock isolating cock can be seen next to the tail lamp. Note that the car has been renumbered but it still retains its Metropolitan Railway graphics. Photo: Collection B. R. Hardy.

The earliest version of the alteration appears to have combined the two modifications so that the TCIC and interlock switch were mounted in a small box on the front of the cab. It was easily visible because a loop of piping had to be added to connect the tripcock to the cock and its interlock box (Figure 8).
