LATIMER ROAD – UXBRIDGE ROAD AND SINGLE LINE TO OLYMPIA

POST-WAR KENSINGTON OLYMPIA

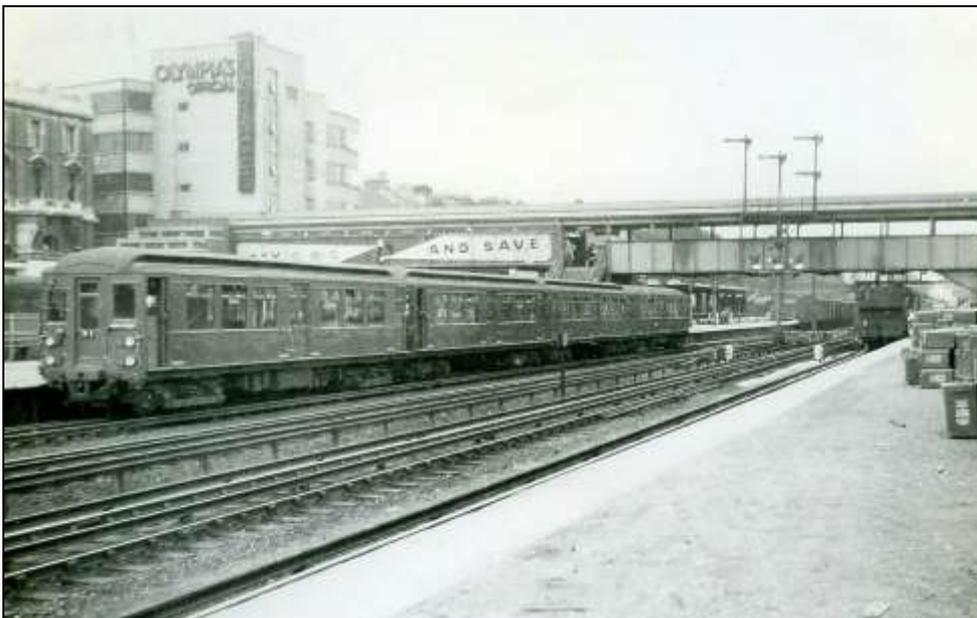
Left: A four-car train of District H Stock stands at Kensington Olympia, which comprises 1910-14 C, D and (at the rear) E Stock. Viewed from the up platform looking north, the train is standing at the south end of the Down platform, which was the limit for District Line trains, although it was possible in an emergency for them to be shunted north of the station to cross over. To that end, all four tracks were once again electrified when District Line services began in 1946.

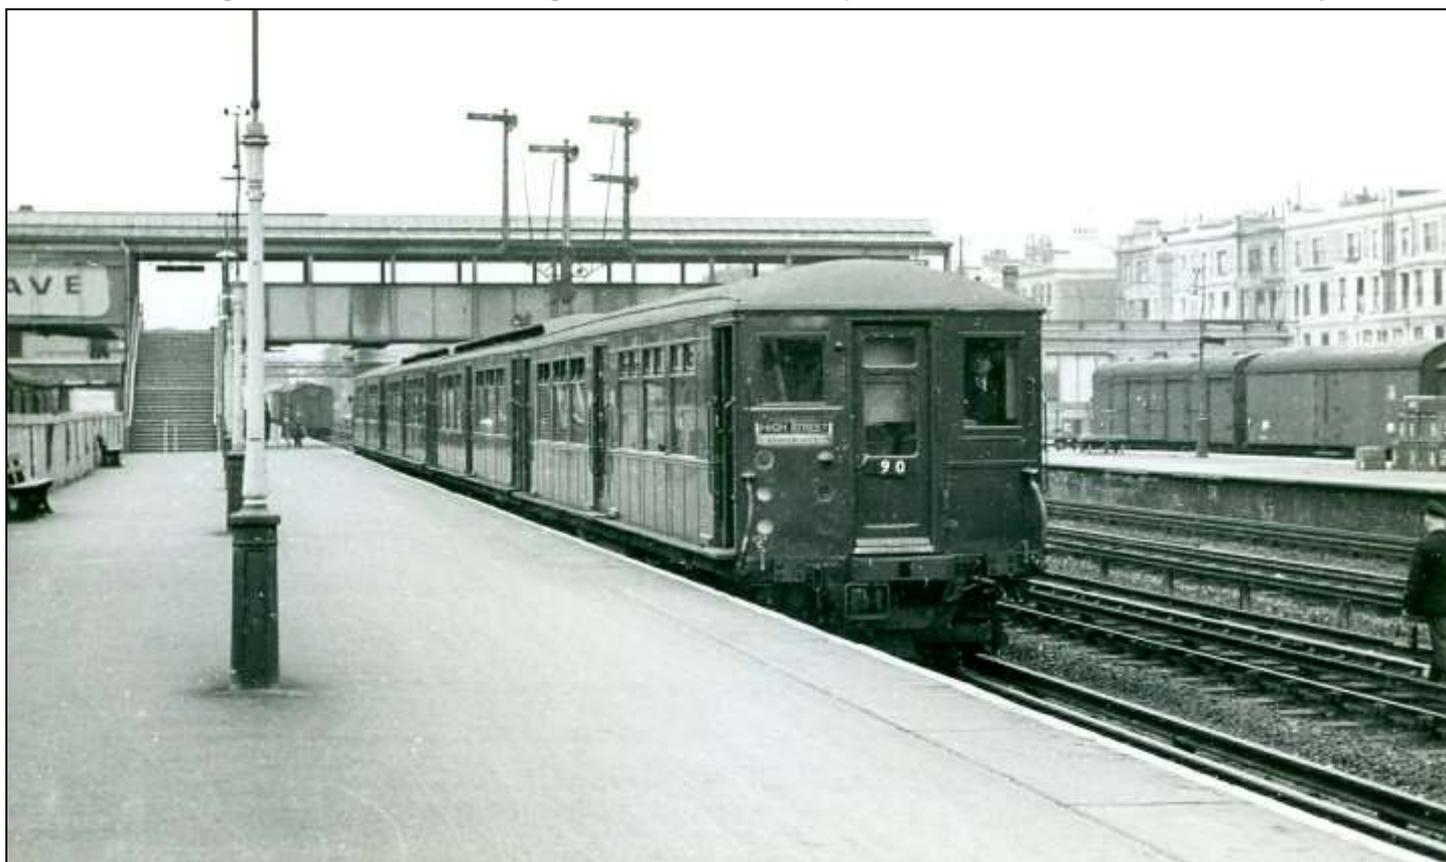
Opposite: (Top) Another four-car H Stock train is seen reversing at the south end of the Down platform. Nearest the camera is a 1914 E Stock motor car, which was one of four converted from trailers in 1928-30, the give-away being the enclosed headlights and destination plates under the left

side cab window. Original motor cars had destination plates placed externally under the motorman's cab window and the headlights were located at the car corners. The photo shows on the left what later (in 1958) became the segregated District Line bay platform, at that time fenced off for miscellaneous goods traffic. On the right can be seen two parcels vans in the south-east bay.

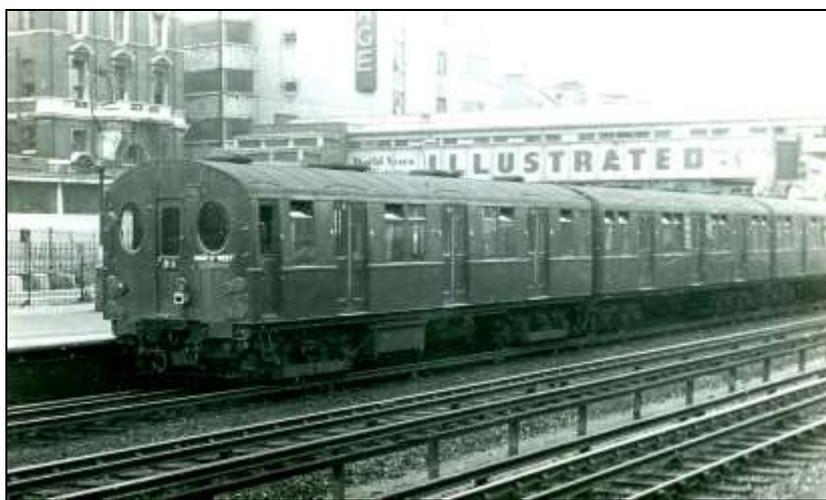
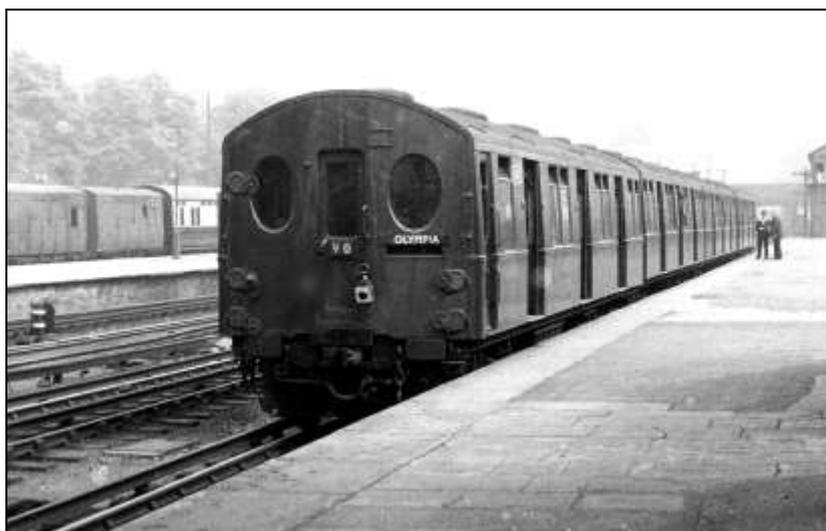
Left: With the District Line having a mix of different stocks, it perhaps wasn't surprising that the Olympia service was worked by a variety of stocks during exhibition periods. Still on the District Line in the late-1940s was the 1920 F Stock, of which two views of four-car trains are seen from the Up platform (*Left*) and the middle of the Down platform looking 'south' (*Lower*). The trailer car seen as the second car on the left-hand photo just about shows the non-stopping panel carried by early District stocks. Both trains have single-equipped motor cars nearest the camera which do not have a guard's position at the trailing end. A feature of the trains used on the Olympia exhibition service into the 1950s was large 'Olympia' stickers provided in the car windows, not visible in our photo selection here.

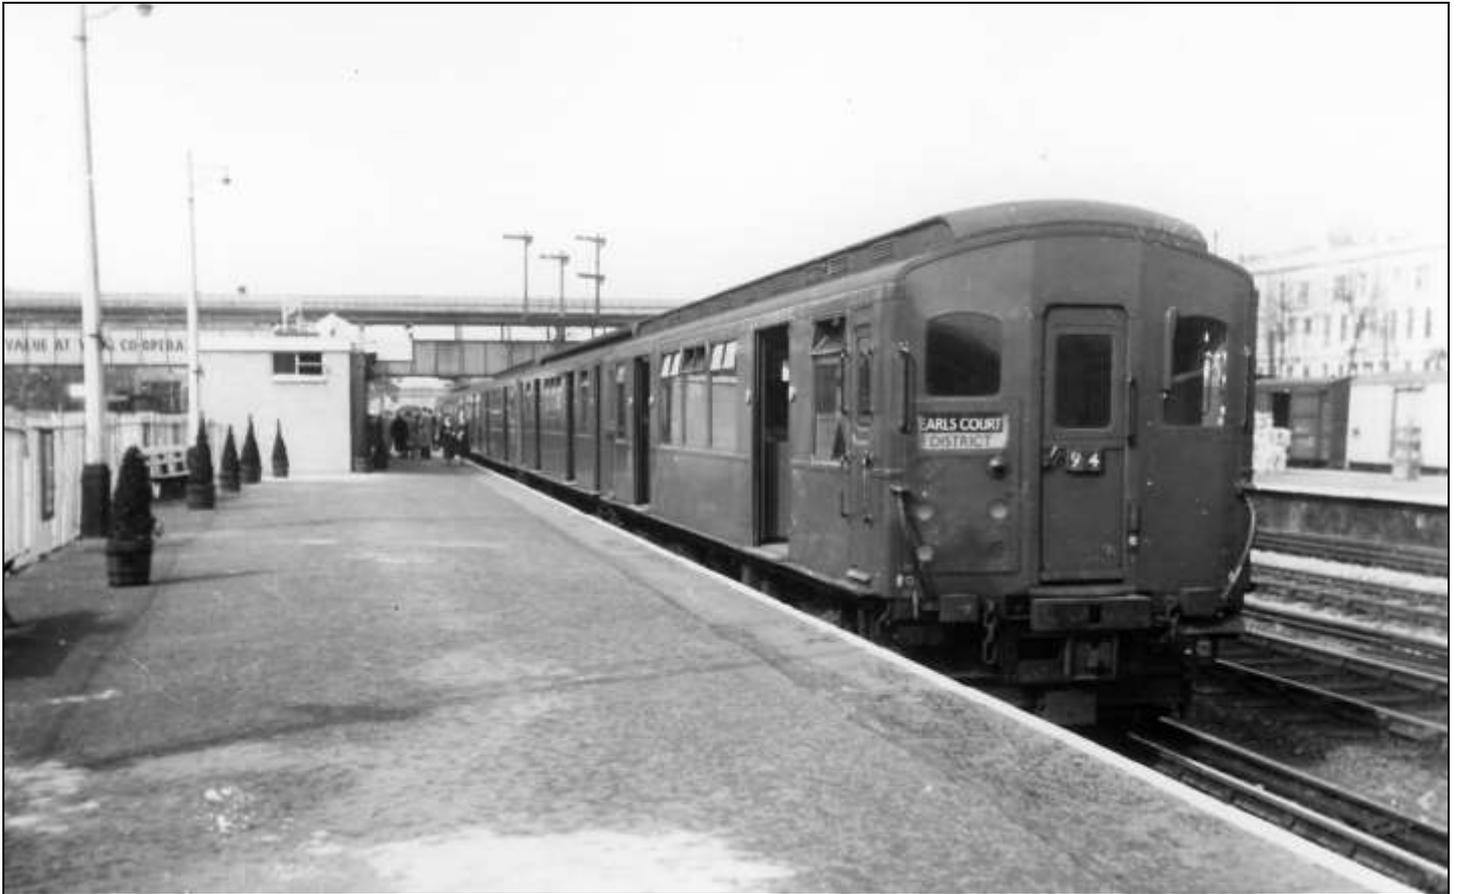
Overleaf: (*Top*) A six-car train of mixed Q Stock stands at the south end of the Down platform which includes a Q38 trailer fourth car back. The building on the left is the one called into question when the new bay platform was being discussed.

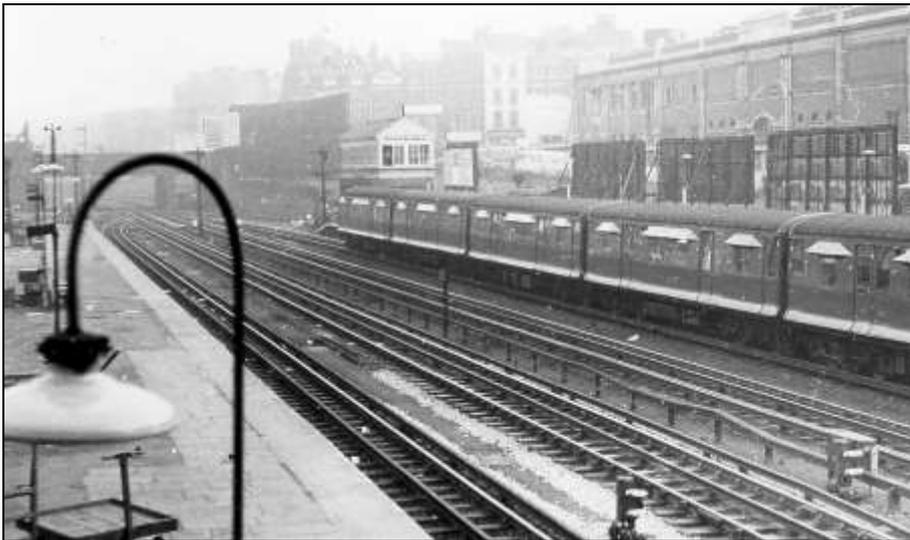
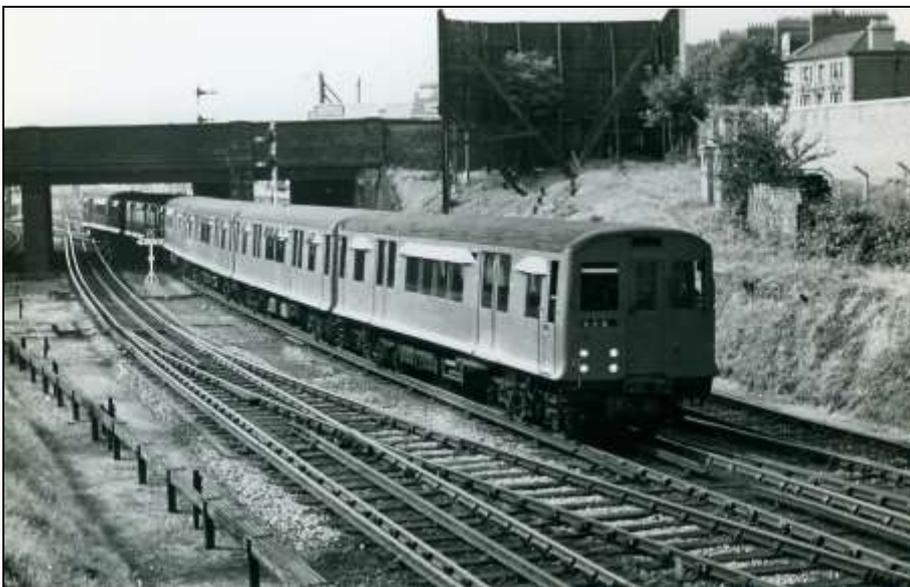
Left: Two views of R Stock in red livery at Kensington (Olympia). That (*at Opposite, Left*) was taken from the footbridge looking 'south' in the direction of Earl's Court. Both the two platform tracks and the two through roads have current rails, which indeed they had before services were withdrawn in 1940. Kensington South Main signal box can be seen above the far end of the train. The photograph (*Below, Left*) shows a six-car R Stock train departing, heading for High Street Kensington according to the headlight code. The rear of the train is still on the crossover from the Down platform to the Up line. When the segregation from British Railways took place in March 1958 the LT single line was provided on the left and used the partly obscured left-hand side of the bridge in the background. As it was still early days of the then new R Stock, it had unique beamless shoe gear. The use of this stock instead of the handworked door H Stock was seen as far preferable on such a 'prestige' service.

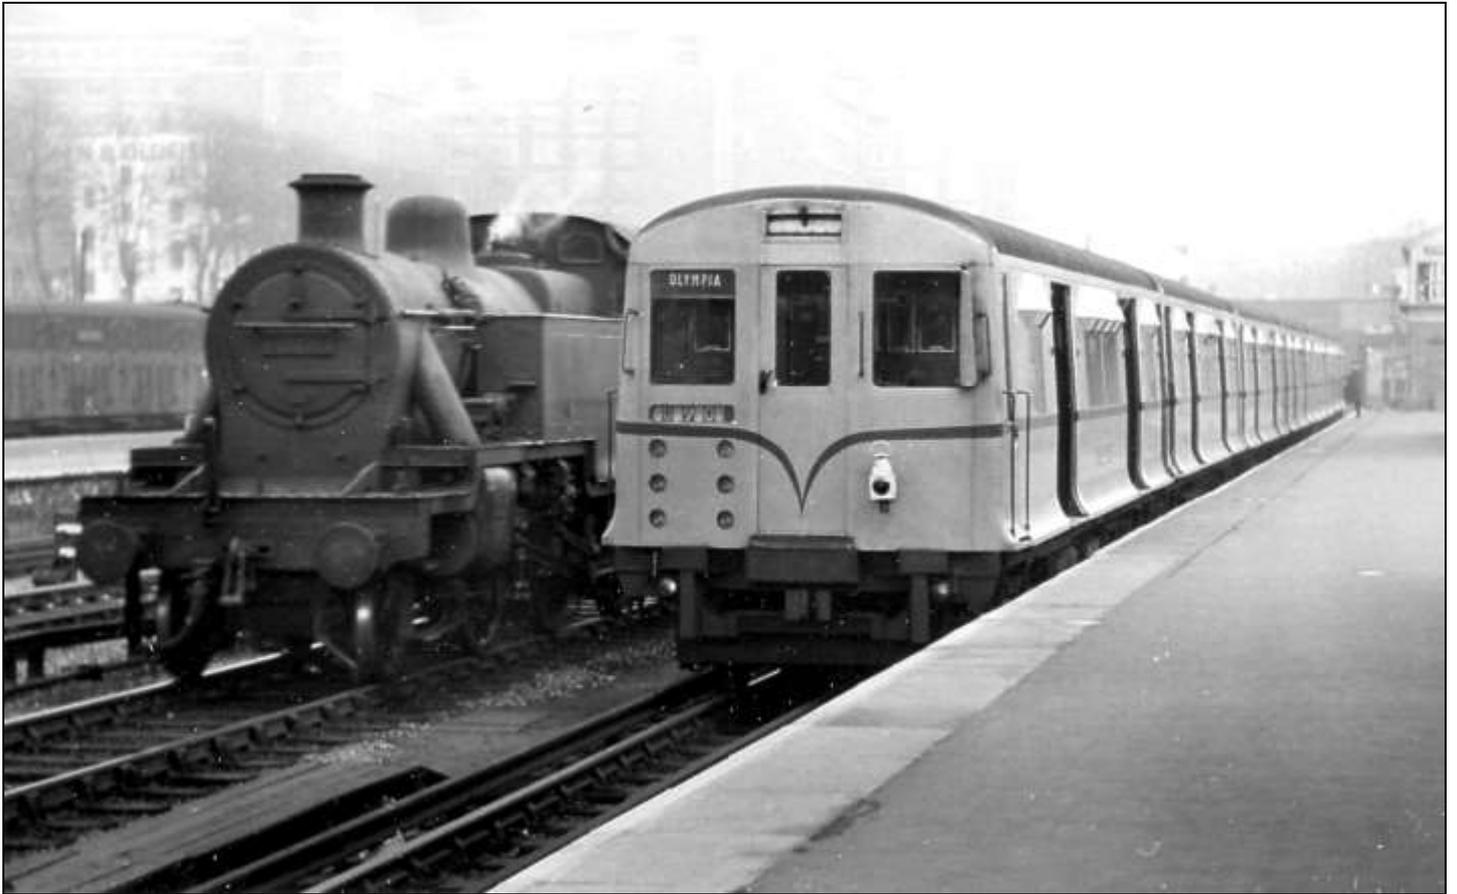
Above: The District Line's pride and joy in the mid-1950s was its train in unpainted aluminium, six out of the eight cars being seen in the Down platform. Note that there are no current rails on the through roads – these had been removed in 1956. In keeping with providing modern trains for a prestige service, the 1910-14 H Stock on this service was withdrawn as soon as possible.

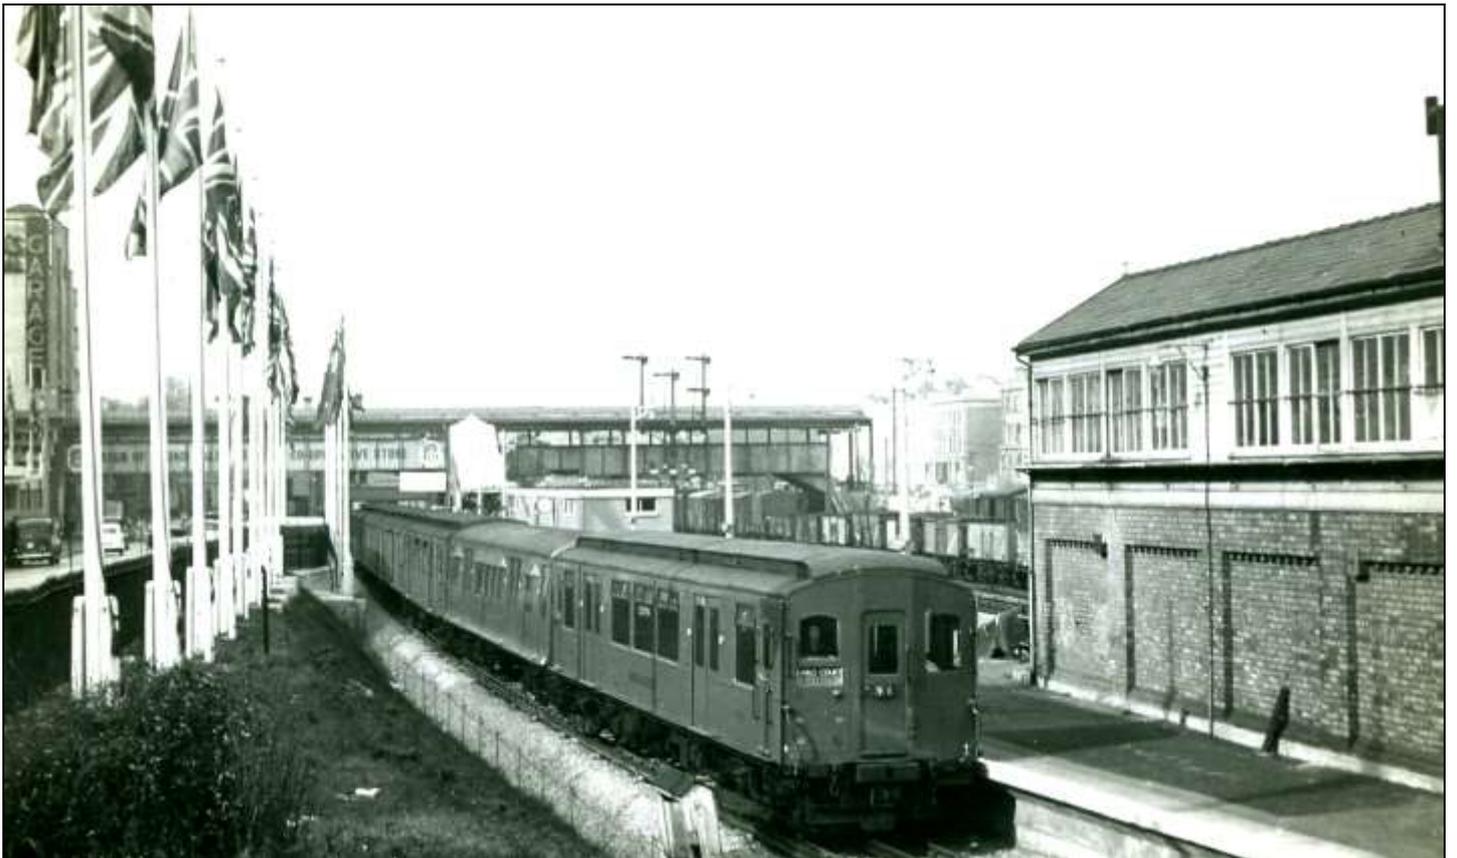
Below: After many years in the planning and talking stage, the segregation of the District Line service from the main line was achieved on 3 March 1958, after which the current rails were removed from the Up and Down platform roads. A six-car mixed Q Stock train is seen in the new bay platform with Kensington South Main signal box on the right.

- Segregation of District Line from main line on Olympia branch.
- Control of the single line from West Kensington East LT box.
- Earl's Court Junction Western Region signal box closed and abolished.
- New hand-worked crossover provided 500ft east of new bay for LT – WR freight transfers.

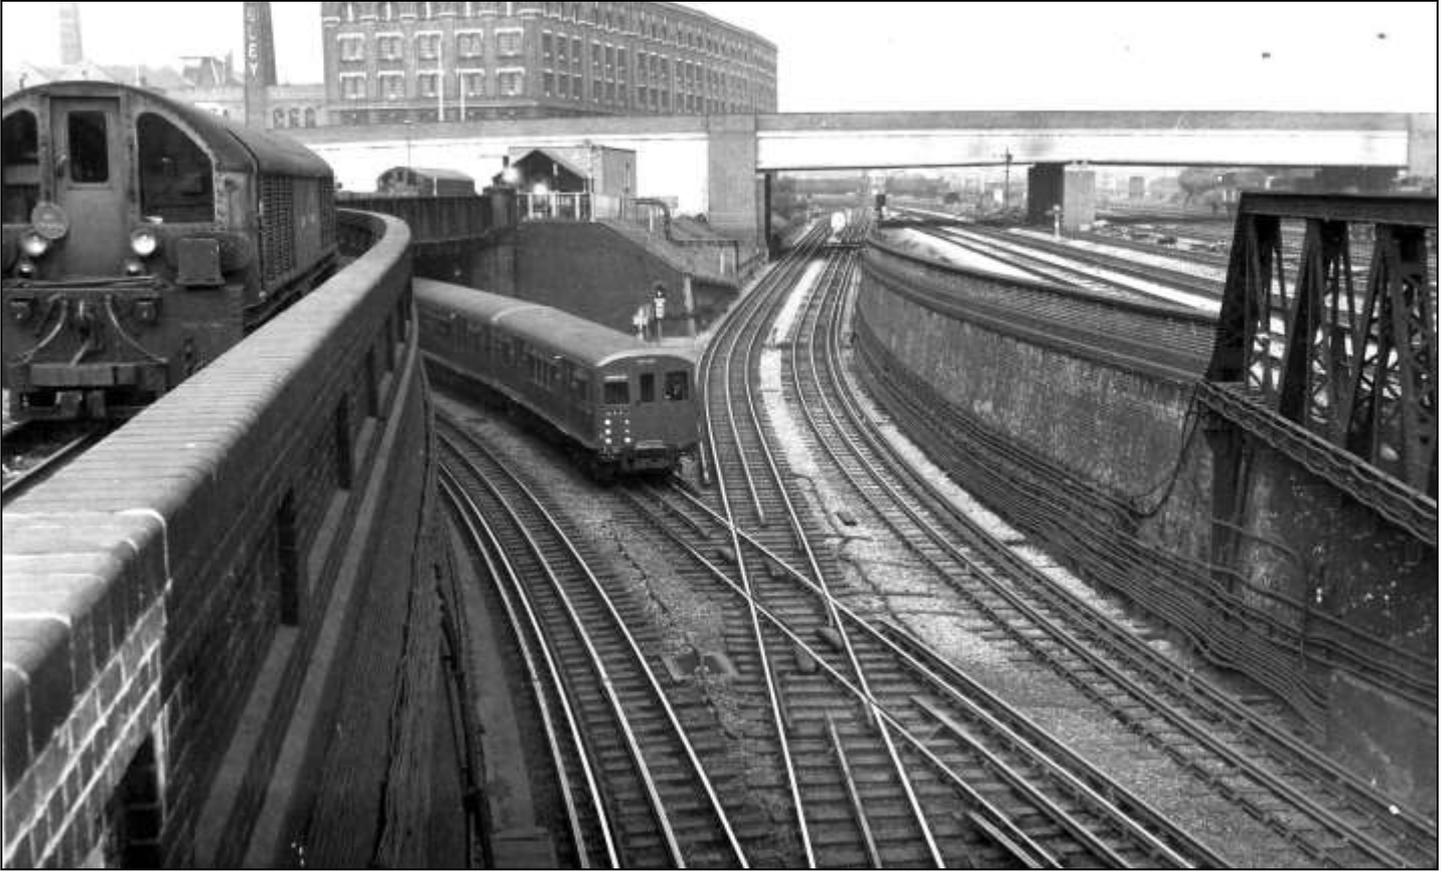
Top: The beginning of the District Line to Kensington Olympia is at West Kensington East Junction, seen here from Lillie Bridge depot. An eastbound train of R Stock approaches from the West Kensington direction. The electrified track on the right from Warwick Road Junction to West Kensington East Junction was provided from 25 January 1914. **Photo: Alan A. Jackson**

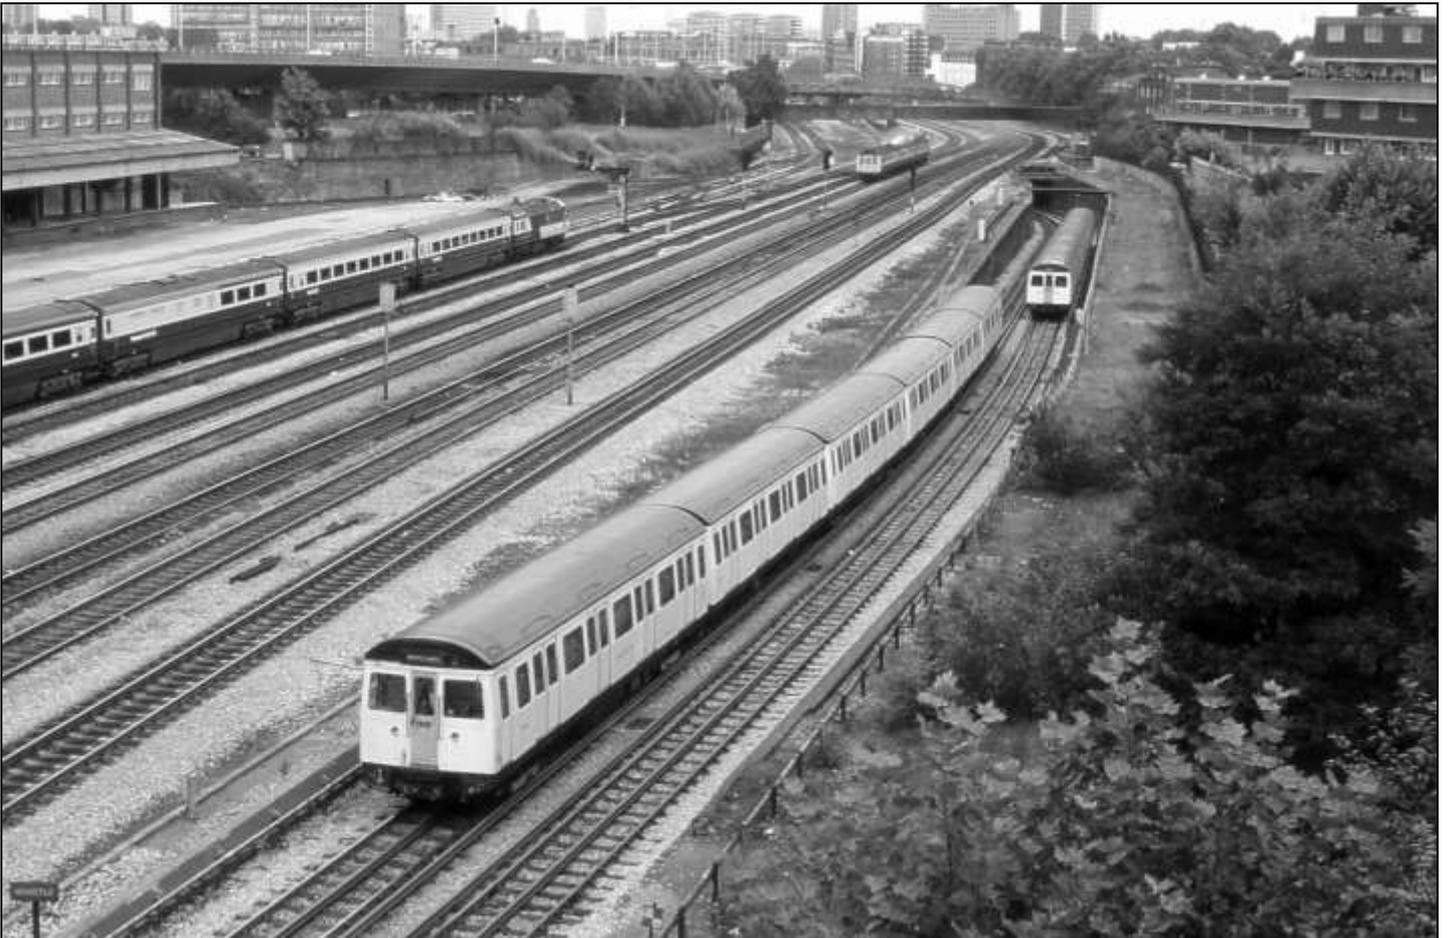
Above: A view of the Hammersmith & City Line in the foreground with the Western Region main line tracks to Paddington behind. Two C Stock trains are seen on the ramp to the flyunder leading to

west of Royal Oak with an HST in Inter City livery upper left and a class 117 suburban DMU in the distance. Mention has been made in these notes about the 'Crystal Palace Loop' (see also diagram below) and it is believed that this was the abandoned track to the right of the flyunder which joined the westbound Hammersmith & City Line roughly at the bottom centre of the photo.

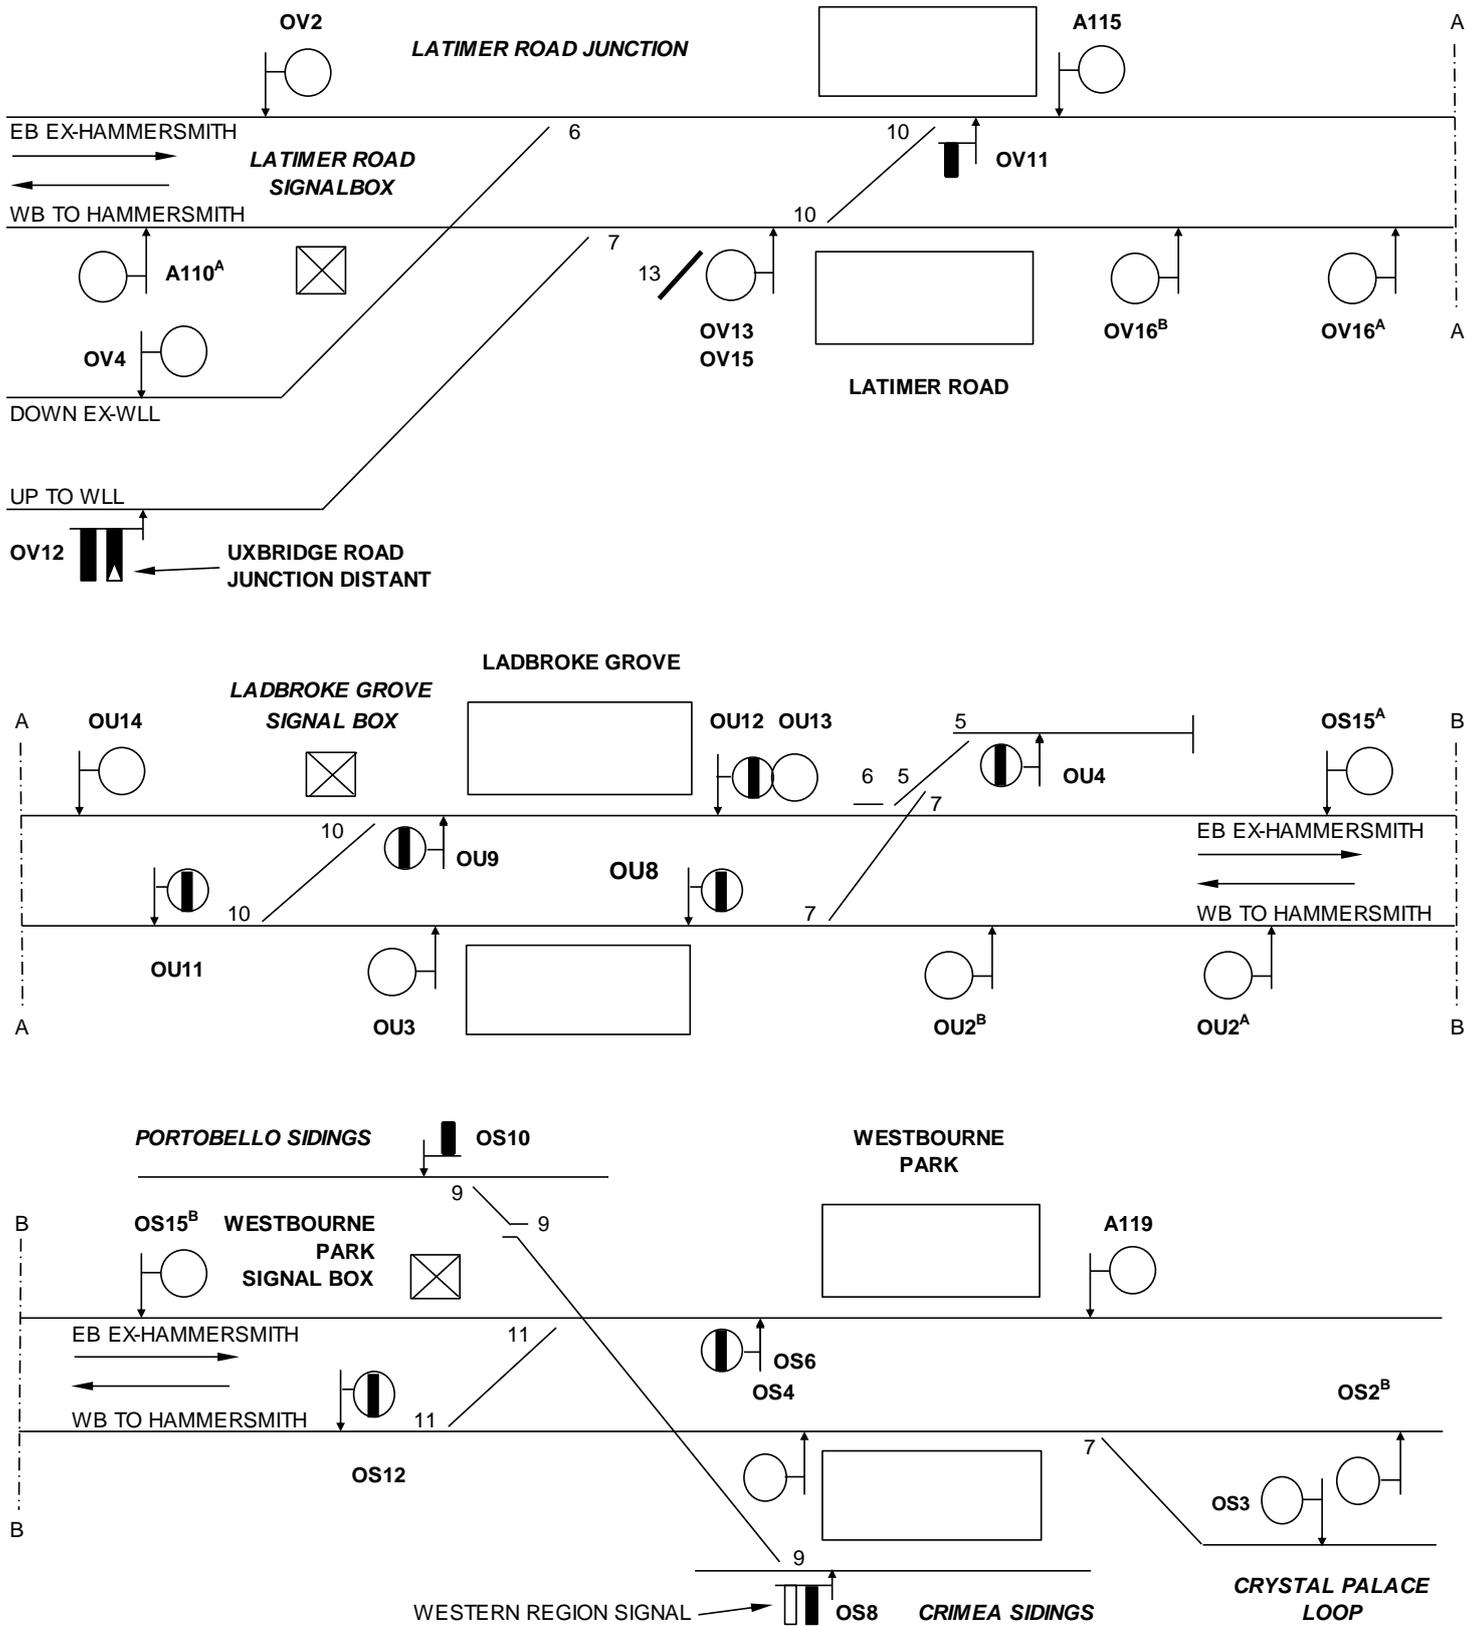
Above: Not-to-scale diagram showing the signalling between Latimer Road and Westbourne Park after signalling modernisation on 28 August 1950 and 10 December 1950 respectively. The connection to the West London Line between Latimer Road Junction and Uxbridge Road Junction then remained in use for freight trains but passenger electric services hadn't used it since October 1940. When this link was severed, Hammersmith freight trains ran via Paddington. For reference, the signalling at Ladbroke Grove was modernised at the same time as that at Westbourne Park.

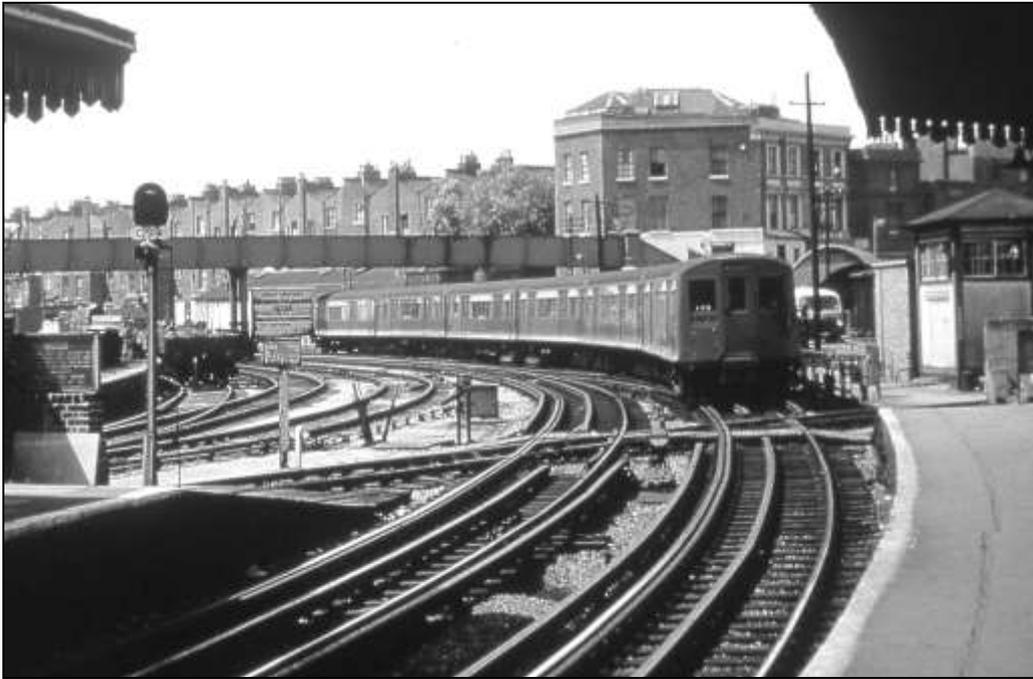
Left: Looking west from the west end of the eastbound platform at Westbourne Park with a six-car eastbound train of CO/CP Stock approaching the station. Westbourne Park signal box can be seen on the right which closed on 13 March 1970 and the area converted to automatic working. Note the flat crossing which, on the left, came from Crimea sidings and led to Portobello sidings on the right. Access to the westbound Hammersmith & City Line was east of the

station from what was known as the 'Crystal Palace Loop'. This was converted to a 'holding' siding and connections with the westbound Hammersmith & City Line were severed from 15 January 1956 with the removal of the relevant signalling and points.

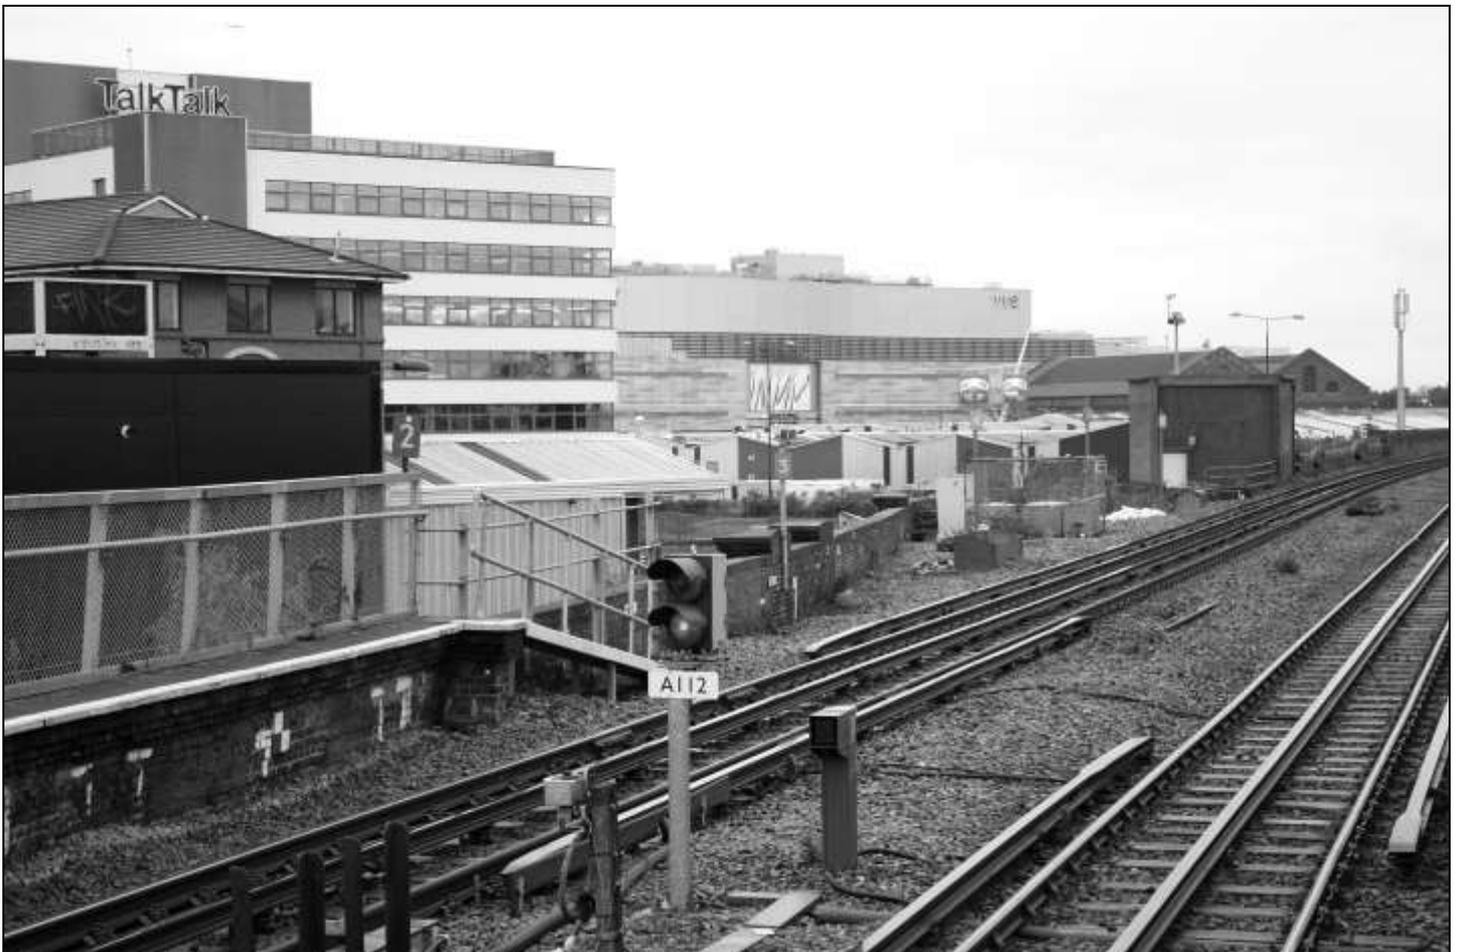
Below: Looking 'west' at Latimer Road from the west end of the eastbound platform on 31 October 2013. Just to the right of starting signal A112 can be seen the brickwork for the viaduct which used to carry the line towards Uxbridge Road Junction and the West London Line. Nothing else of this route now remains as it was finally obliterated by the West Cross Route road (originally the M41 and, since 2000, downgraded to the A3220) which opened between White City and Shepherd's Bush in 1970. In the right background can be seen the former Central London Railway power station, now in use as bus accommodation at Westfield.
