## TERMINAL PROTECTION ET AL

Further to John Hawkins' letter regarding "Terminal Protection" in the April 2008 issue of *Underground News* (page 319), it does indeed seem that "... most advances are made with the benefit of hindsight".

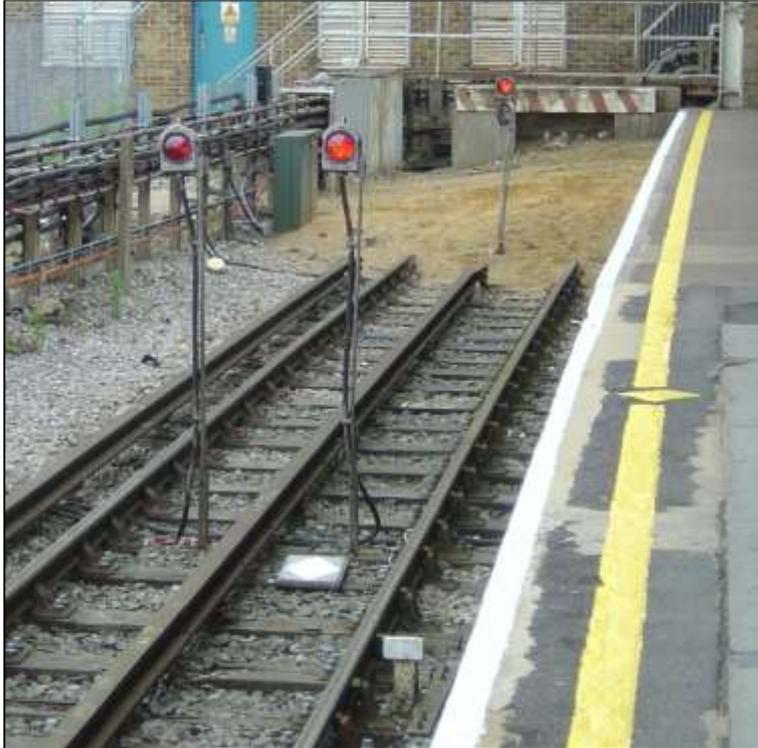
**Left:** Two fixed red lights, a 'diamond' stopping mark (which denotes the point where all trains should stop, irrespective of length) and a fixed trainstop are seen at the east end of the bay platform at Plaistow on 18 June 2008. The sand drag and single fixed red light (which were all that were provided pre-Moorgate) are seen beyond.

This is why places like Stratford (Jubilee Line) have the stopping marks located a considerable distance from the actual end of the line which means passengers have a walk between the concourse and the first available carriage. On the existing railway, Stanmore is another example where trains no longer reach the buffers.

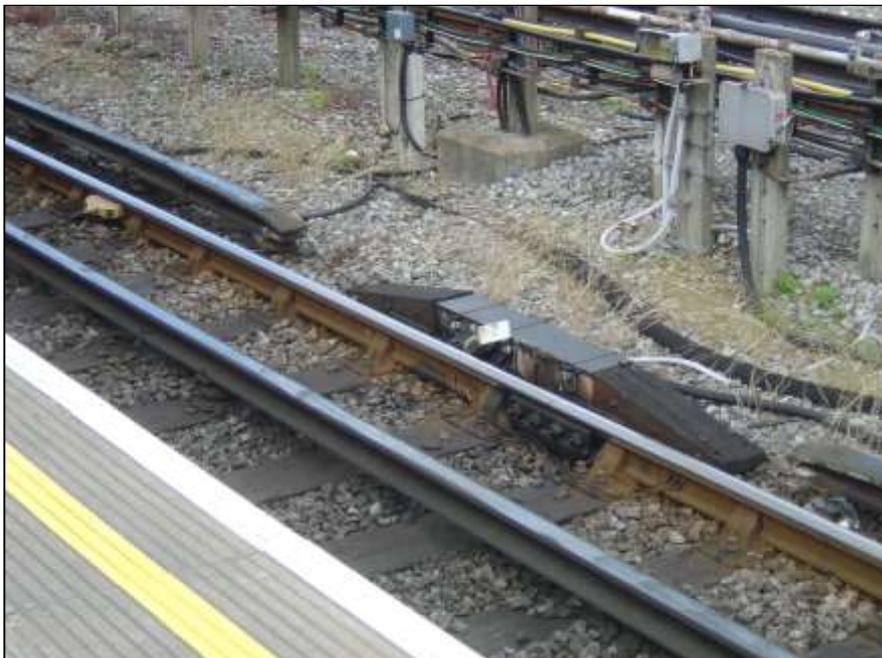
Another stage of “Terminal Protection” was to install trainstops (generally two but sometimes one, sometimes three) in platform areas, which would only lower if the speed of an arriving train had been sufficiently reduced. If the speed was in excess of that stipulated (generally 15 and 10mph), then the train would be ‘tripped’ and brought to a stand long before the dead end. The second of two trainstops, this one (*left*) is set to lower when trains approach at 10mph or less, in platform No.2 at Stanmore.

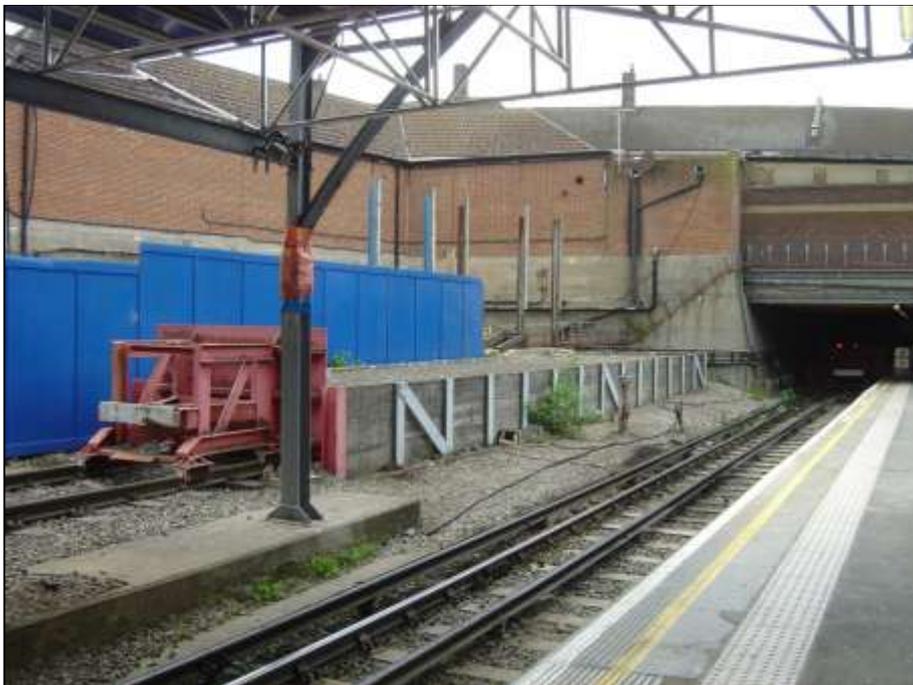
The train arrestor at the end of platform No.1 at Edgware on 25 June 2008 (*left*). To the left is the crash dolly which will slide along the track if hit by a train. The large 'container' of granite chippings is beyond it.

The next stage of "Terminal Protection" was the development of the train "arrestor". Trials were undertaken out of the public eye in a corner of Upminster depot, which involved deliberately running trains into various designs of sand drags and buffer stops at speeds up to 22mph – without a motorman on the front, of course! There was sufficient withdrawn 1938 Tube and CO/CP Stock available to do these tests and in the end the system decided upon was a "crash dolly" which, if hit by a train, would engage with it and slide back into a large rectangular area full of granite chippings.

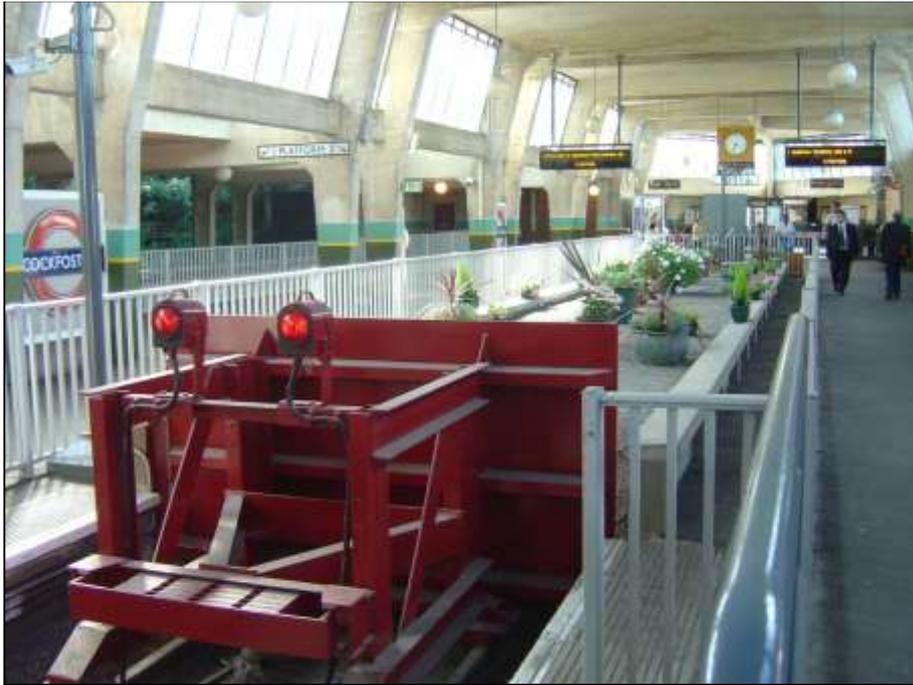
The train arrester at Cockfosters at the end of platforms 2/3 is seen (left) on 1 July 2008. Wire netting has been placed over and proud of the granite chippings, and plants and flowers now stand on top, making the ambience more presentable.
