# DISTRICT ELECTRIC TRAINS

## 31 – THE END

by Piers Connor

### C STOCK ON THE DISTRICT

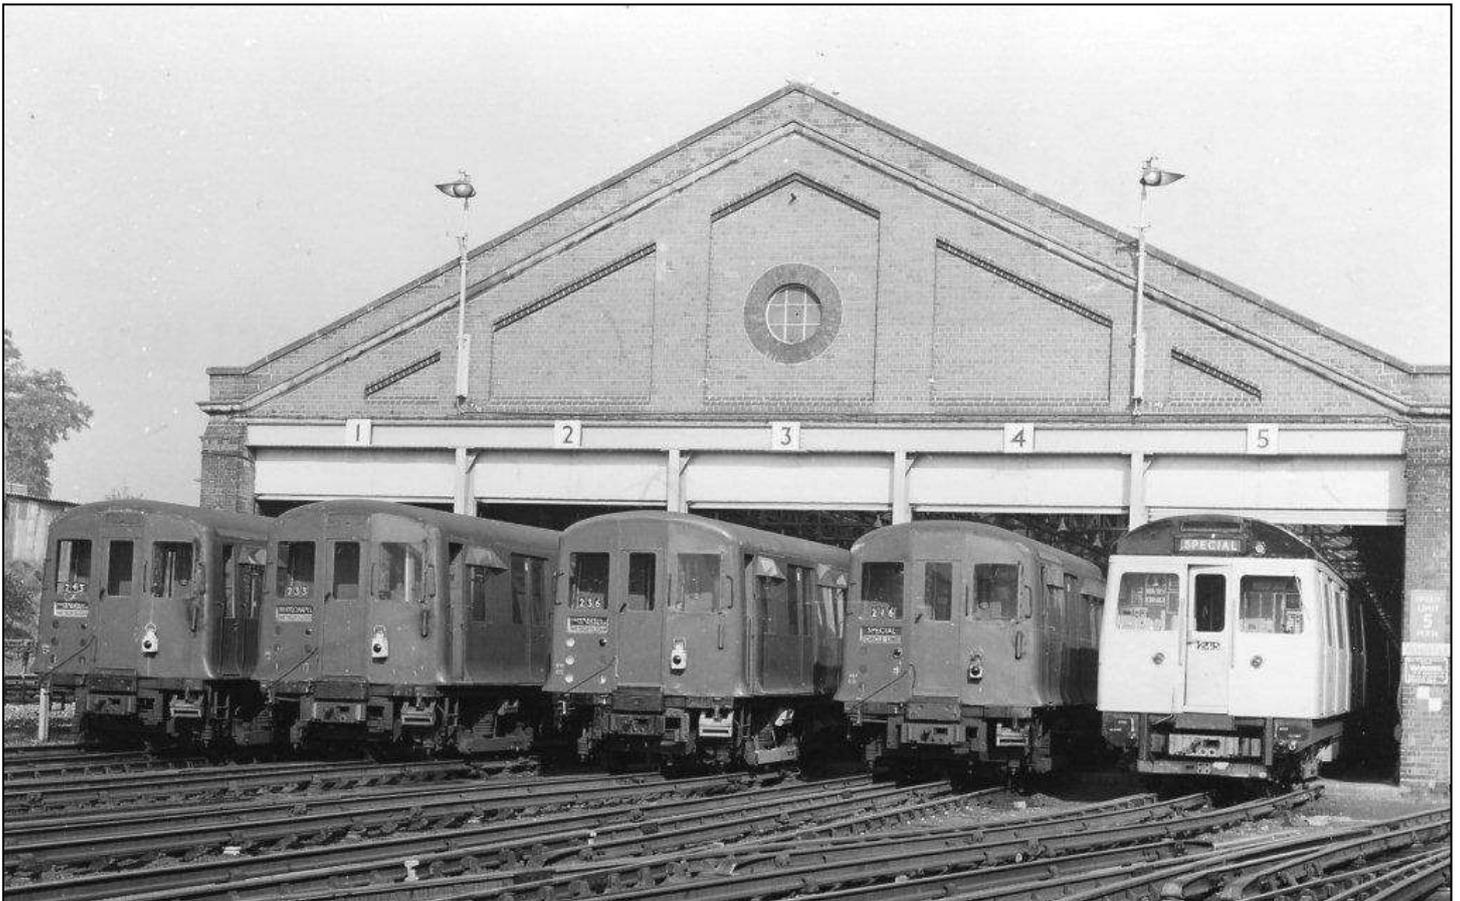
*Fig. 1: Two CP (on 1 and 2 roads) and two CO Stock motor cars (on 3 and 4 roads) lined up with one of the first C Stock trains that were to become their replacements. This was in late 1970, when your author was a driver on this line. We greeted the new trains with a degree of suspicion since they were rather more complicated than the old stock and they didn't handle very well. They also lacked external handrails, which made getting in the cab difficult. I also recall the fitters in the depot struggling with the compressor oil filler and they had to design a long neck to a funnel to get oil into it*

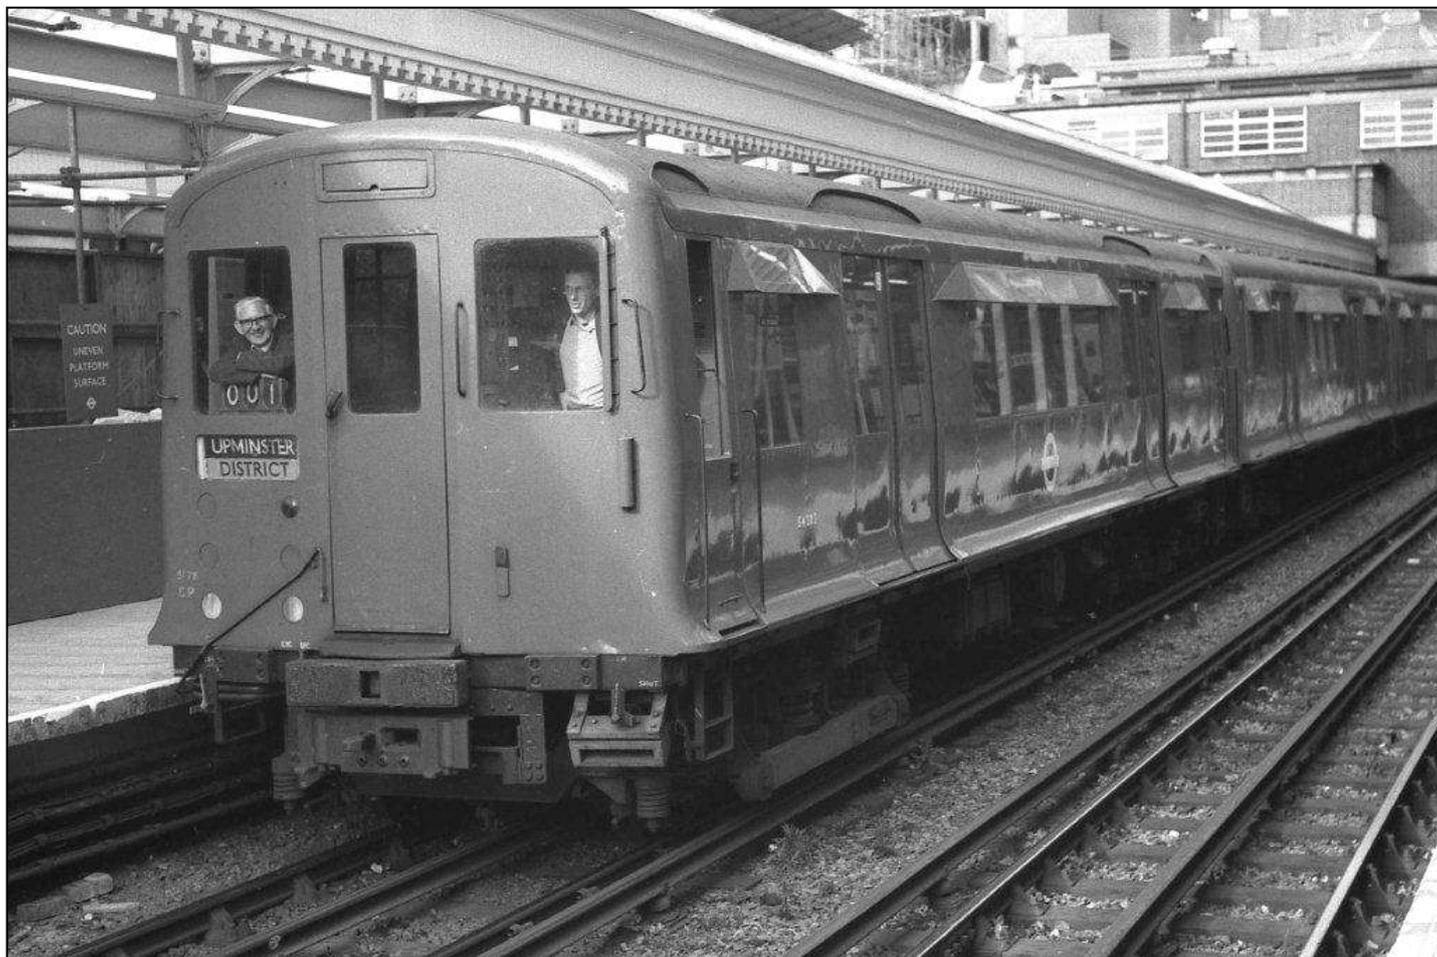
*Fig. 2: CP Stock motor car No. 54202 on an Upminster train at High Street Kensington one Sunday in October 1978 during a diversion required by the renewal of the crossing diamond at Gloucester Road. The second driver, grinning widely and leaning on the set number rack is one Motorman George Tovey from Baker Street Metropolitan depot, who is acting as pilotman for the District driver. George, who was a colleague of mine when I was at Baker Street, was always a cheerful character and is no doubt especially pleased here as, being on pilot duties, he is saved the work of driving Circles. Or, perhaps he was just smiling for the photographer, our own Brian Hardy. The motor car in this photo is one of two that were given modified autterina to trv to eliminate the persistent drainaae problems of the flare-sided stock.*

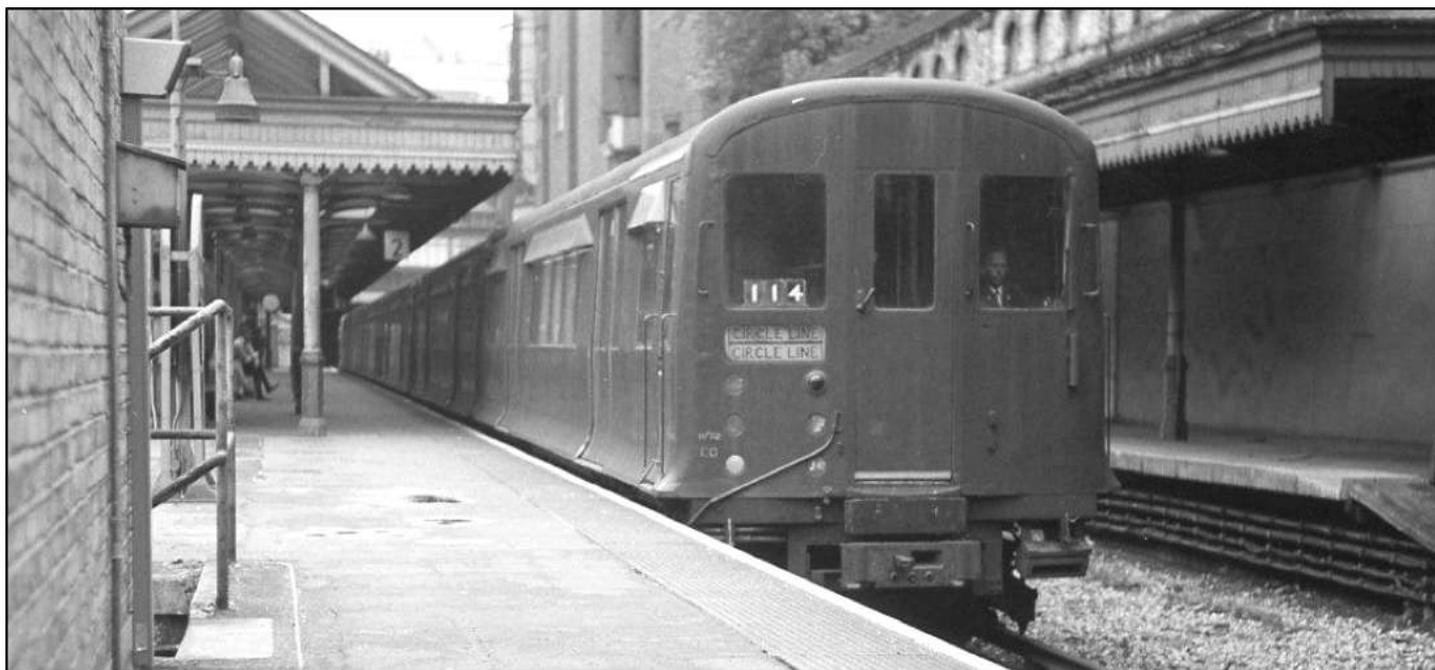
*Fig. 3: Six-car Circle Line train led by a westbound CO Stock motor car on the eastbound road at South Kensington. The odd orientation of the train is because trains on the Circle faced the wrong way round on the south side of the line. The train is actually a District-based train, as denoted by the set number 114, so this is on a Sunday. The cab front shows a couple of modifications carried out in the early 1960s. The curved pipe across the marker light array carried the tripcock reset rope. It was extended from its original position on the headstock to avoid the necessity for the driver to get down from the cab to reset the tripcock. On the other side, just below the driver's window is the whistle housing. This was moved from under the cab floor, where it often got blocked by dirt and failed to work.*

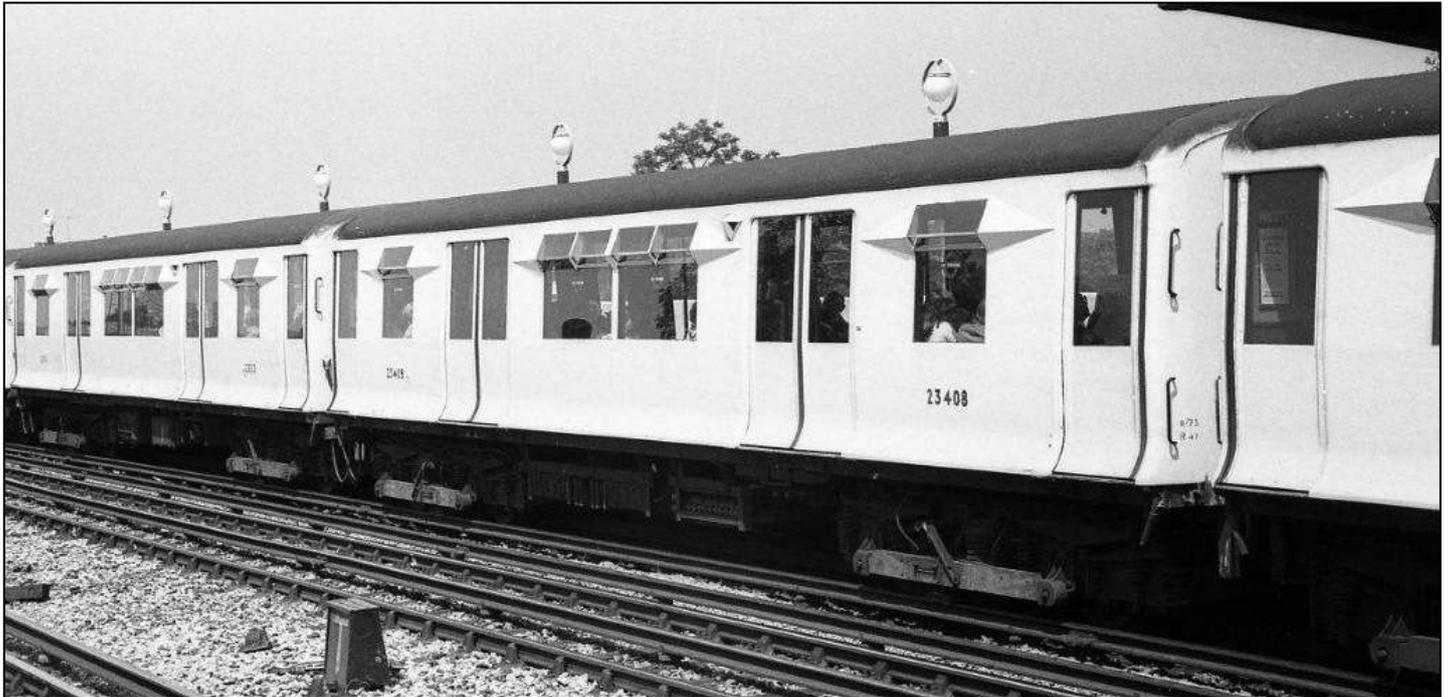
*Fig. 4: An R Stock train in its final days at Stamford Brook showing a No.4 car. This was a Non Driving Motor but it had an automatic coupler at the east end (nearest the camera) so that it could couple to the east end 2-car unit. Its east end had additional handrails near floor level to assist crews who had to align the coupler. These were also provided on the west end of the adjacent No. 5 car.*

<sup>4</sup> A "cutting" key was a used on the New York Subway to "cut" or uncouple cars. The key was inserted into a switch housing on the outside of the car. The R Stock had a similar switch on the west end of the No. 5 car that was used to operate the automatic couplers between the units.
