STATION REFURBISHMENT SUMMARY

as at mid-February 2009

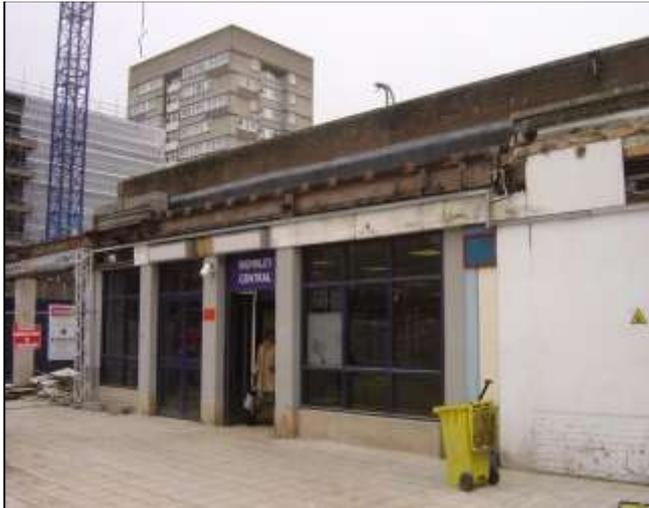
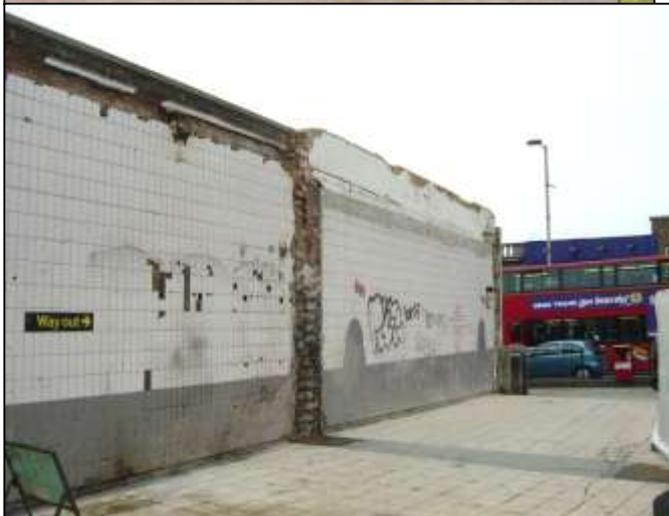
Below: These two photos of Wembley Central were taken on 12 February 2009 and show the temporary 'main' entrance (*left*) and the view looking out at Wembley High Road (*right*). The furthest wall still retains two of the silhouettes of the former Wembley Stadium 'towers', but probably not for much longer.

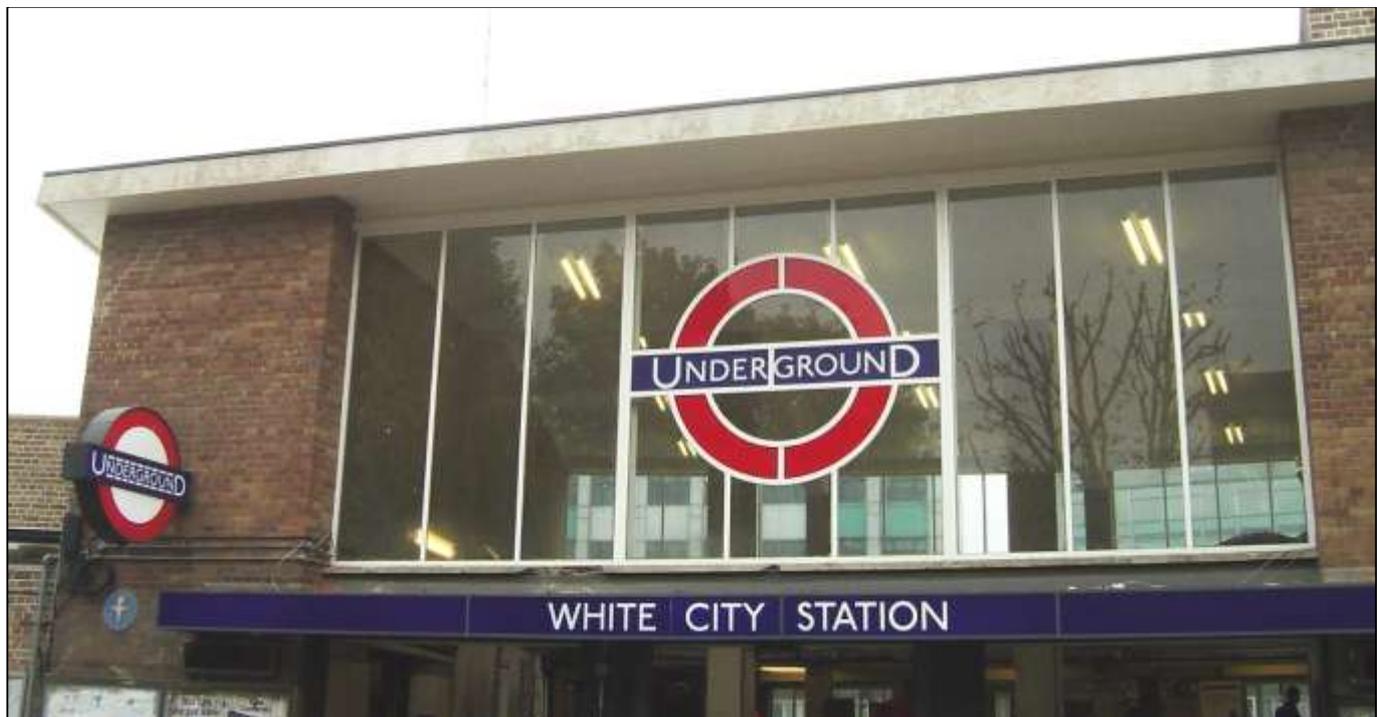
Below: The 'restored' station entrance at White City. The Underground signs at right angles to the building (one of which is seen at the left-hand-side), although in heritage style, are not in keeping with a post-war station which opened in 1947. Nevertheless, the incorporation of 'heritage' features is to be commended. On 5 February 2009 the sign at the left of the photo had been removed but that on the right (out of the picture) was still in position.

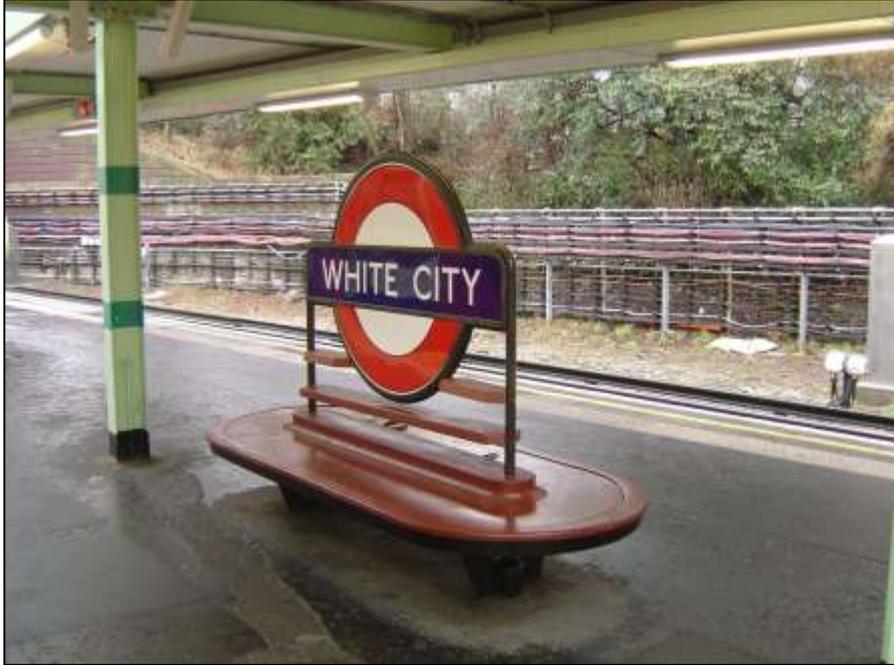
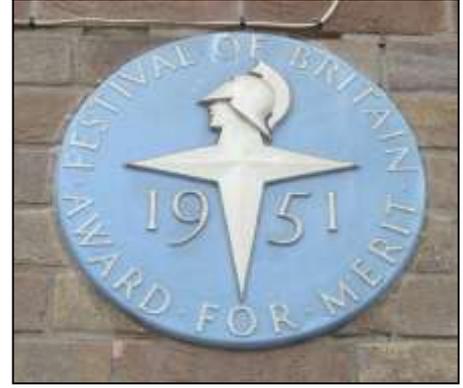
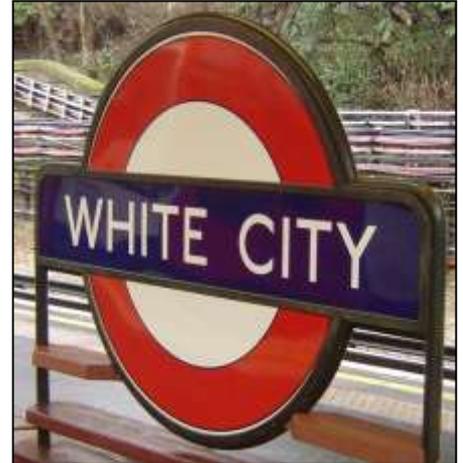
The restored combined seat/roundels at White City (*above*) although the roundels themselves (*right*) are 'lined' whereas at least some of the previous ones were not. The plaque commemorating the Festival of Britain in 1951 (*above right*) has been retained outside the station entrance.

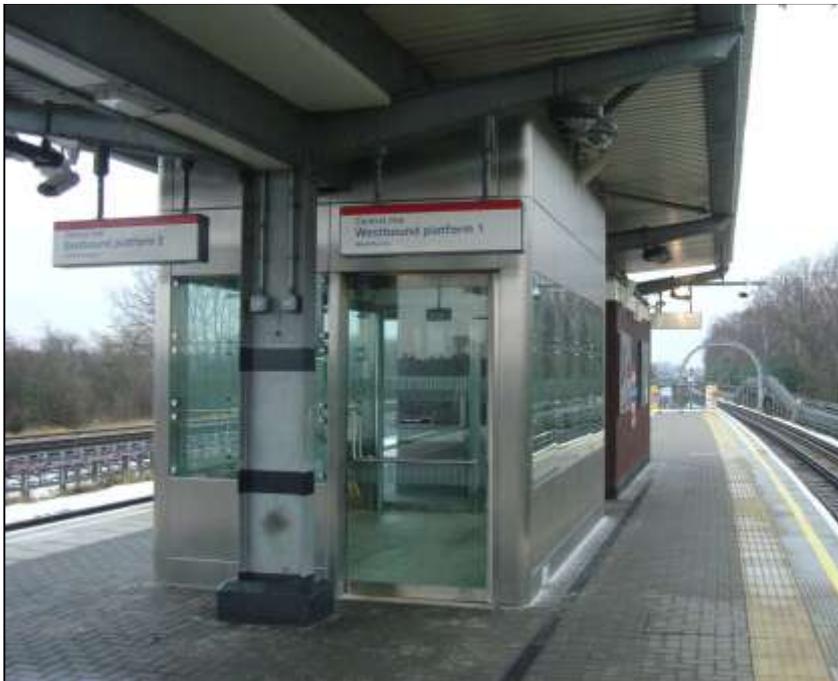
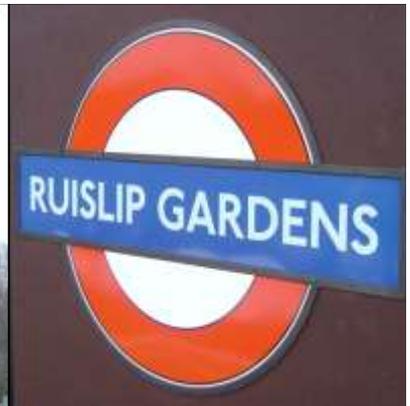
It appears that the incorrect font has been applied to the new roundels at Ruislip Gardens (*above*), and the waiting room (*left*) comprises an 'aluminium' shell rather than the usual glass. For many years the platform numbers here have been different from the normal

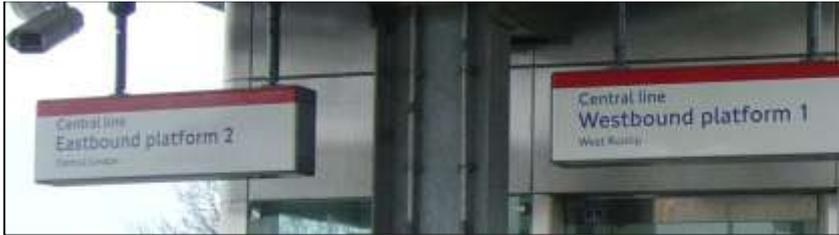
standard but resigning has meant that traditional numbering has been restored (left).

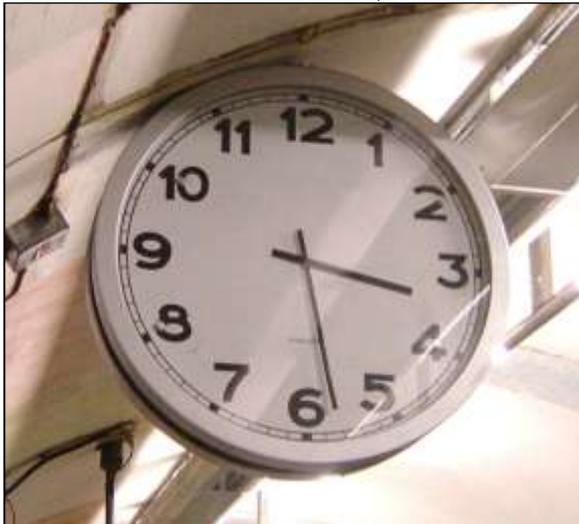
The low-level passageway to the ‘Shell’ escalators has many ceiling panels removed but in the ‘Shell’ ticket hall, no work has been noted.

The refurbishment of both Bakerloo Line platforms are at a similar stage with new biscuit-coloured tiles (on which temporary paper roundels have been stuck) with dark grey tiles at the passageway corners. New lighting has been installed parallel to the old, but is not in use yet and neither are the new Help Points – they have generally been placed next to those still in use. Platform edge tactile strips haven’t yet been fitted. The former Yerkes tiles have been exposed on the opposite tunnel walls. This new clock (*left*) on the northbound Bakerloo Line platform looks quite out of keeping compared with traditional railway clocks that can be seen at other refurbished stations around the network.

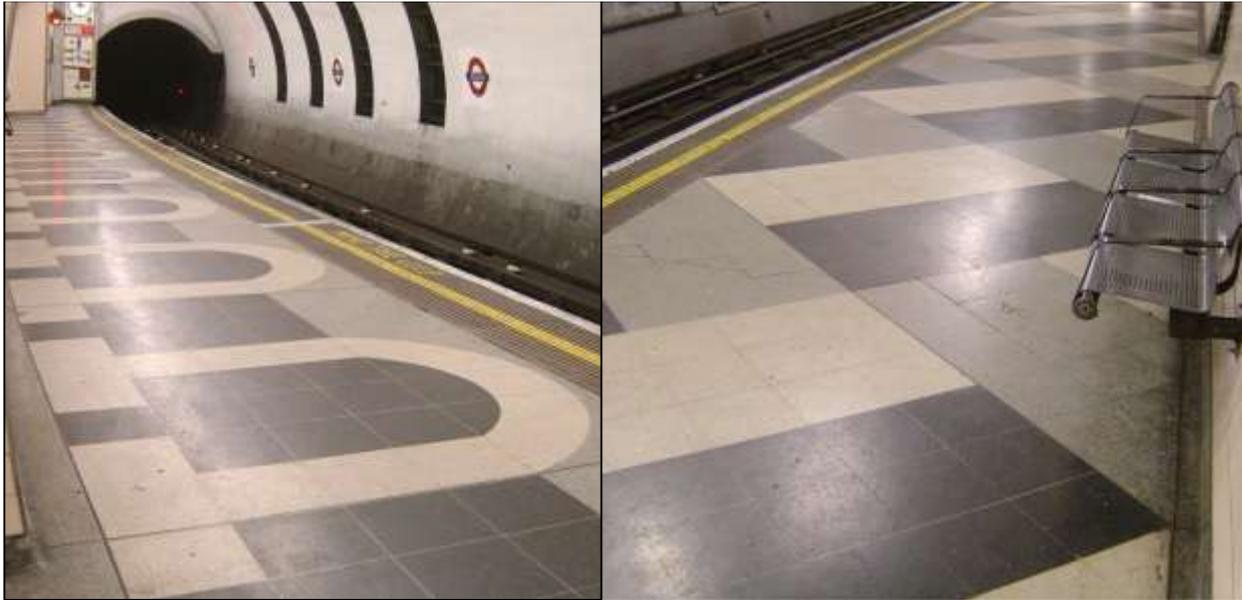
The Northern Line platforms are being finished in the same style as the Bakerloo and both seem to be running in parallel, progress wise. The distinctive platform flooring on both the Bakerloo (*below, left*), and Northern platforms (*below, right*) is being kept.

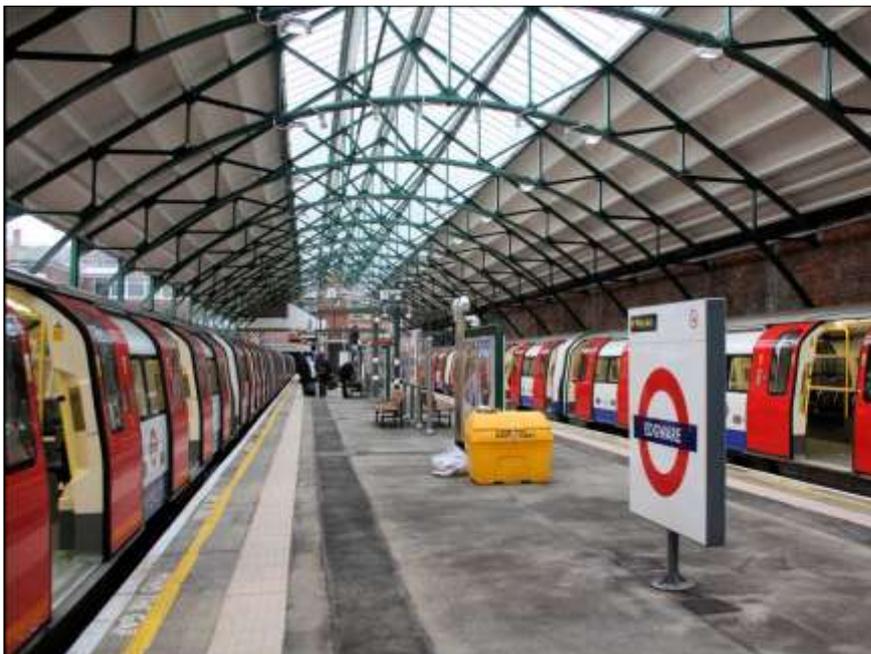
EDGWARE – The station refurbishment has been completed and the end result is very pleasing, especially the roof. Not yet complete, however, are the new MIP lifts, which are expected to be in service in April 2009.

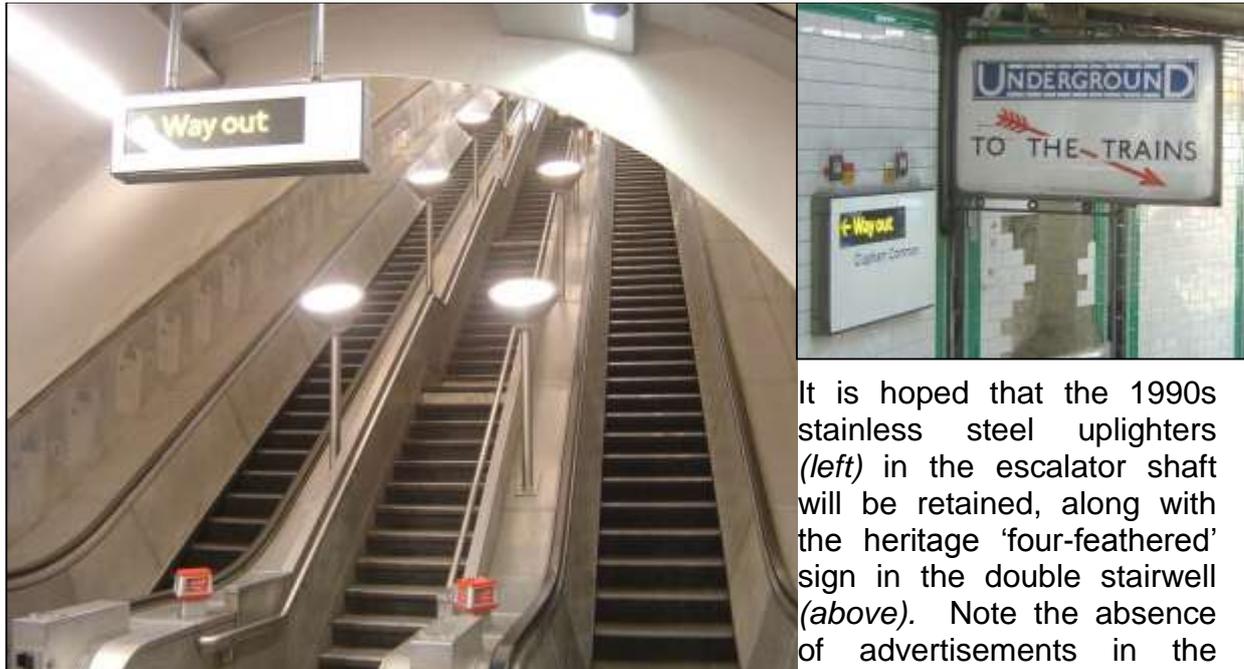
It is hoped that the 1990s stainless steel uprighters (*left*) in the escalator shaft will be retained, along with the heritage 'four-feathered' sign in the double stairwell (*above*). Note the absence of advertisements in the escalator shaft.

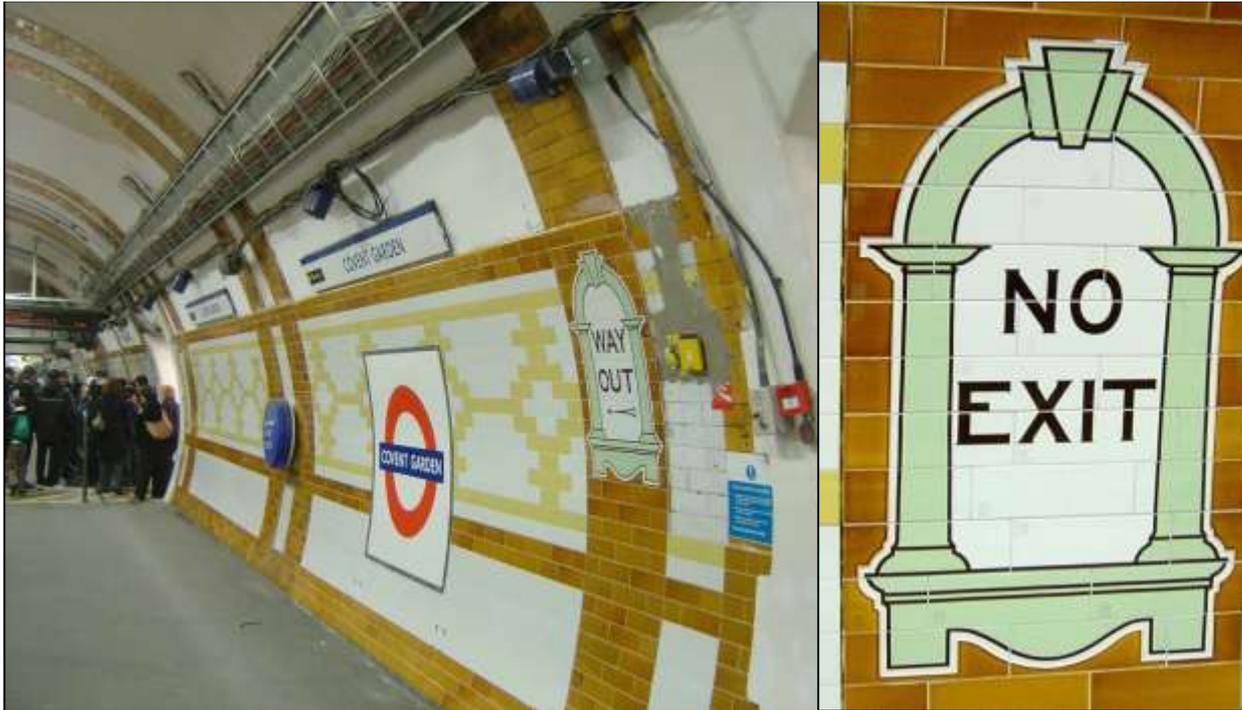
COVENT GARDEN – This station is also being retiled in heritage style, but again with the new tiles being applied over the old ones (*above, left*). Despite this, it is pleasing to note that the ‘Way Out’ and ‘No Exit’ tiles have been copied with most now in place (*above, right*). New lighting has been commissioned on both platforms. The troughing for the cables can also be seen and at present, the old ‘tin can’ PA speakers remain in use.

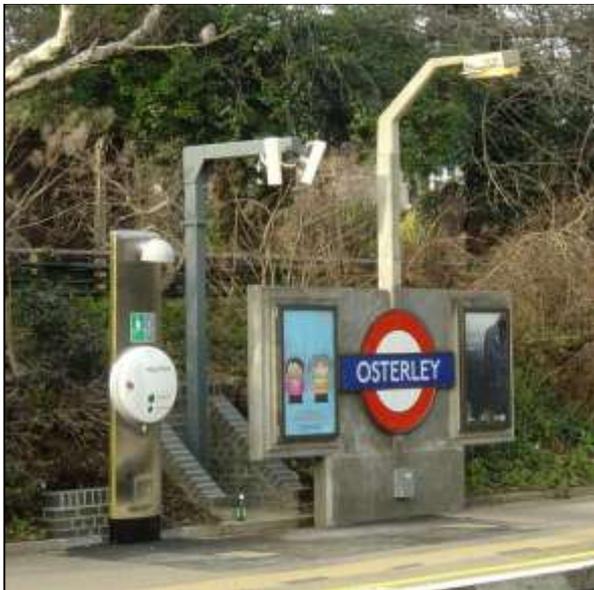
OSTERLEY – One of the pleasing aspects of the now completed refurbishment here is that the posts for CCTV and PA speakers have been set back in specially constructed brick recesses, seen here (*left*) on 16 February 2009. One of the new Help Points is seen to the left, which is illuminated, the lamp for which is above. The concrete lamp and sign stands are not, of course, original, having been replaced in the 1980s. The originals had more graceful curves, while the replacements, seen here, are more ‘angled’. The ticket hall has also been restored with heritage features, including the individual lettering above the various doors.

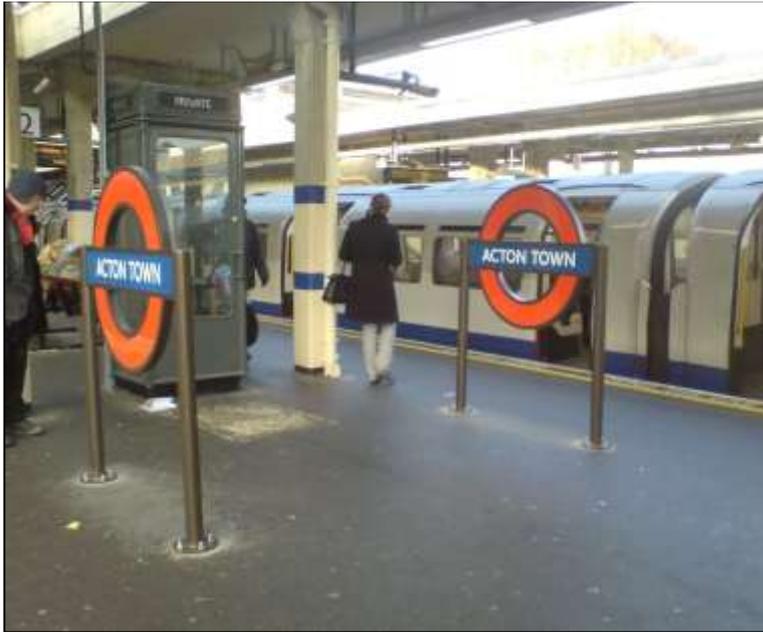
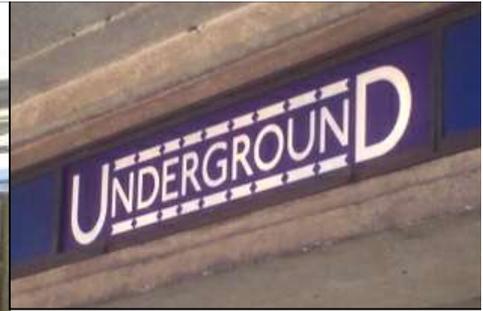
A nice touch at Acton Town are the 'fishtail' heritage Underground signs under the canopy (*above*), which look even better when illuminated at night. A traditional full-size roundel, normally found on platforms, has also been installed on the wall at the Bollo Lane entrance to the station. The free-standing roundels (*above left*) were remarkably only in place for a couple of weeks. Not only were they out of keeping on a 1930s heritage station but were probably unnecessary obstructions. By the end of January 2009, one had been removed and the other had been placed between seats (*left*) giving a sort of modern 'take' on the old wooden roundel seats at Hammersmith and High Street for example. One wonders if the displaced roundel will find its way into a similar position on the eastbound?

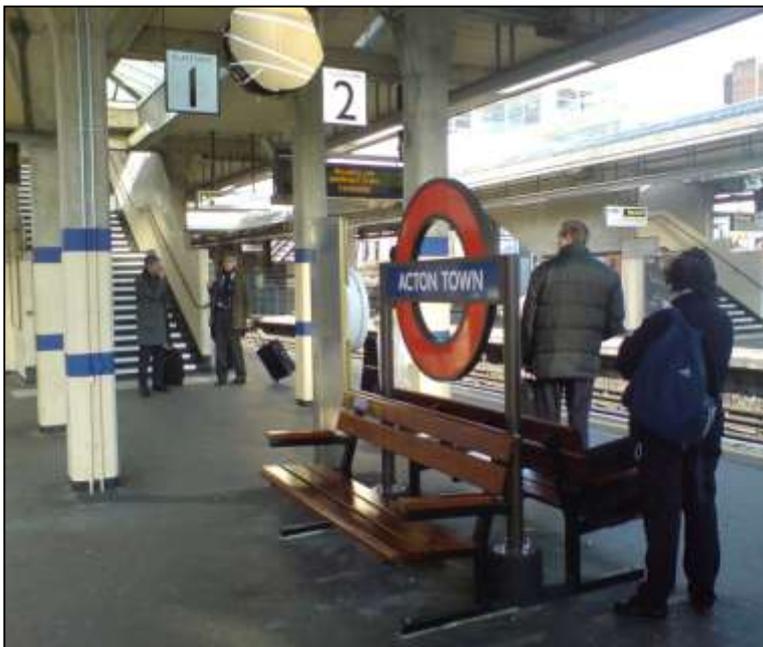
All in all, the finished work at Acton Town looks very good, but already the cream paintwork has scuff marks from wandering feet that can't be left on the ground whilst waiting for trains!

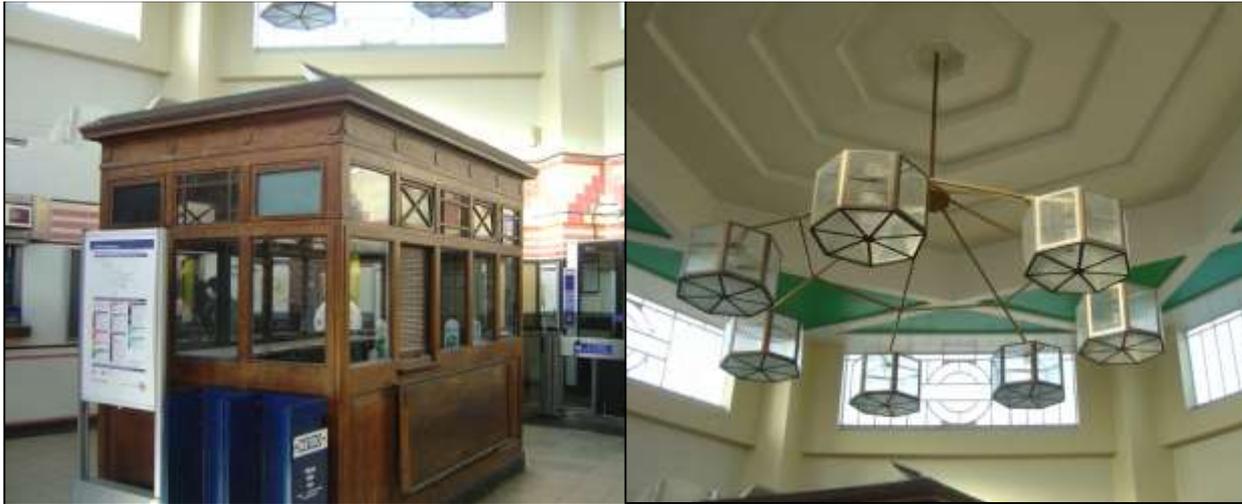
HOUNSLOW WEST – The platforms here remain virtually unchanged, save for a general tidy up, as they are only 34 years old and in good order. The heritage ticket hall, presumably having listed status, retains the wooden District Railway passimeter (*overleaf, top left*) and the seven-sided lamp shades (*overleaf, top right*), behind which can also be seen roundels in the glass.

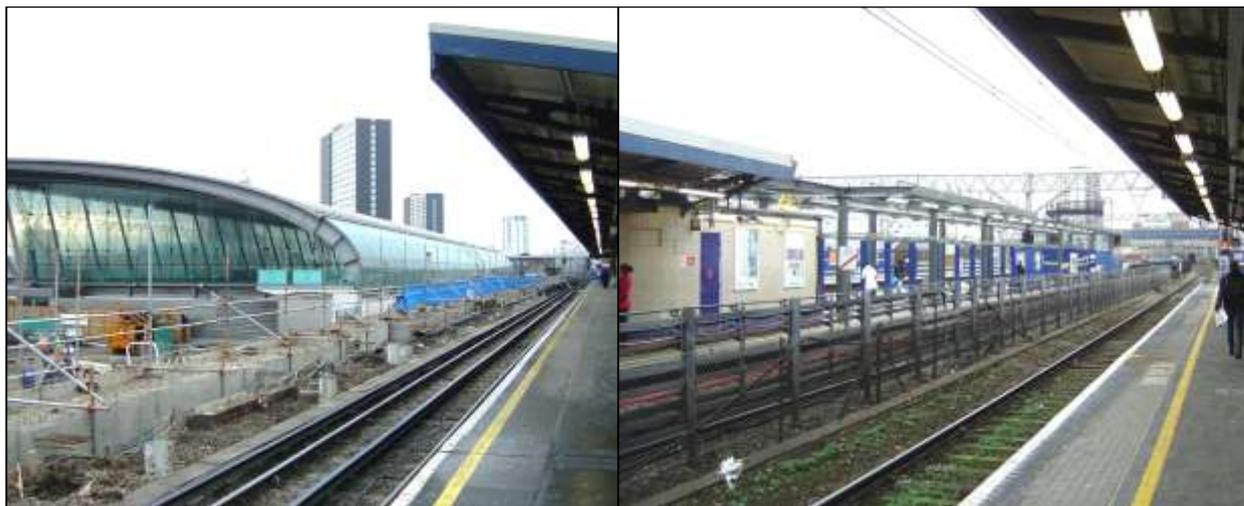
STRATFORD – The situation on 12 December 2008 is shown below with the site of the additional westbound platform taking shape (*below, left*) and the new canopies being installed over platforms 5 and 6 (*below, right*).

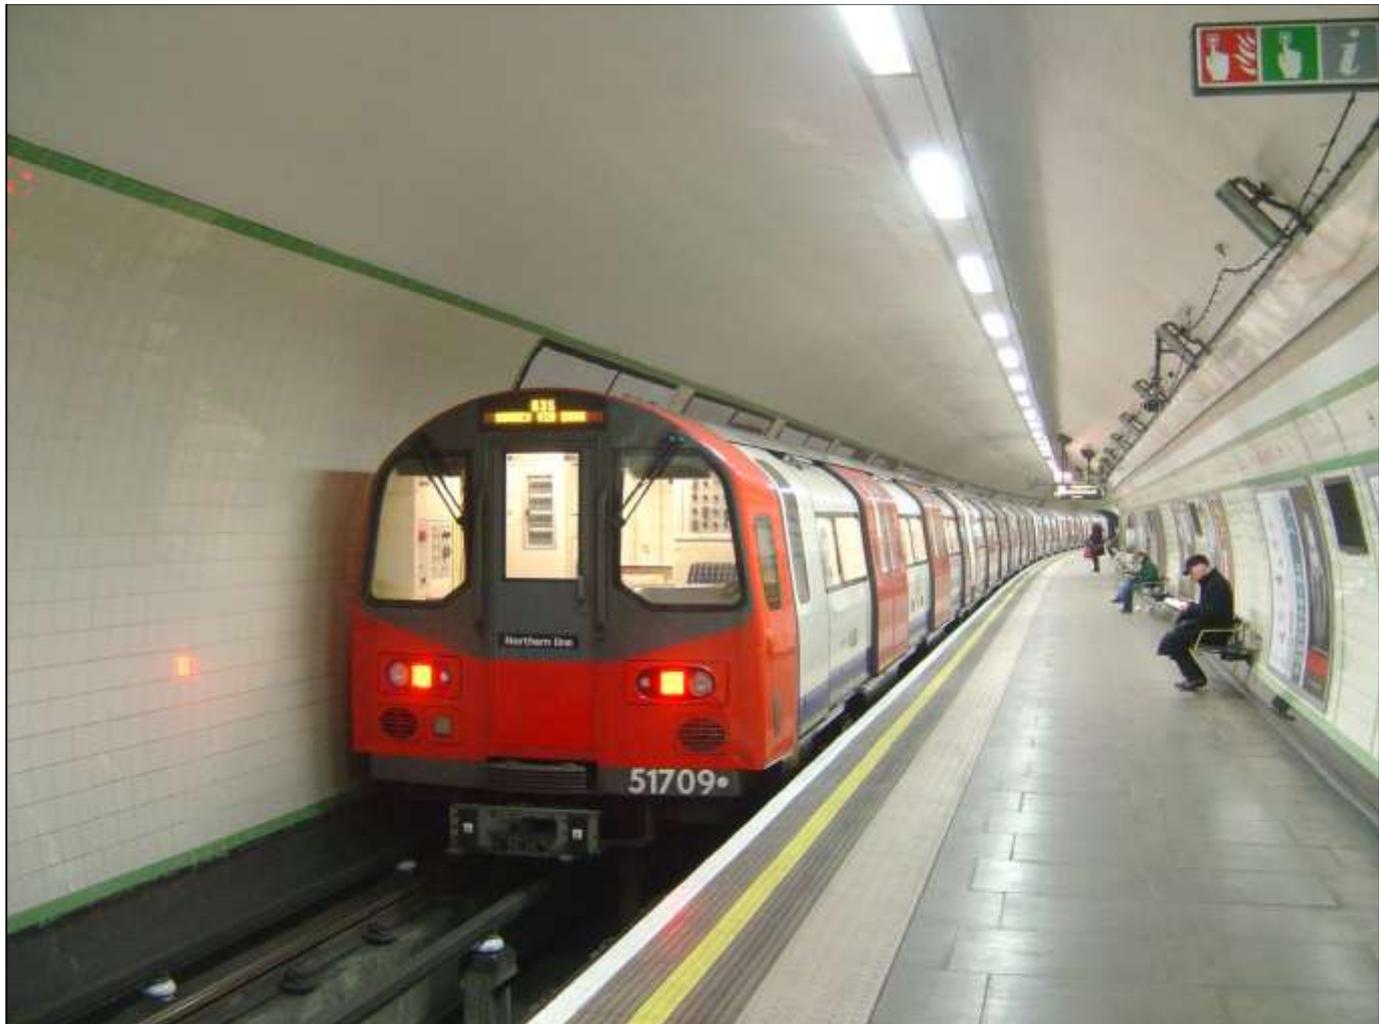
HIGHGATE – Although regarded as ‘completed’ in 2008, there are cables which continue to run along the platforms above frieze level, rather than having been enclosed, as seen here above, at the top right, on 16 February 2009.
